FINAL REPORT
U.S. AIR FORCE RADIO RELAY STATION LANDFILL (LF007)
SUPPLEMENTAL REMEDIAL INVESTIGATION
PORT HEIDEN, ALASKA

CONTRACT NO. W911KB-17-D-0019
DELIVERY ORDER NO. W911KB17F0078

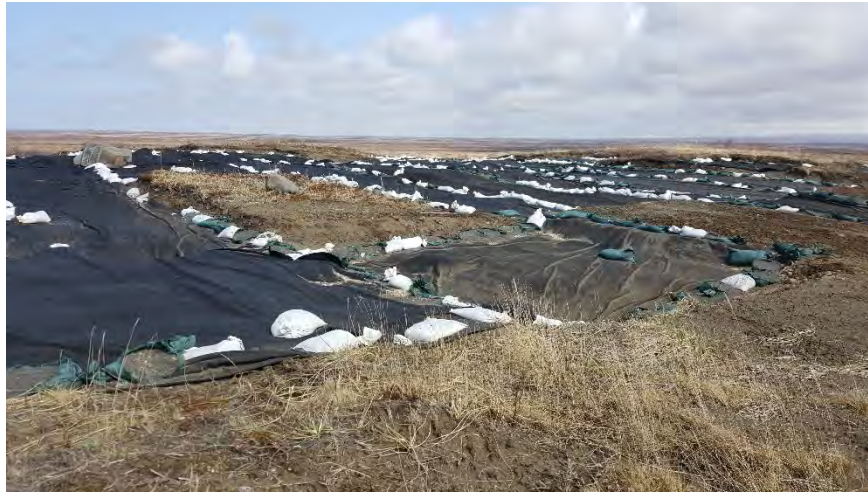
- Main road to the landfill is blocked at the former facility area by fencing marked “Danger: Keep Out”. Meeting attendees were not aware of the reason, speculated that it was due to remaining PCB contamination. Heather Williams followed up with Greg Rutkowski (Jacobs) following the meeting. Greg indicated that the fencing is to limit public access to the landfill, since excavations there were not backfilled.

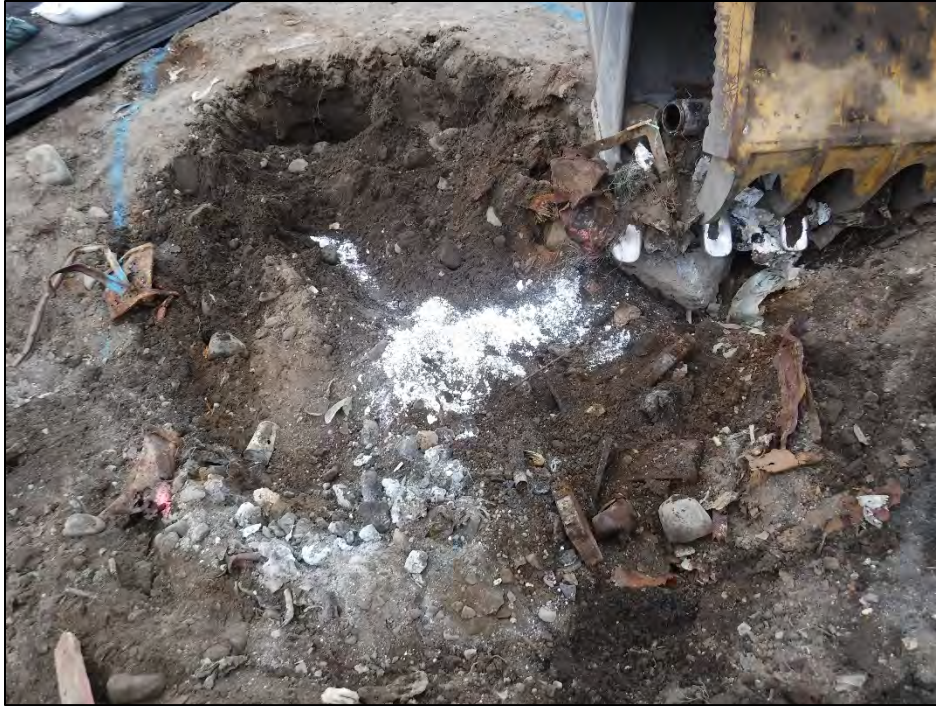
Photograph 39: Close-up of observed white power in TP-13B. 22 Jul 2018.

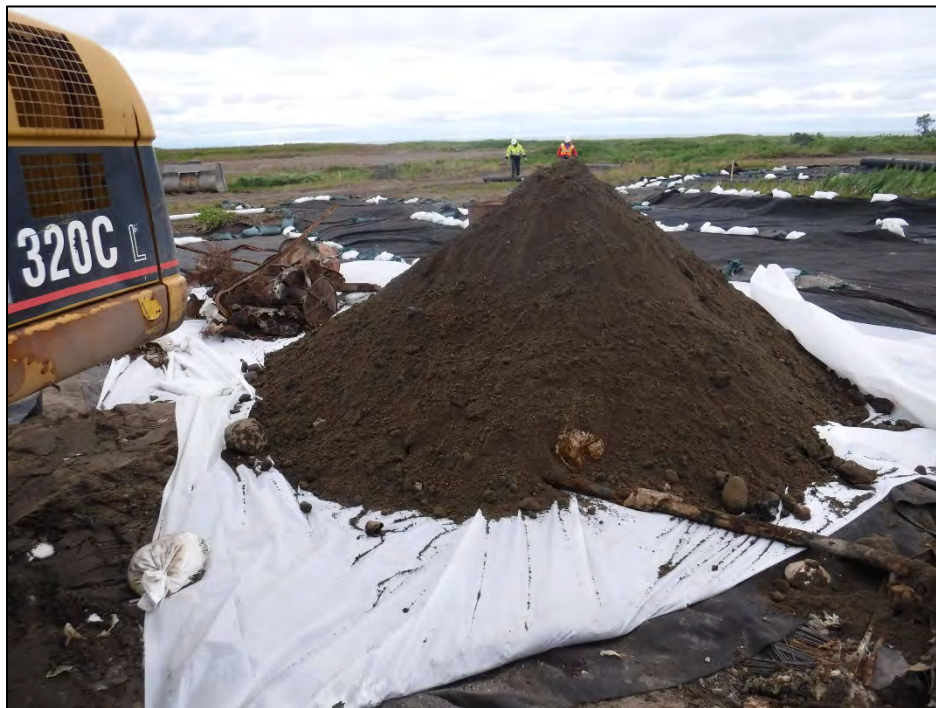
Photograph 40: TP-13B excavated debris, facing west. 22 Jul 2018.

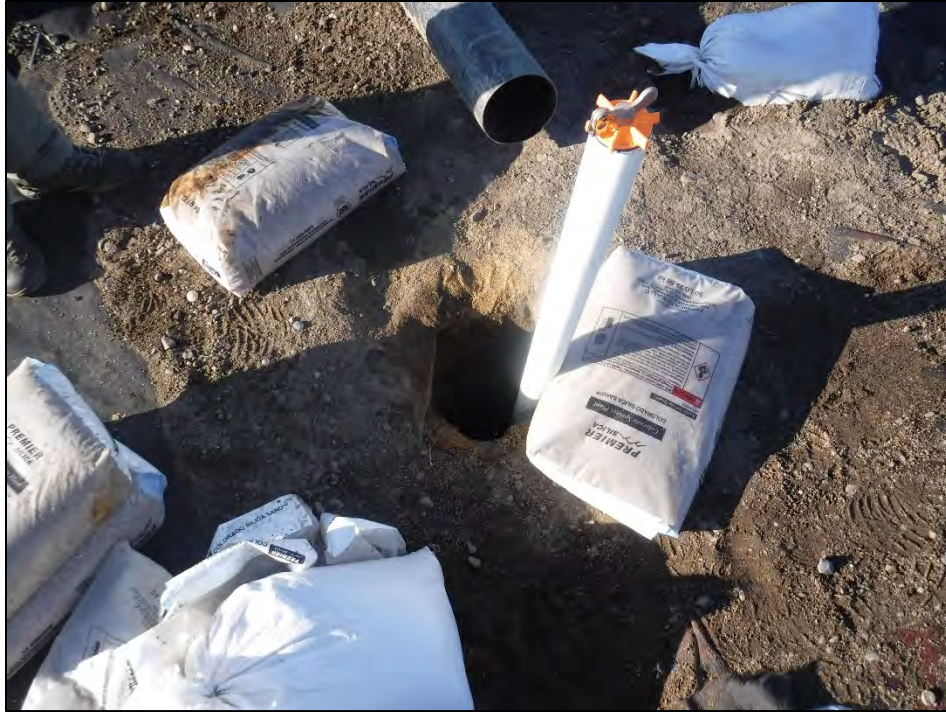
Photograph 75: Cavity observed at MW-10 during attempted well development. Cavity observed to extend approximately 24 feet below ground surface (ft bgs). 29 Jul 2018.

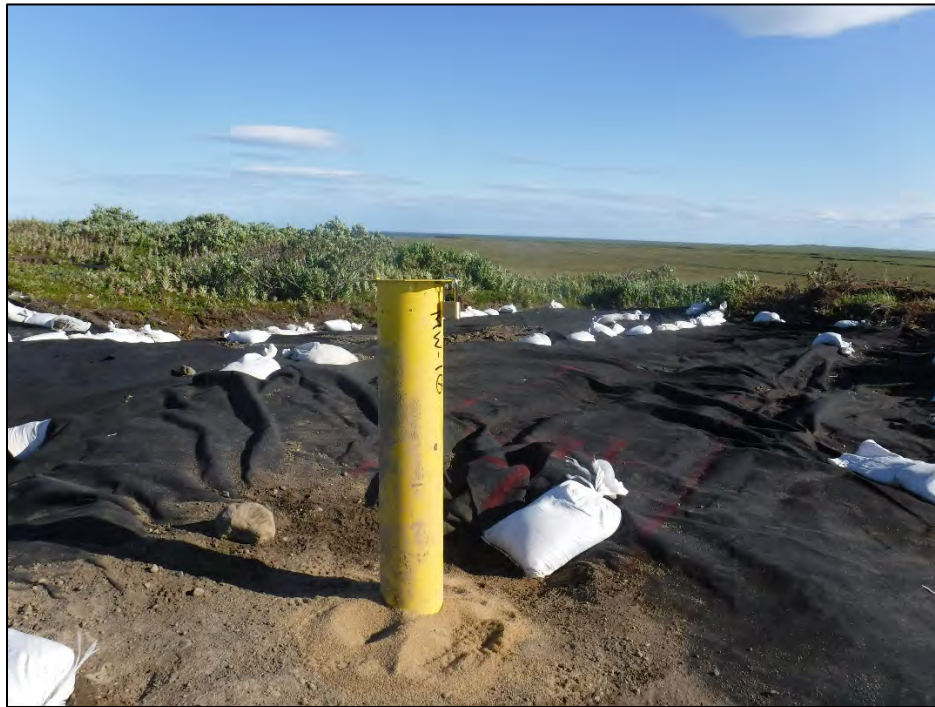
Photograph 76: MW-10 monument re-establishment. No water observed in well and no further well-development or sampling possible, facing north. 29 Jul 2018.

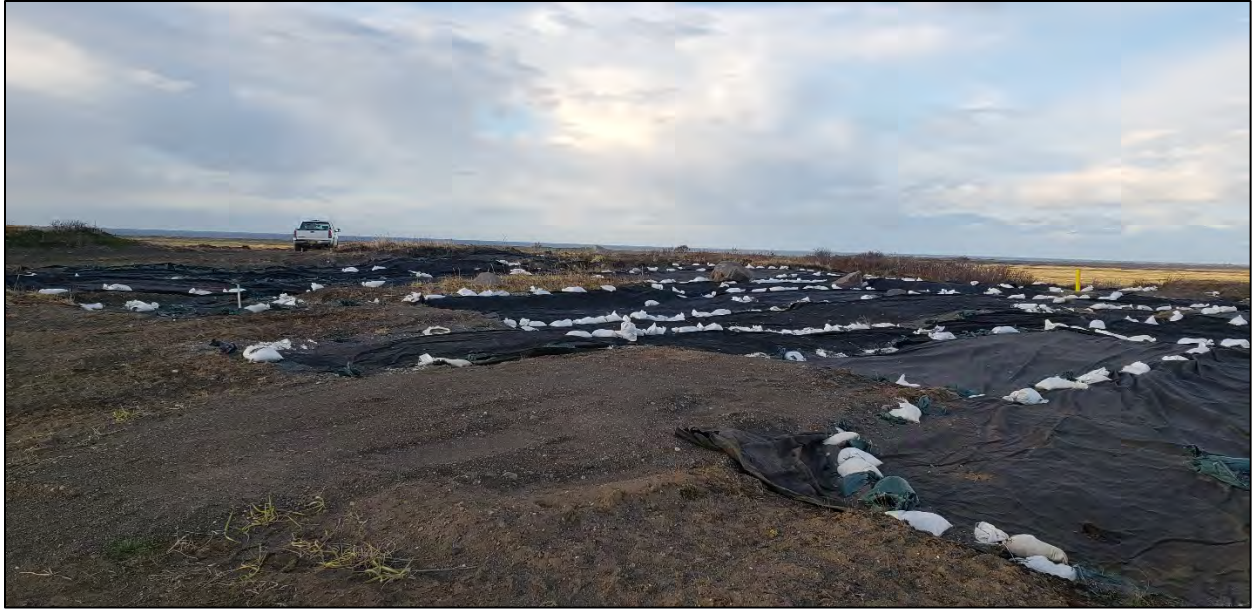
Photograph 77: Site overview after 2018 field work conclusion, facing northwest.
02 Nov 2018.
