**SECOND CERCLA FIVE-YEAR REVIEW FOR SITES OT001, WP002,  
SS004, LF007, AND FOUR UNNUMBERED SITES (ANTENNA PADS,  
CONTAMINATED SOIL REMOVAL AREAS, DRUM STORAGE AREA,  
AND FOCUS AREA)**

**FIRST NON-CERCLA PERIODIC REVIEW REPORT FOR SITE SS006  
AT THE FORMER PORT HEIDEN RADIO RELAY STATION, ALASKA**

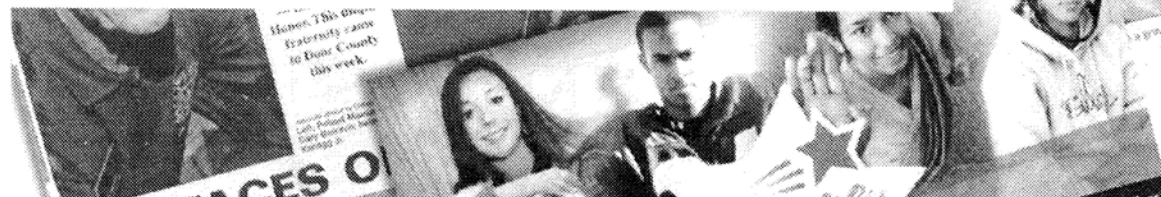
Community newspapers  
the original social networking site

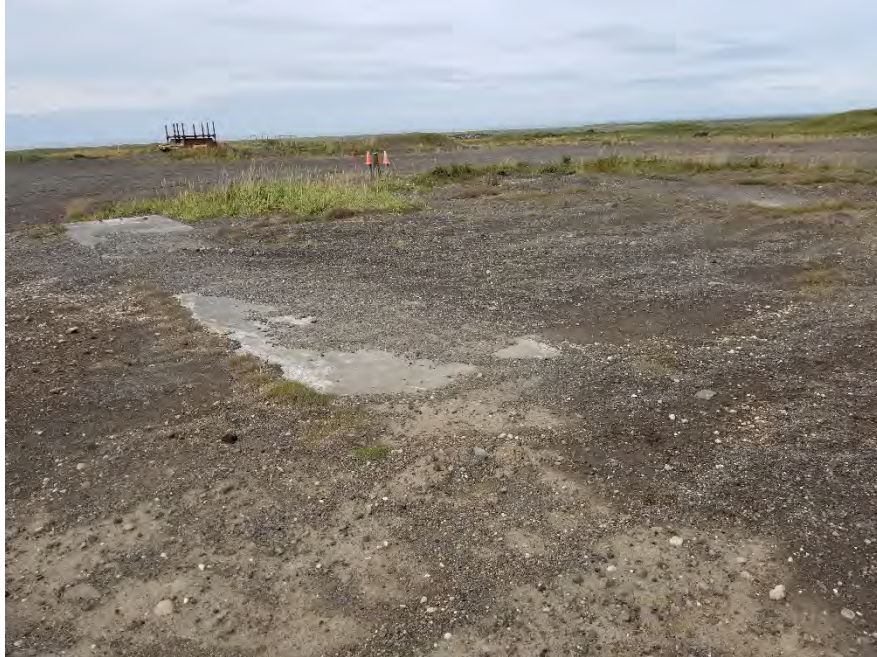
OT001 - Remnant concrete foundation for the Former Composite Building, looking southeast. Much of this area remains unvegetated and as exposed soil. There are several monitoring wells found around the former Port Heiden LRRS, most of which are not labeled. On the far edge of the concrete pad, flanked by bollards with traffic cones is the Monitoring Well UST-MW-02, which is secure and in good condition.

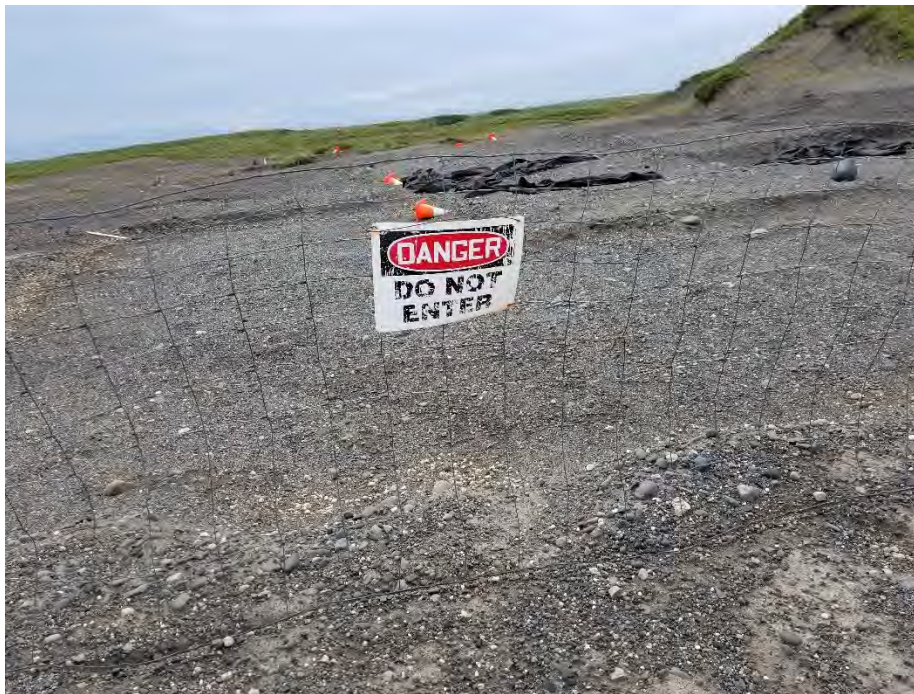
OT001 - Partial fence on the northern boundary of the Soil Removal Areas (and former antenna pads). Note the excavations beyond the fence and the Danger sign attached to the fence.

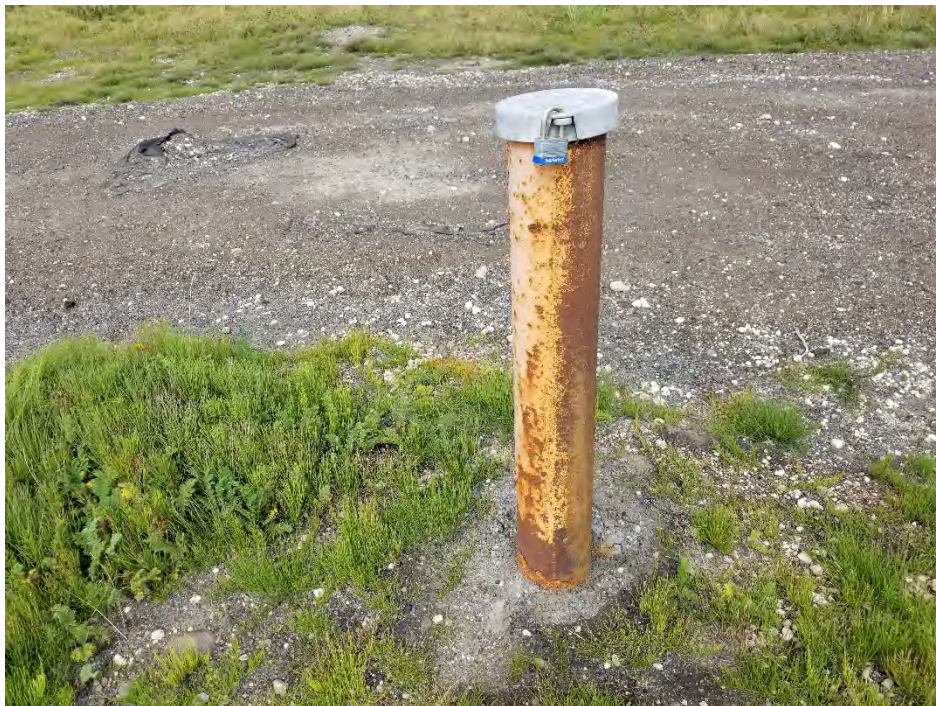
Ground Water Monitoring - Well DSA-MW-01 is secure and in good working condition.

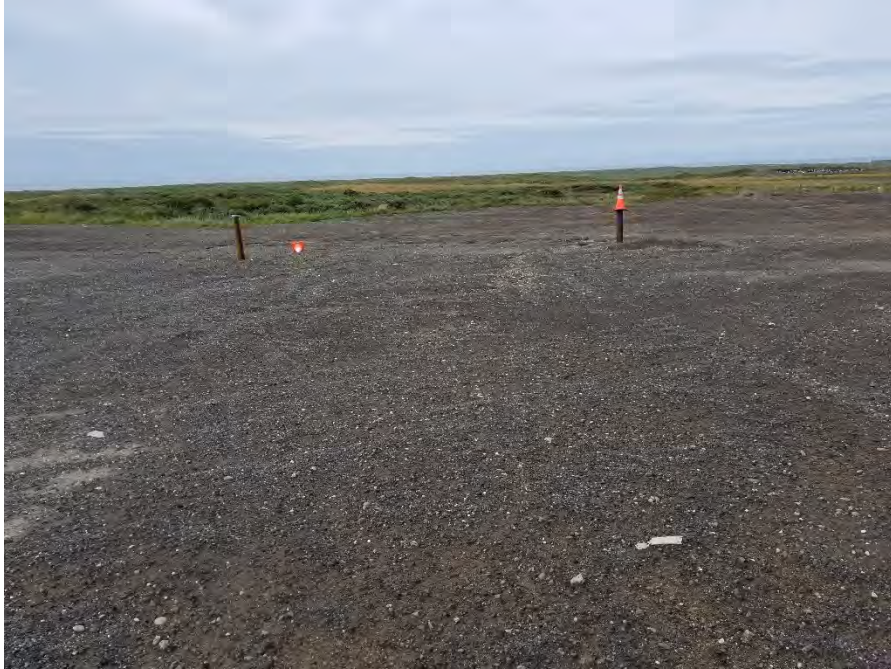
Ground Water Monitoring - Wells DSA-MW-02 and DSA-MW-04 are secure and in good working condition.

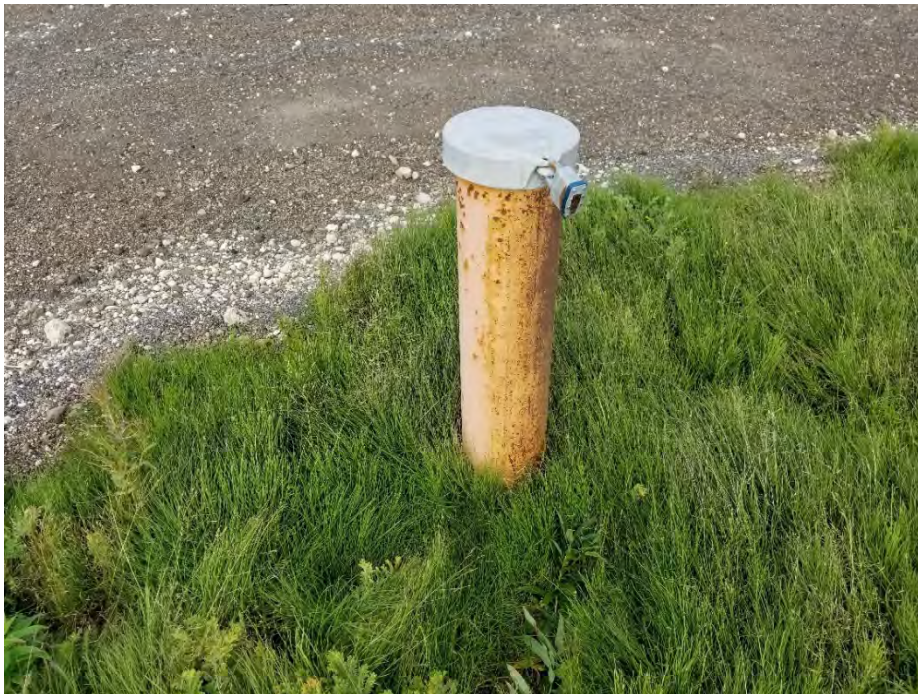
Ground Water Monitoring - Well DSA-MW-05 is secure and in good working condition.

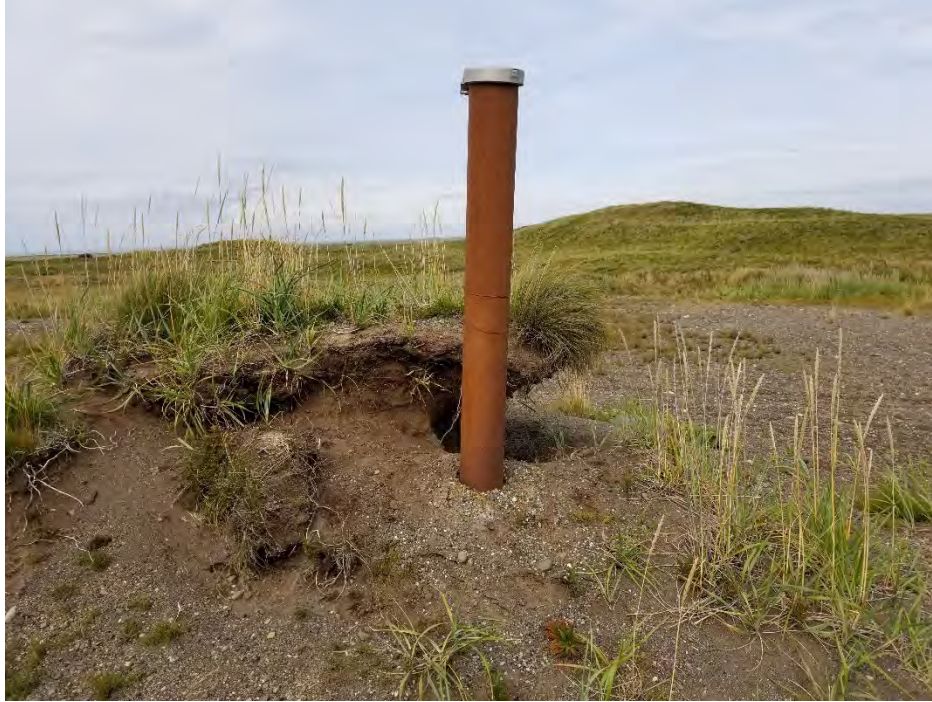
Ground Water Monitoring - Well GLO-MW-03 is secure and in good working condition. The soil around the protective well casing has eroded significantly and if left unrepaired is likely to fall over and damage the well.

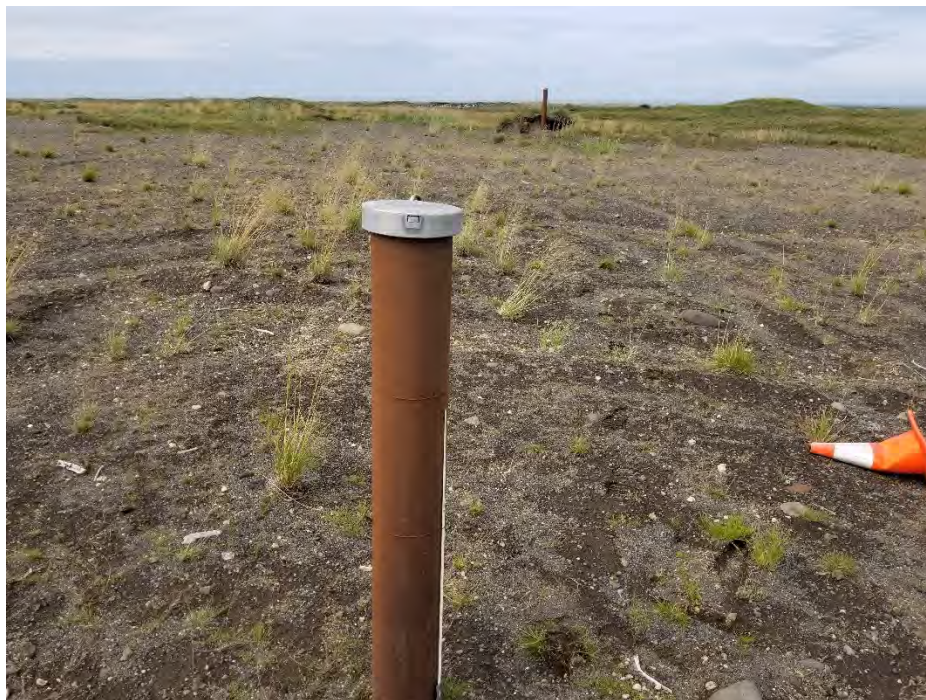
Ground Water Monitoring - Well GLO-MW-04 is secure and in good working condition.

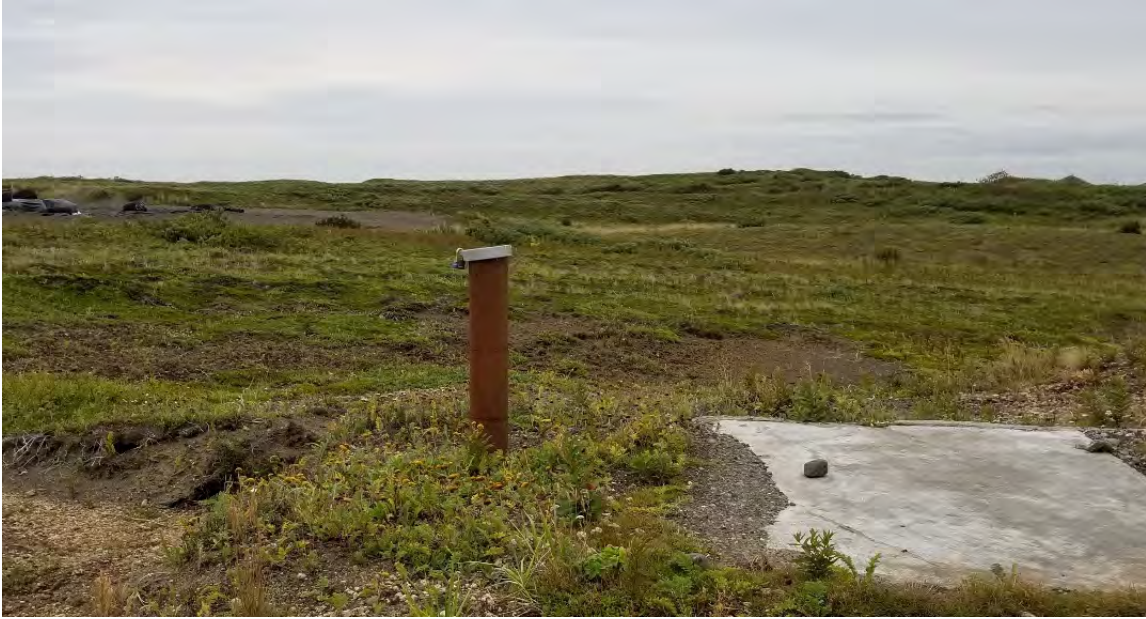
Ground Water Monitoring - Well RRS-MW02 is secure and in good working condition.

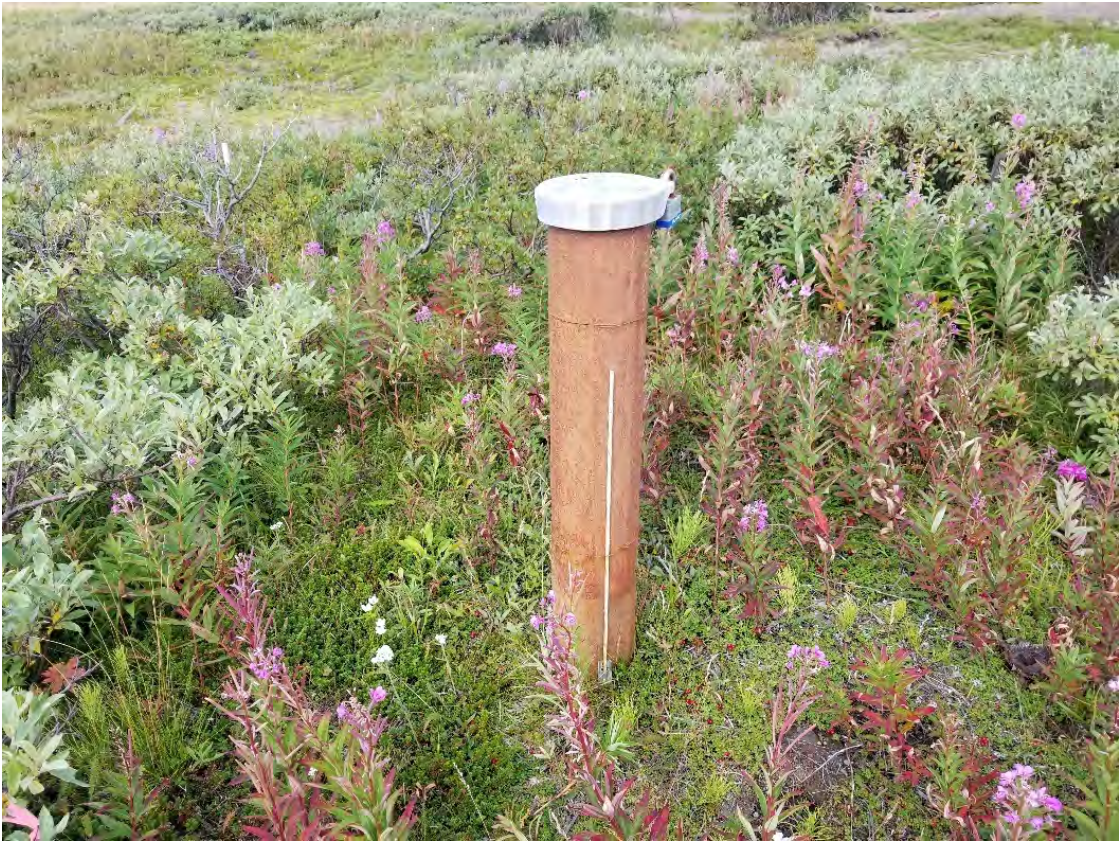
Ground Water Monitoring - Well RRS-MW05 is secure and in good working condition.

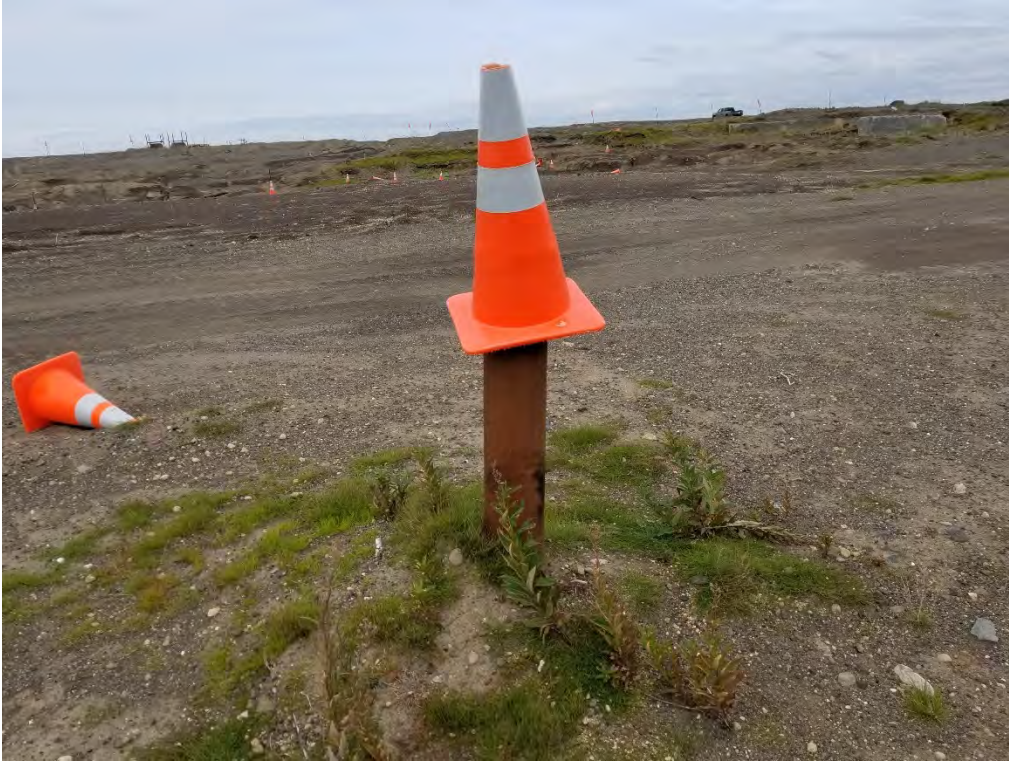
Ground Water Monitoring - Well RRS-MW-06 is secure and in good working condition.

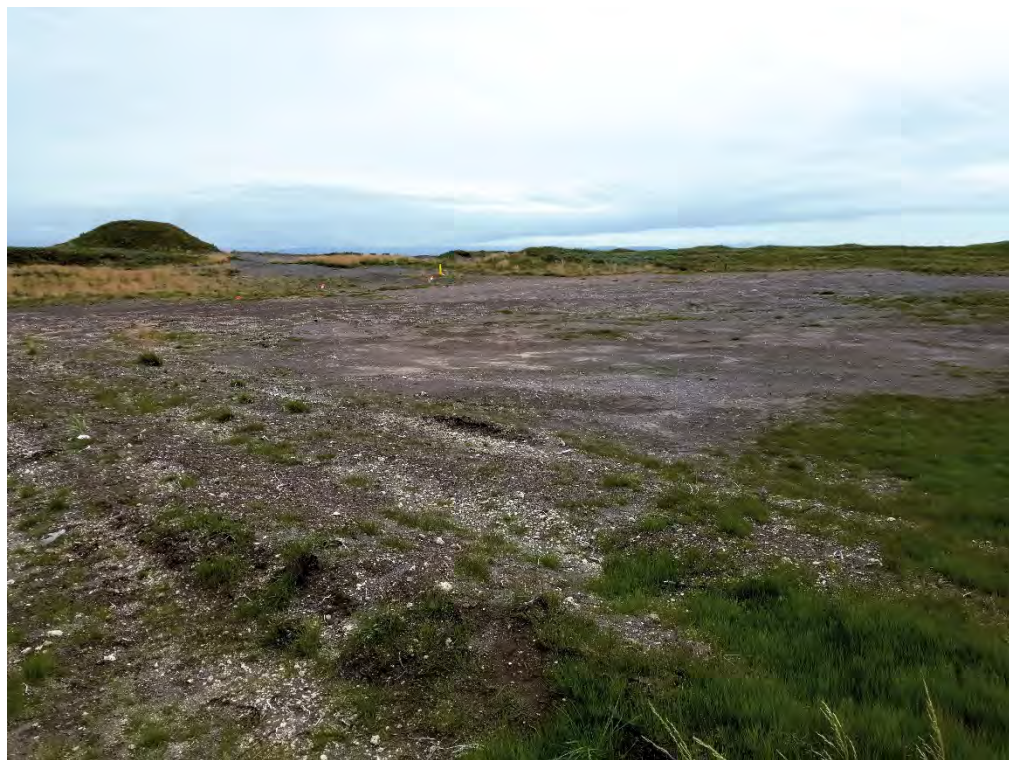
WP002 - A view southwest looking across the Black Lagoon Outfall Plume. Much of this site remains unvegetated.

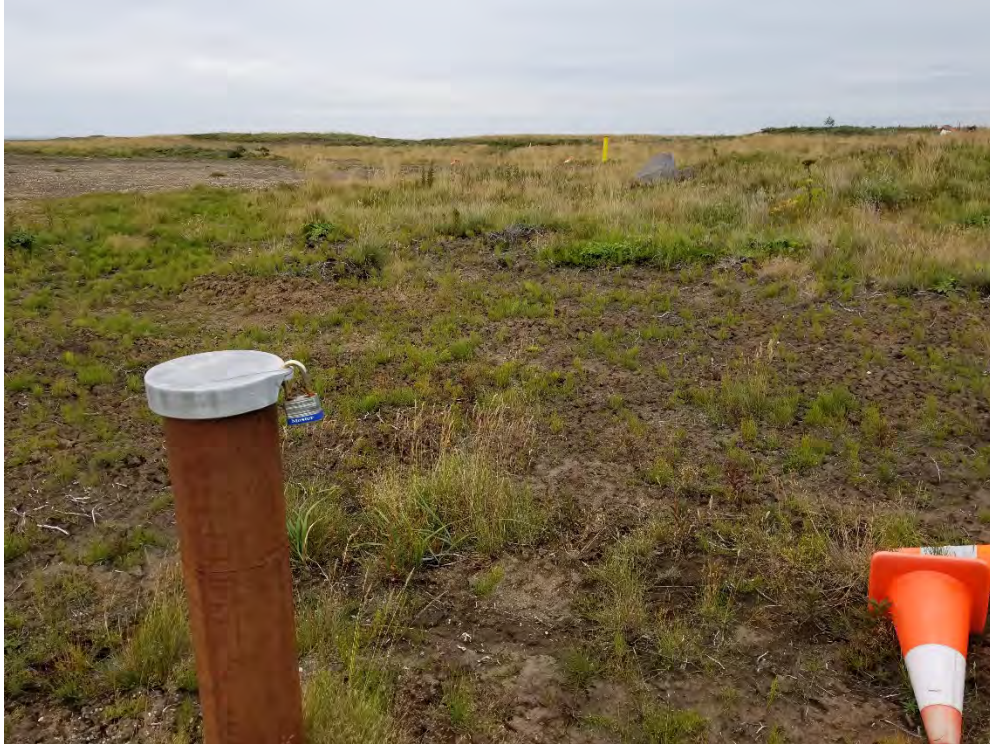
WP002 - Monitoring Wells BLO-MW-01 (background, yellow casing) and BLO-MW-06 (foreground) are secure and in good working condition.

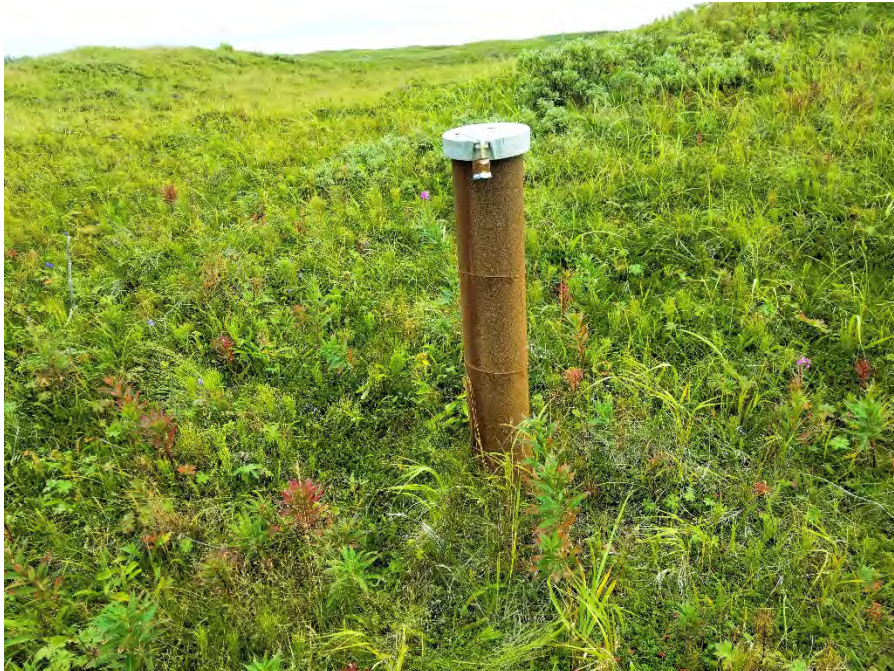
WP002 - Monitoring Well BLO-MW-02 is secure and in good working condition.

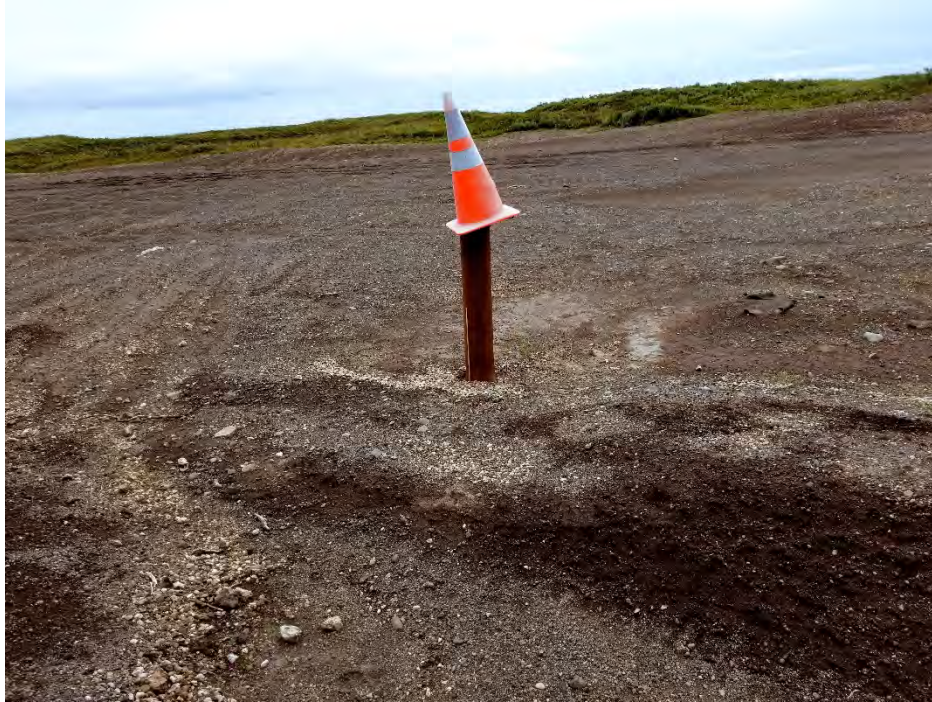
WP002 - Monitoring Well BLO-MW-05 is secure and in good working condition.

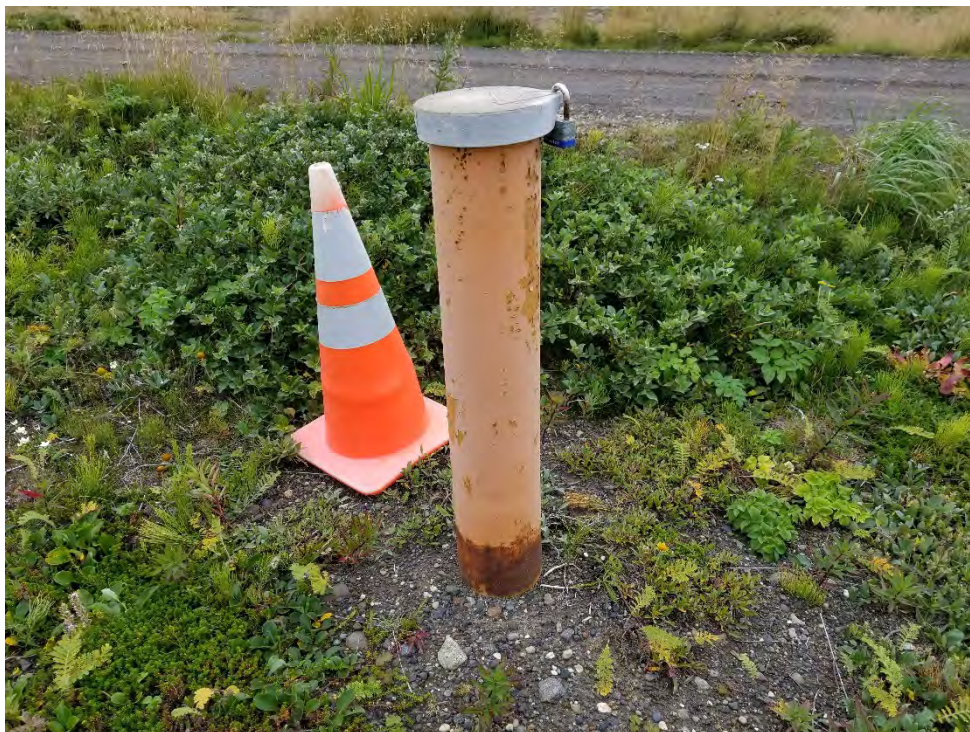
WP002 - Monitoring Well BLO-MW-07 is secure and in good working condition.

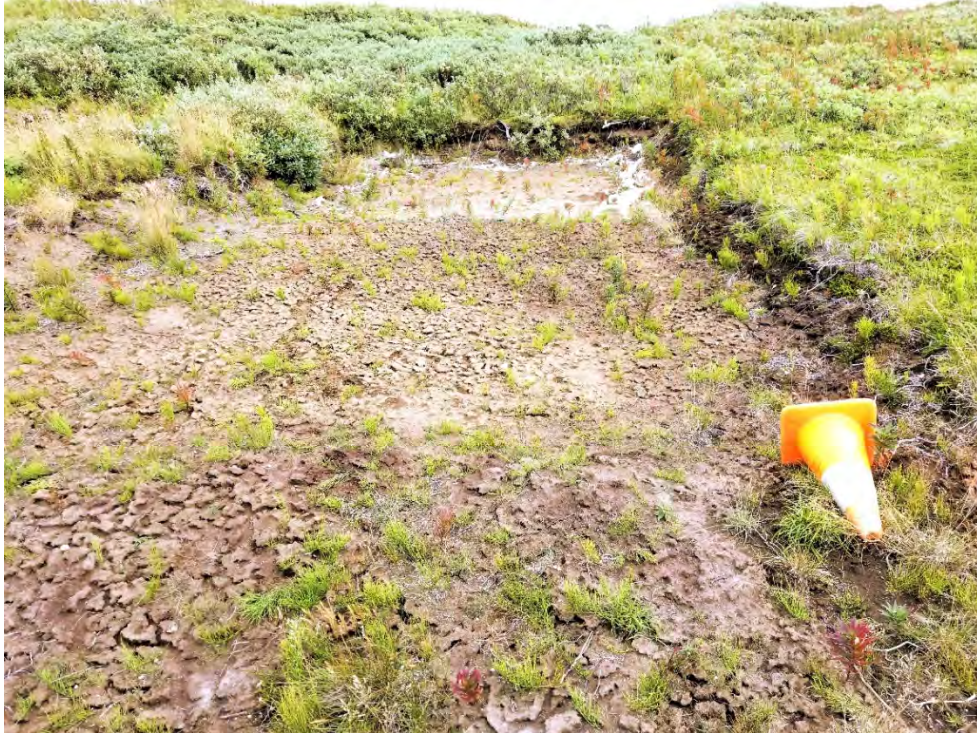
SS004 – Septic System Outfall, a view of what remains at the outfall.

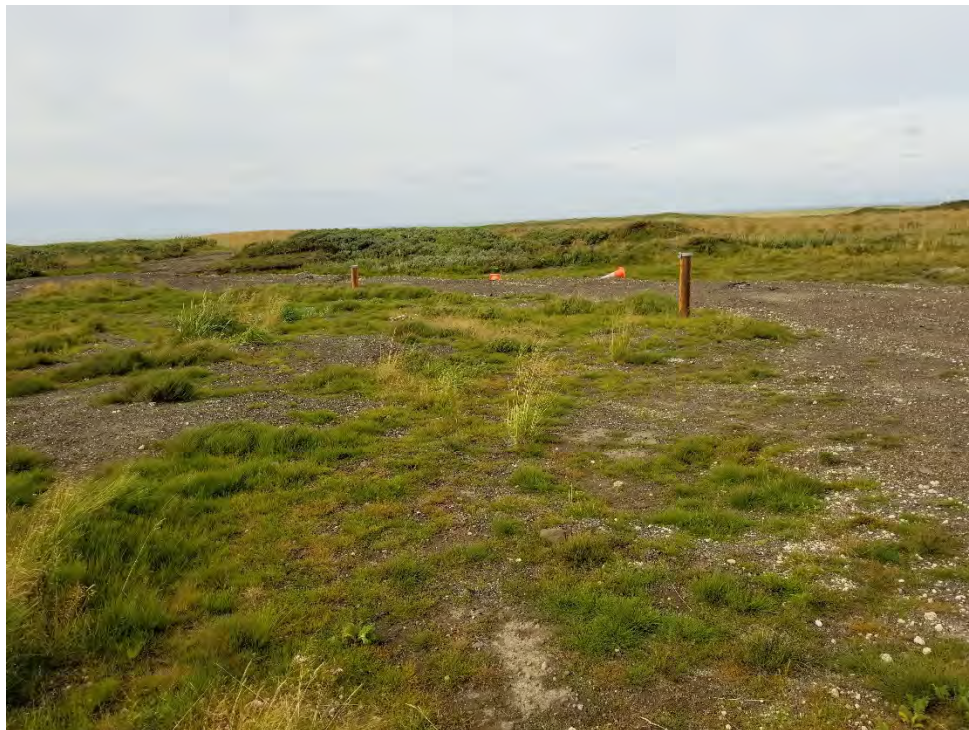
Drum Storage Area - Monitoring Wells DSA-MW-07 and DSA-MW-06 are both secure and in good condition.

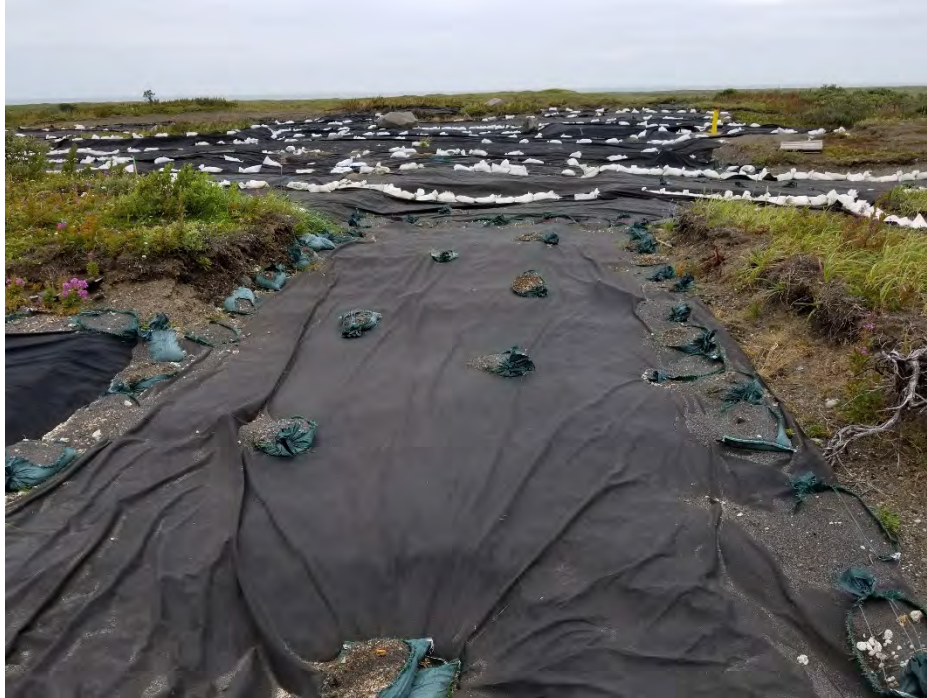
LF007 - General site condition looking west. Note Monitoring Well MW-10 in the background (right). Geo-fabric held in place by sandbags covers most of the site. In the foreground the green sandbags are more weathered than the white sandbags in the background, suggesting this cover consists of different aged materials.

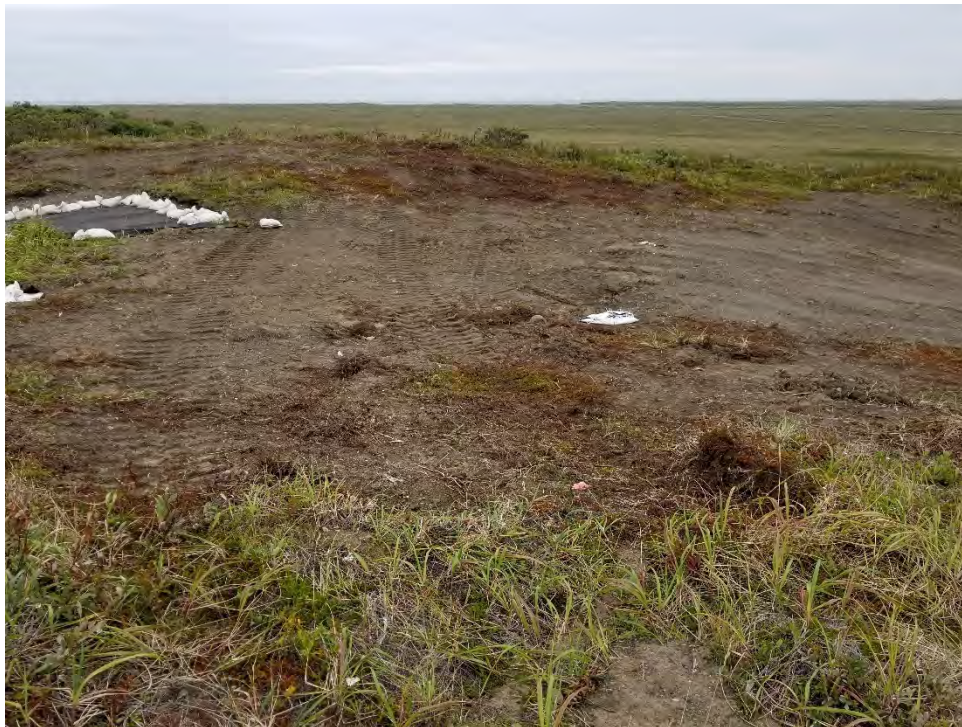
LF007 – This photograph is of the eastern edge of the landfill cap, looking north. An example of an unvegetated area.

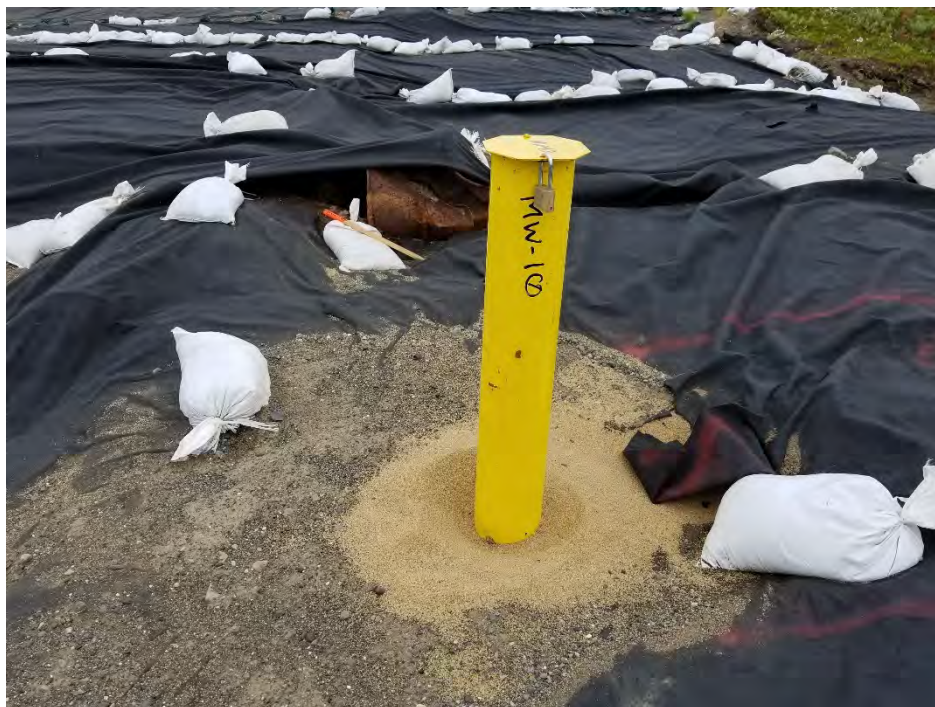
LF007 - Monitoring Well MW-10 penetrates the landfill cover and appears to have been recently installed and is secure and in good working condition.

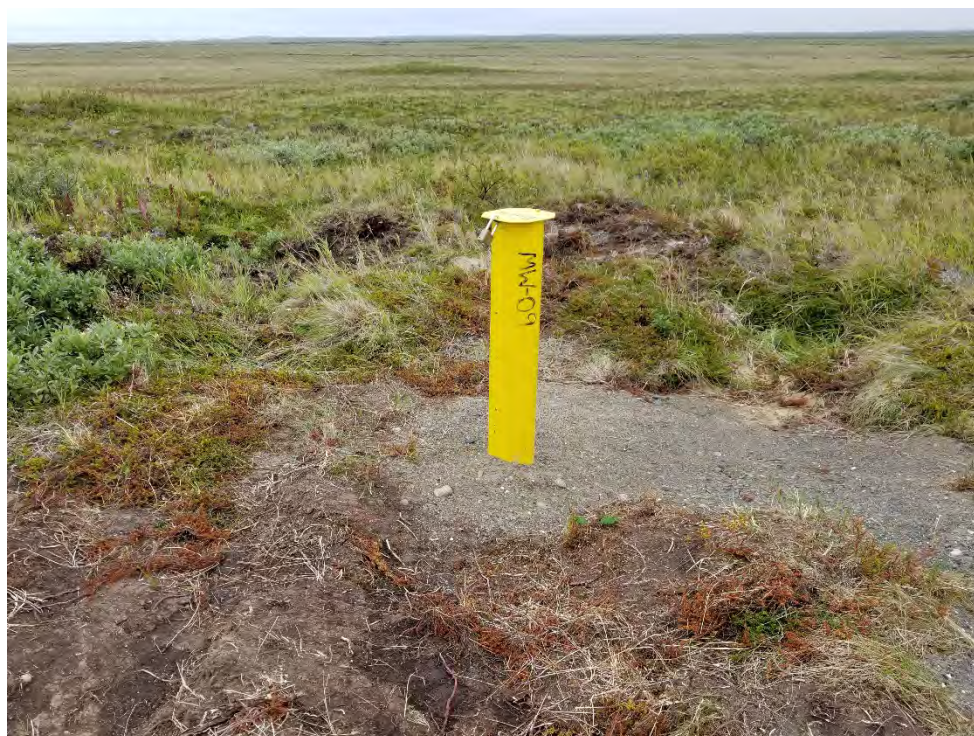
LF007 - Monitoring Well MW-09 is secure and in good working condition. This well appears to have been recently installed based on its new condition and the recent disturbance around it.

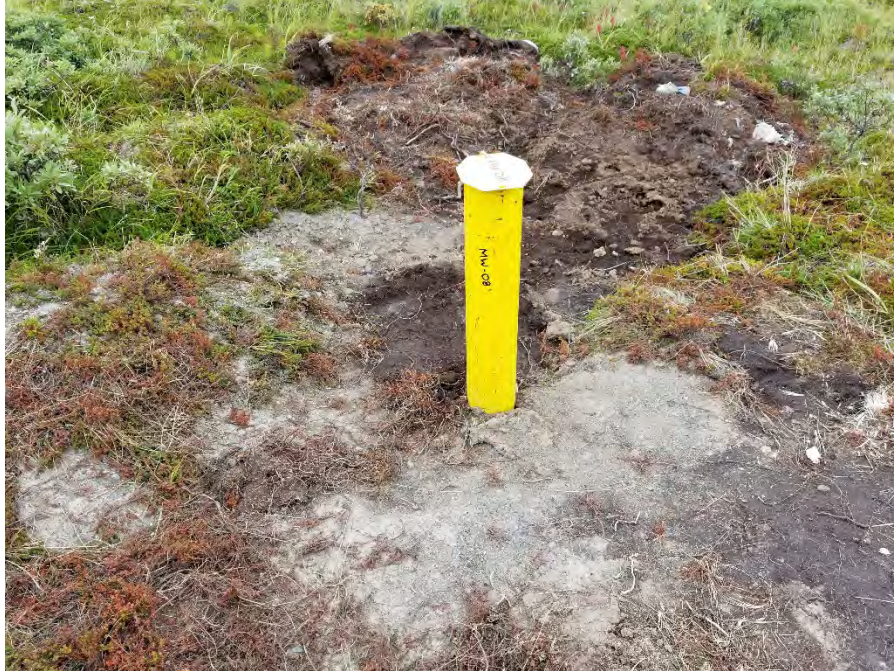
LF007 - Monitoring Well MW-08 is secure and in good working condition. The well appears to have been recently installed based on its new condition and the recent disturbance around it.

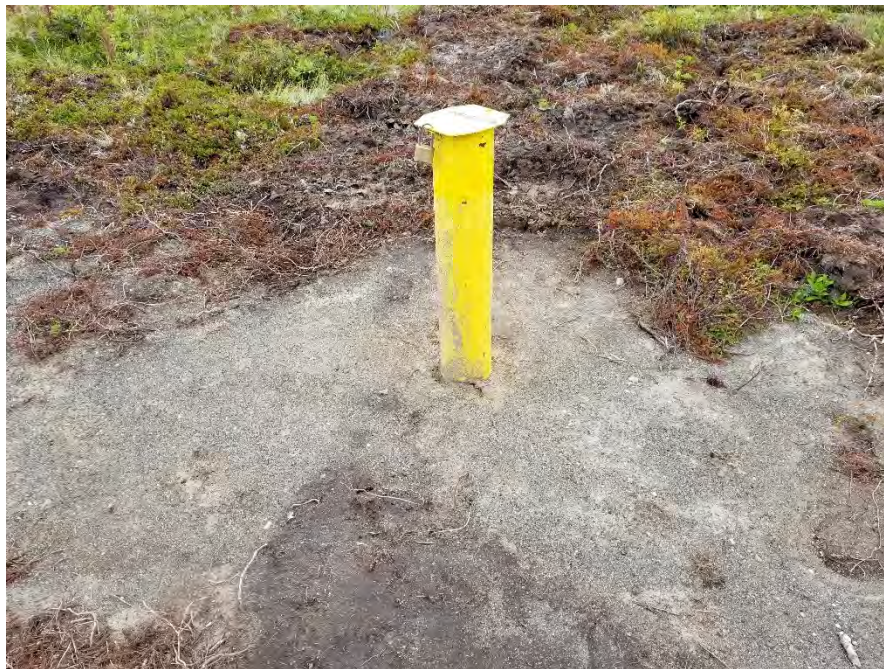
LF007 - Monitoring Well MW-07 is secure and in good working condition. This well appears to have been recently installed based on its new condition and the recent disturbance around it.

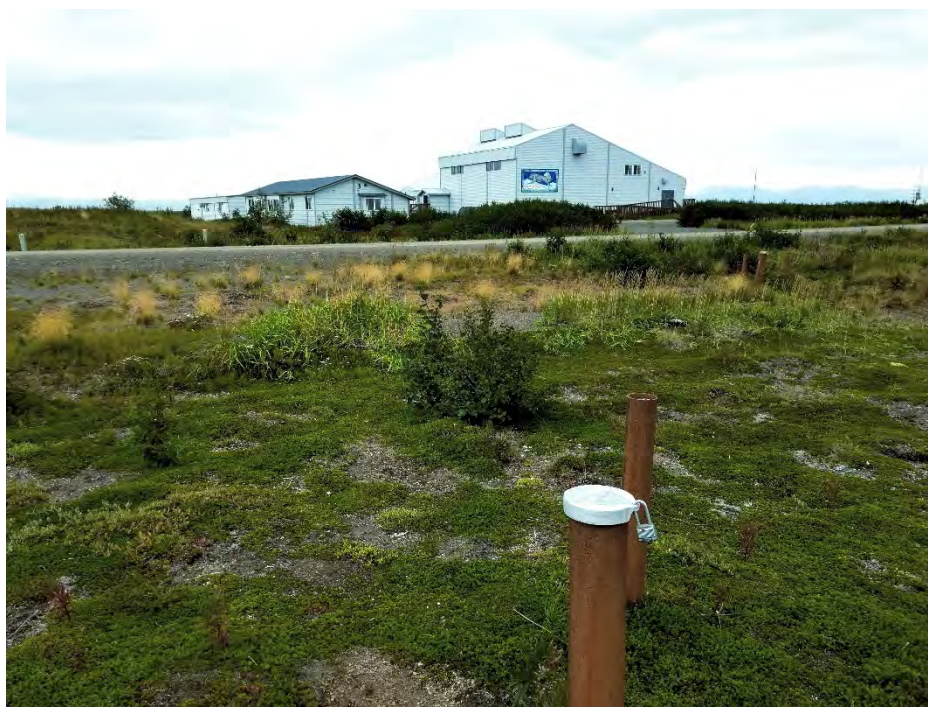
SS006 (FPC-066) - General site condition of, looking south southeast. Note Monitoring Well MW-5 in the immediate foreground and MW-4 behind it near the road. Also note the Port Heiden school in the background. No evidence of land use change observed.

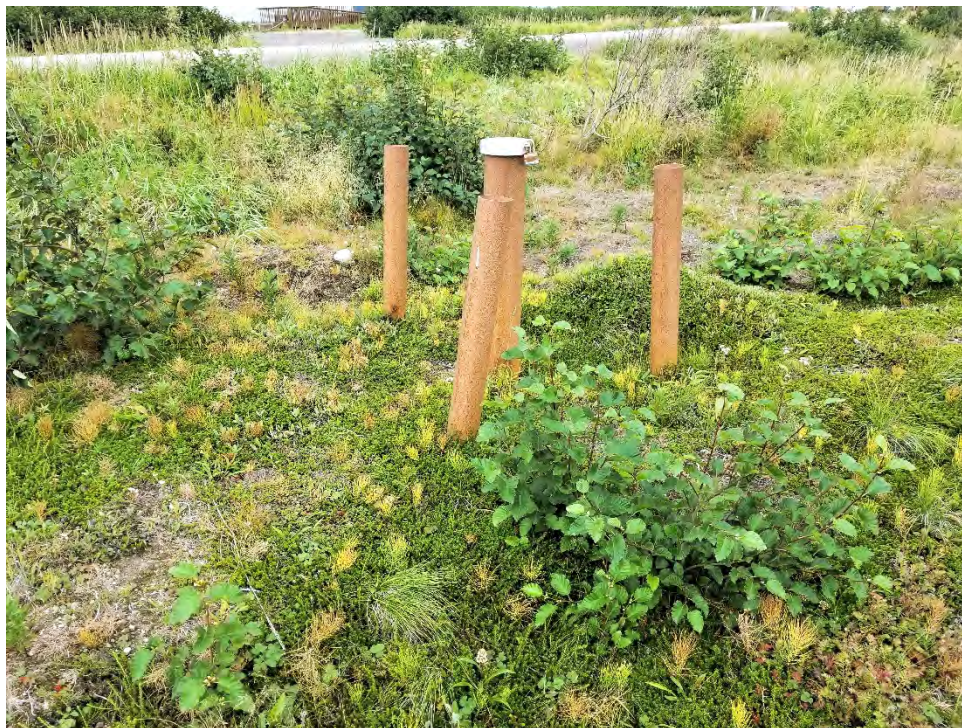
SS006 (FPC-066) - Monitoring Well MW-4 is secure and in good working condition.

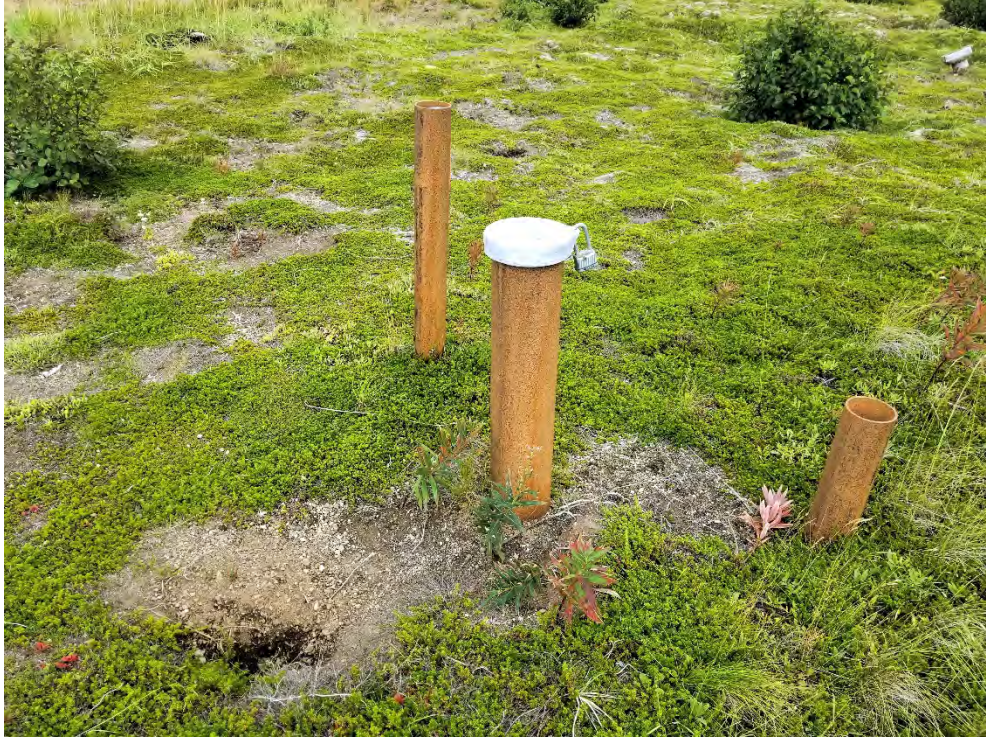
SS006 (FPC-066) - Monitoring Well MW-5 is secure and in good working condition.

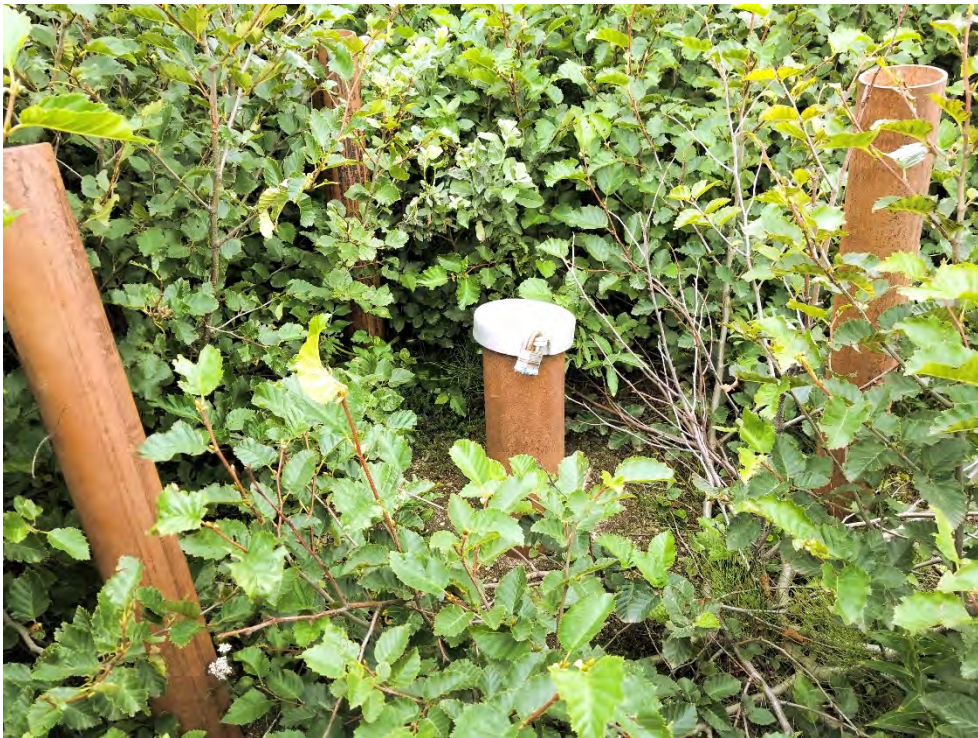
SS006 (FPC-066) - Monitoring Well MW-7 is secure and in good working condition.

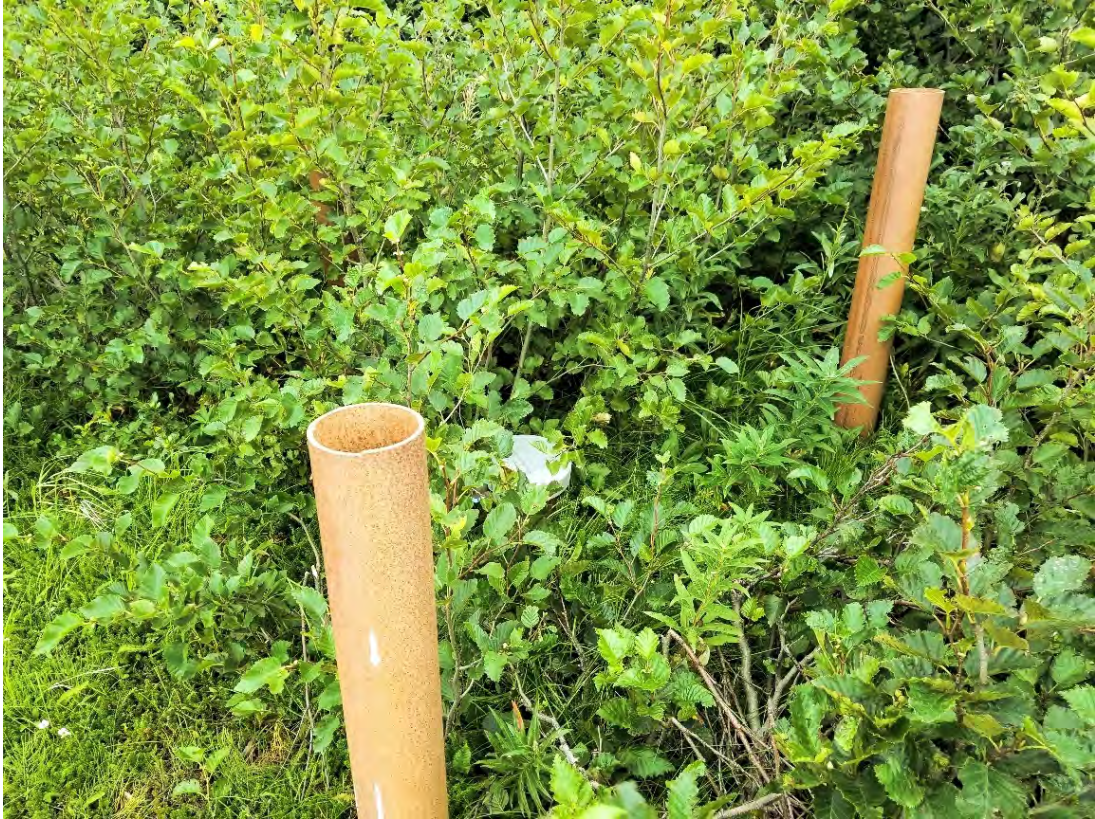
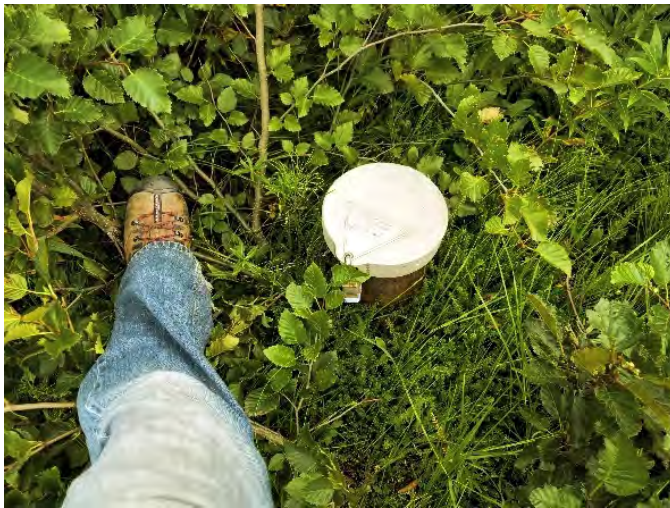
SS006 (FPC-066) - Monitoring Well MW-6 is secure and in good working condition

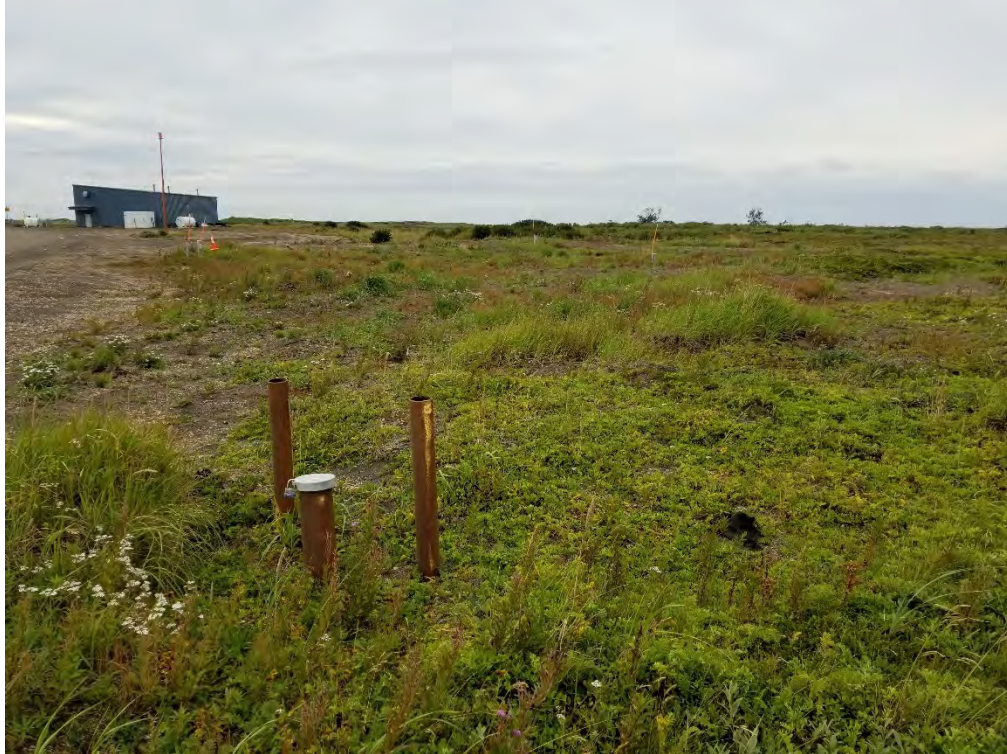
SS006 (FPC-215) - General site condition of looking south. Note Monitoring Well MW-8 in the foreground. No evidence of land use change observed.

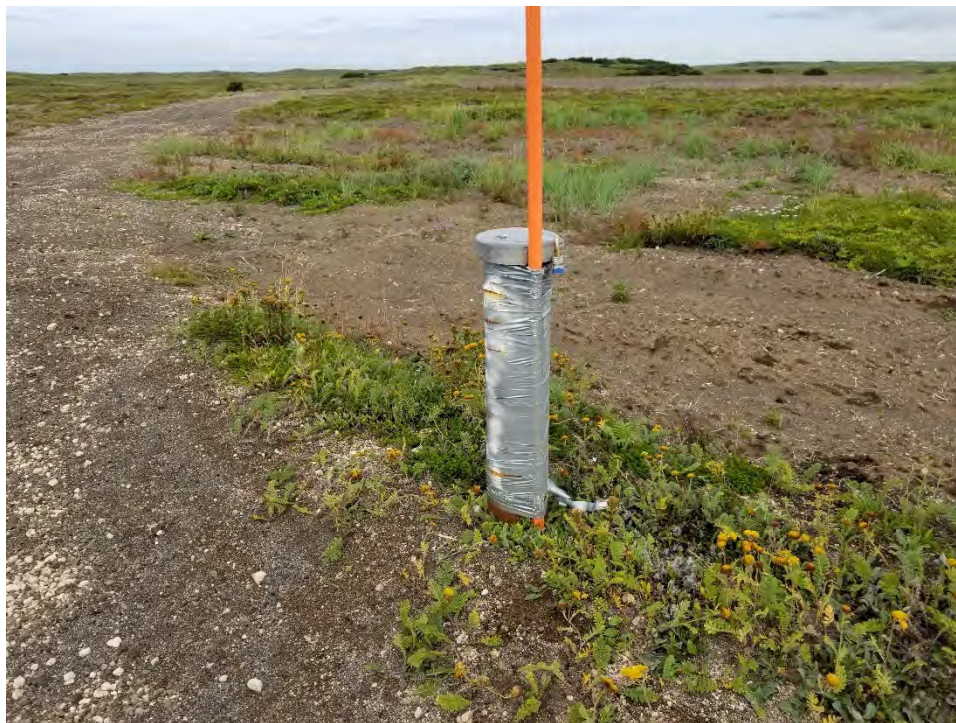
SS006 (FPC-215) - Monitoring Well FPC3 is secure and in good working condition.
