**SECOND CERCLA FIVE-YEAR REVIEW FOR SITES OT001, WP002,  
SS004, LF007, AND FOUR UNNUMBERED SITES (ANTENNA PADS,  
CONTAMINATED SOIL REMOVAL AREAS, DRUM STORAGE AREA,  
AND FOCUS AREA)**

**FIRST NON-CERCLA PERIODIC REVIEW REPORT FOR SITE SS006  
AT THE FORMER PORT HEIDEN RADIO RELAY STATION, ALASKA**

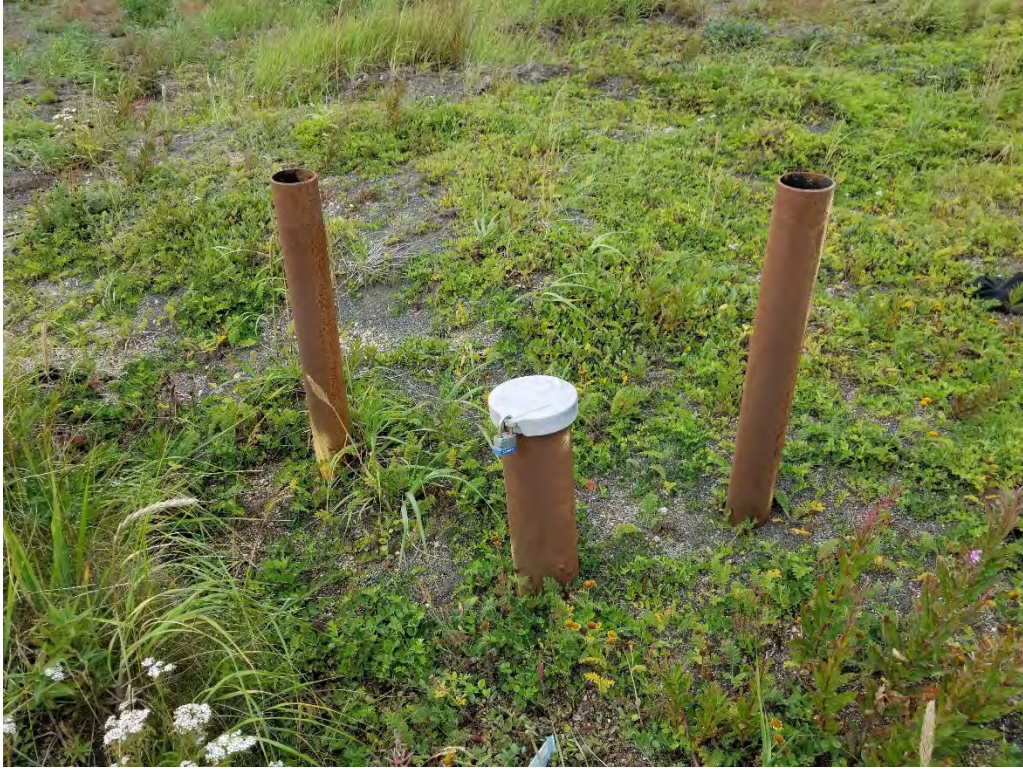
SS06(FPC-215) - Monitoring Well MW-8 is secure and in good working condition.

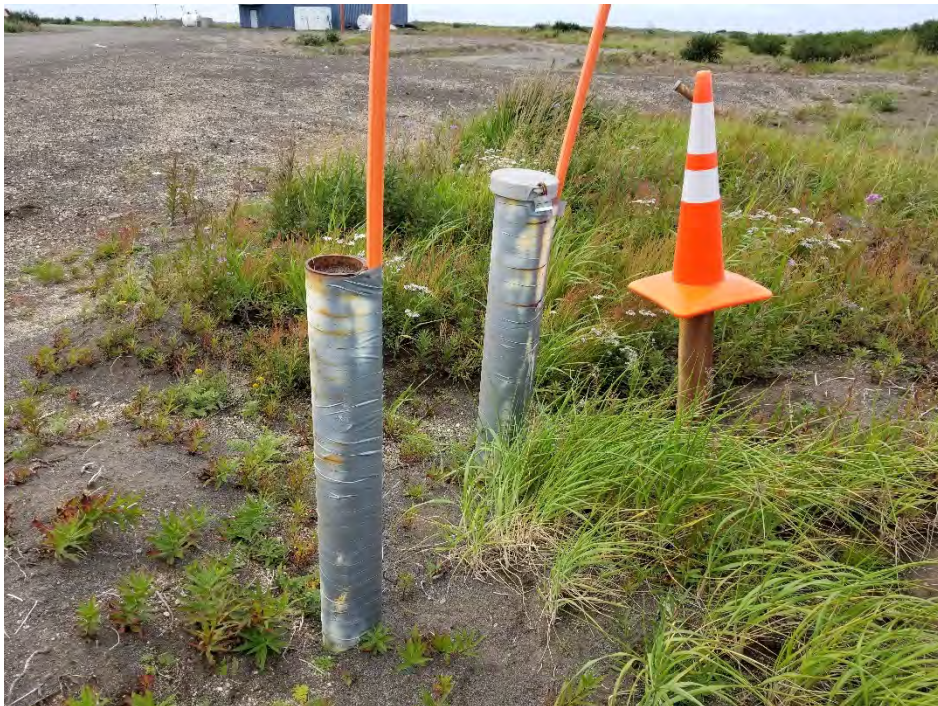
SS006 (FPC-215) - Monitoring Well MW-9 is secure and in good working condition.

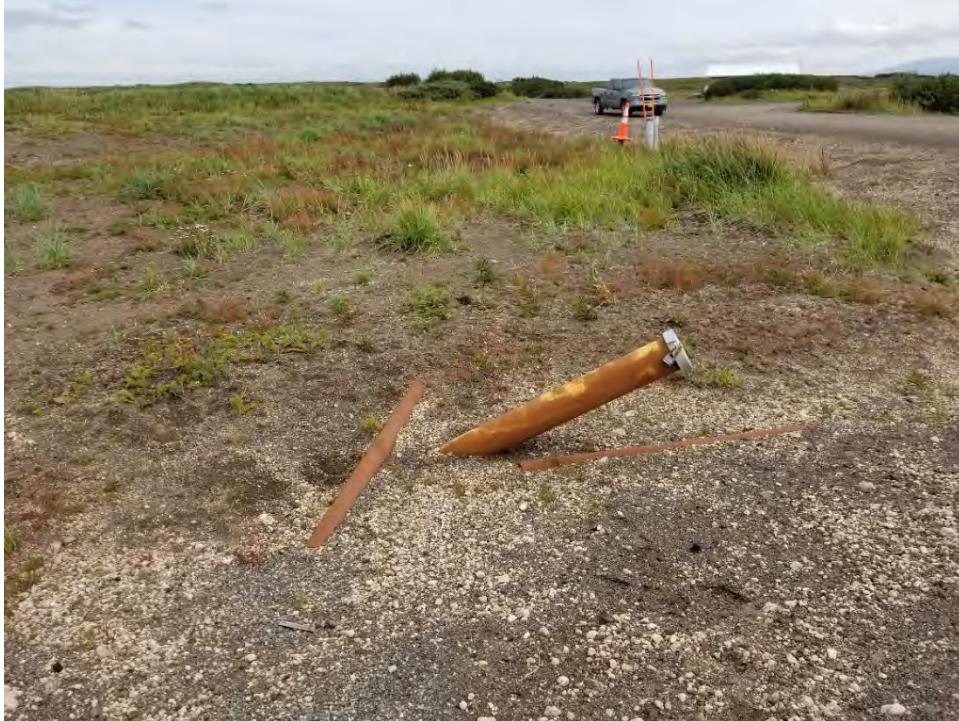
SS006 (FPC-215) - Monitoring Well MW-10 appears to have been struck by a snowplow and needs repair before any future sampling can be conducted.

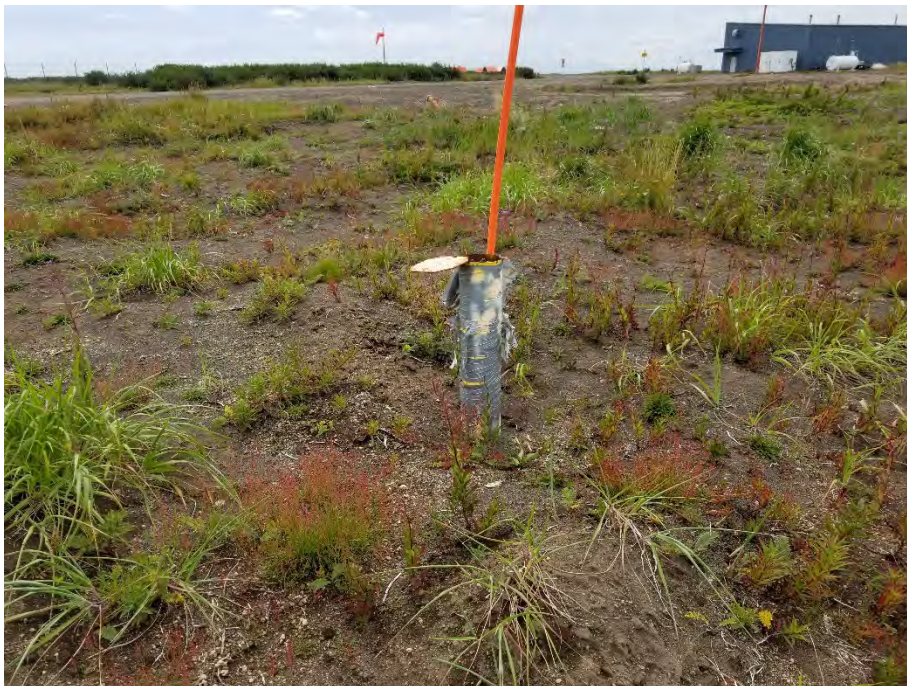
SS006 (FPC-215) - Unlabeled Monitoring Well within at the approximate location of a proposed new Monitoring Well (2016-2017 GW Monitoring Work Plan), north of the road. Although the protective casing is unsecure, the expansion plug is locked, and the well is in good working condition.

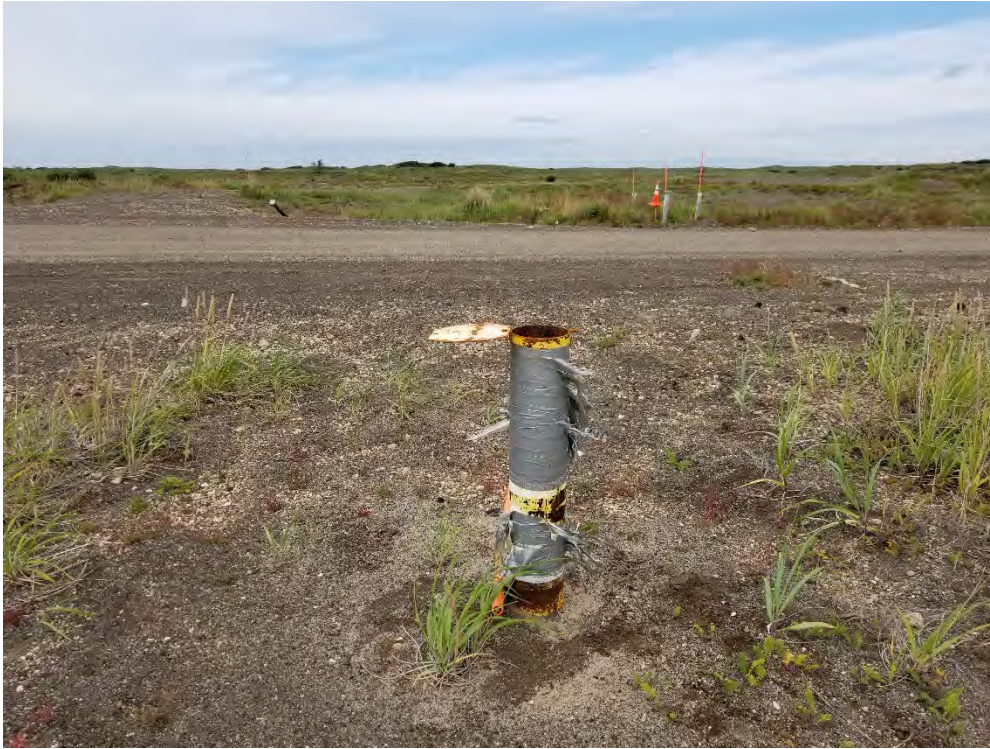
SS006 (FPC-215) - Unlabeled Monitoring Well within at the approximate location of a proposed new Monitoring Well (2016-2017 GW Monitoring Work Plan), south of the road. Although the protective casing is unsecure, the expansion plug is locked, and the well is in good working condition.
