UNITED STATES AIR FORCE

**JOINT BASE ELMENDORF-RICHARDSON,
ALASKA**

**2012–2013 REMEDIAL ACTION SUMMARY REPORT
XU022, OPERABLE UNIT C – EAGLE RIVER FLATS**

**XU022 – Operable Unit C, Eagle River Flats
Joint Base Elmendorf-Richardson, Alaska**

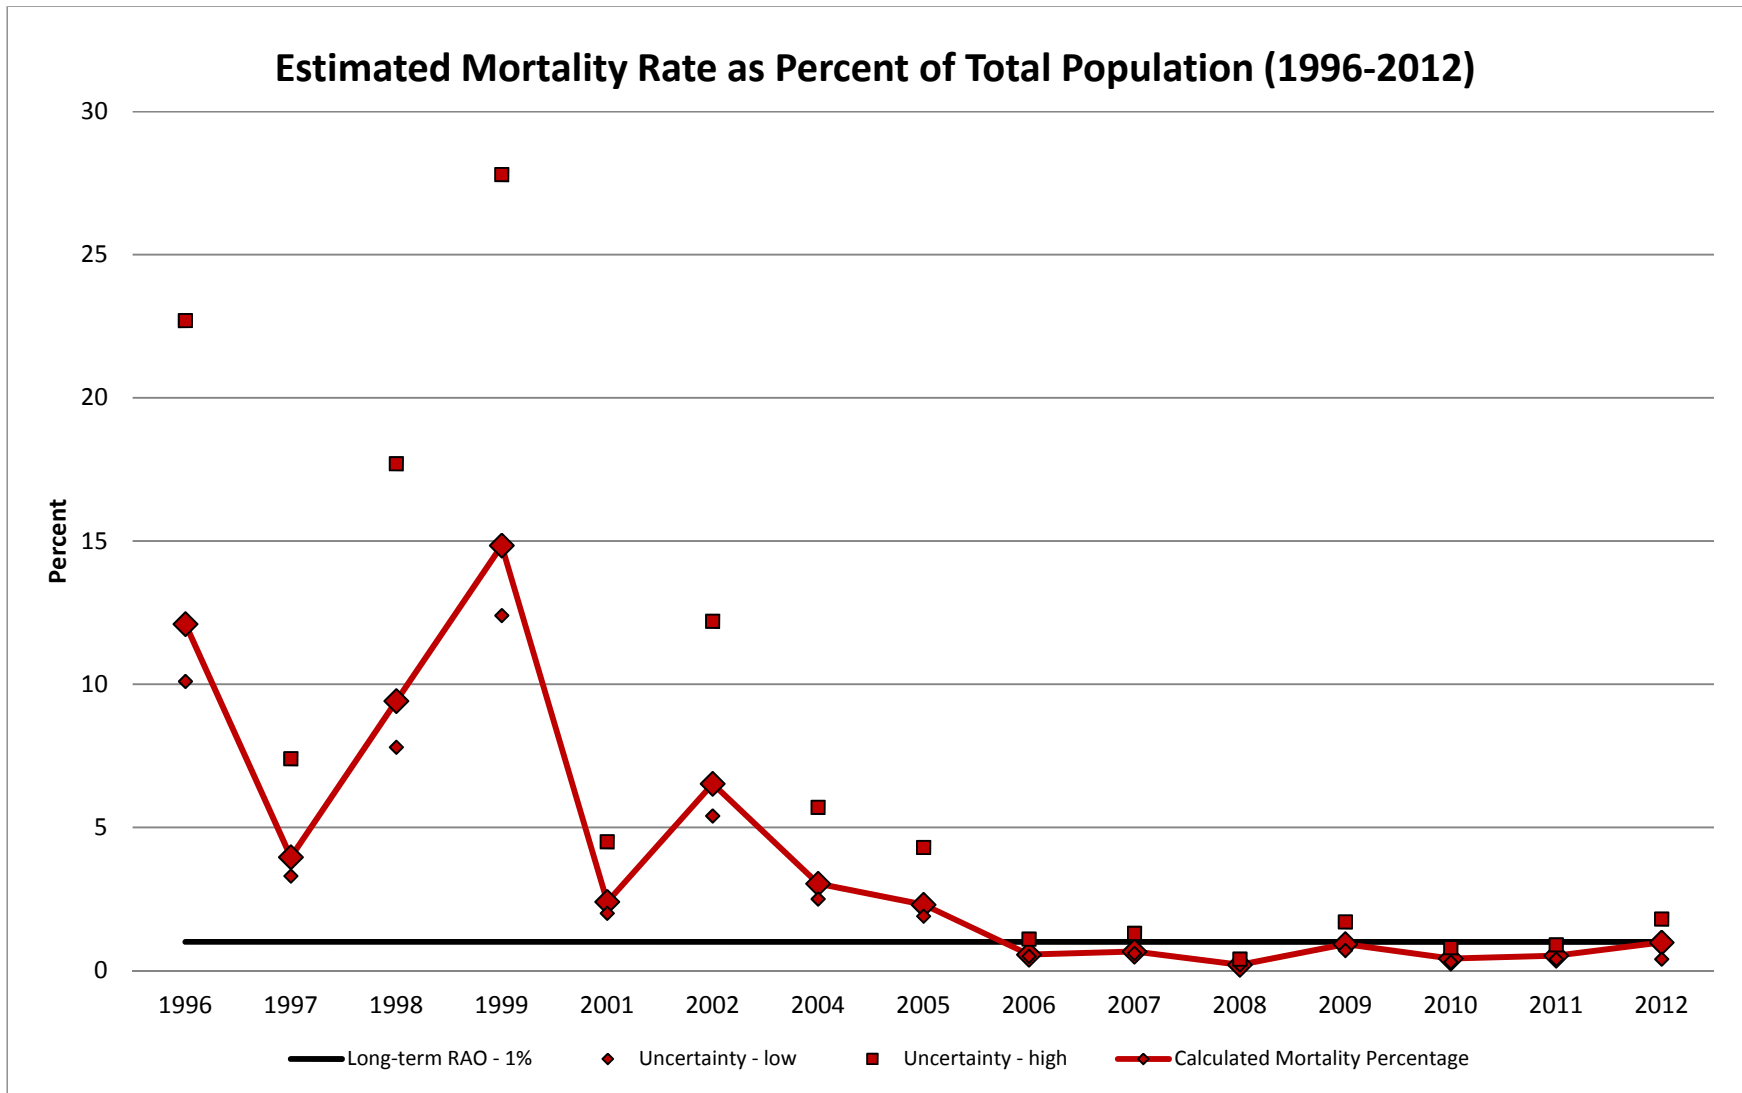
Figure 4-3: XU022 Mortality Rates Since 1996

Mortality monitoring not performed in 2000 and 2003

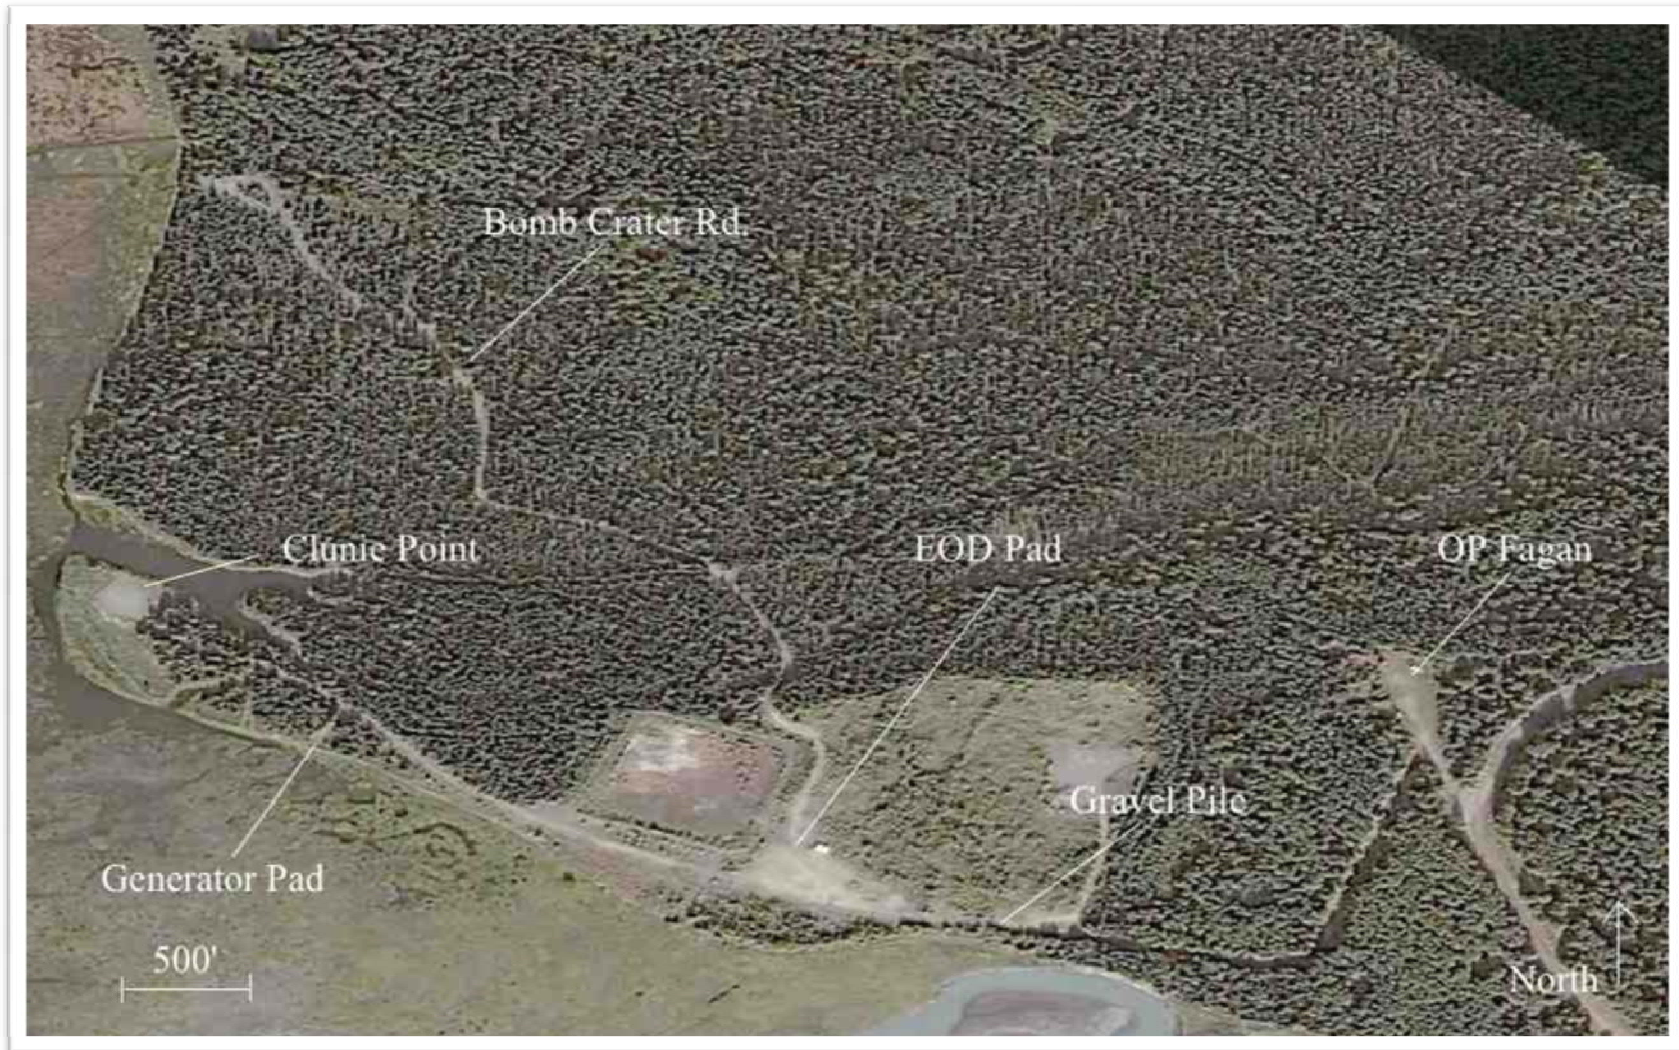
Figure 1 Pre-operational UXO Clearance Areas for ERF

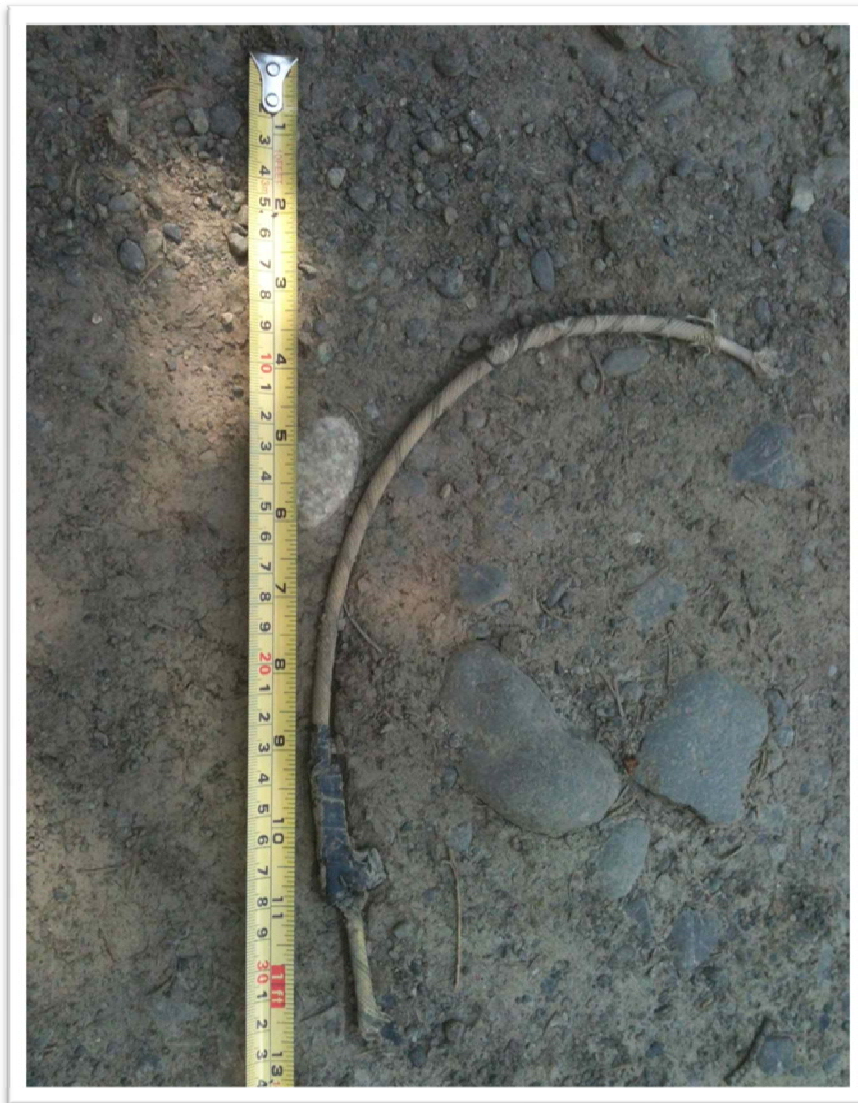
Figure 2 Detonation Cord discovered August 14, 2012

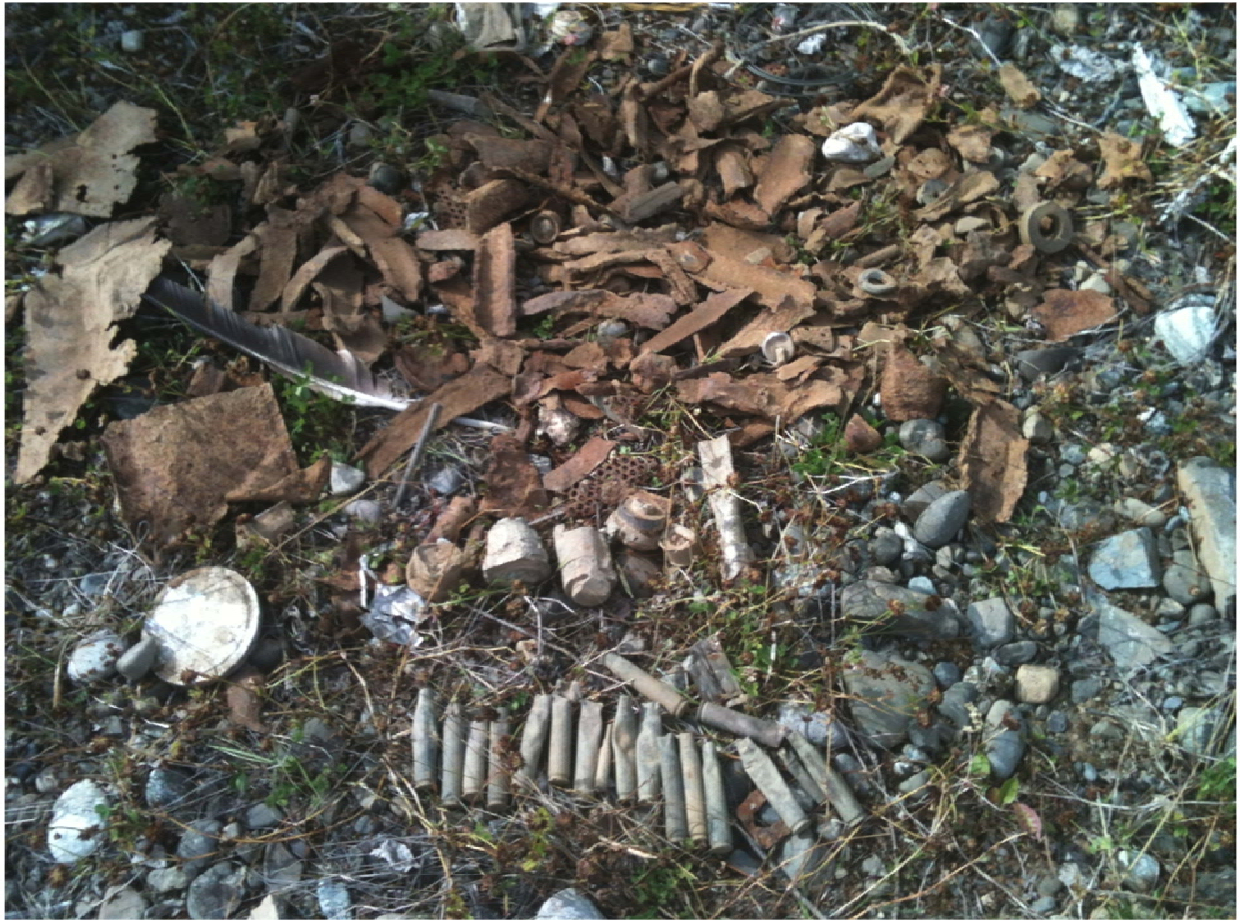
Figure 3 Munitions Debris (.50 caliber, frag, and fuze body components) discovered on EOD Pad August 14, 2012

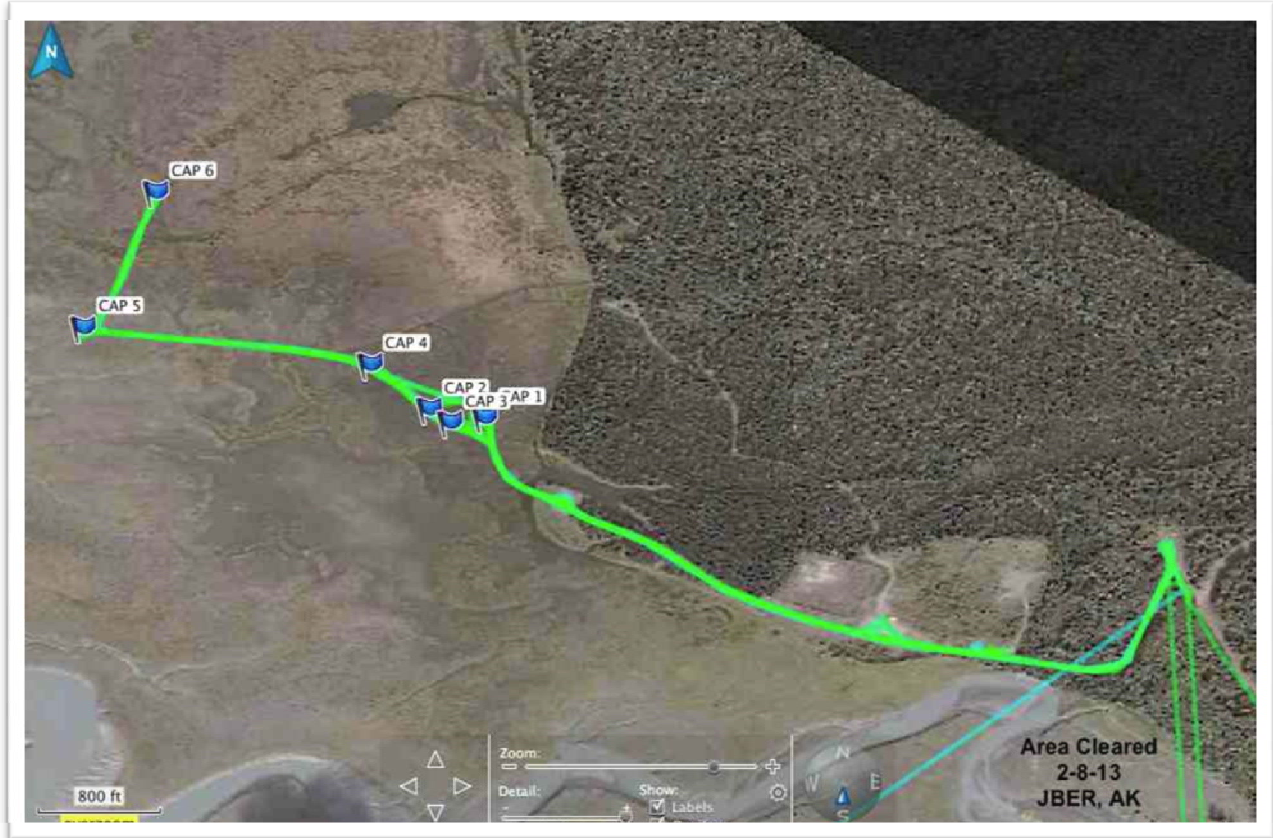
Figure 4 Areas Capped during Feb 2013 Deployment

The objective of the UXO Technician III, Jeffrey Bryant, was to provide UXO assistance to the Capping Team. Annual training was re-accomplished and crew certifications were inspected. The operational areas were cleared on the first field day, February 12, 2013. The gravel pile and areas where the team planed to operate were cleared for UXO. The team placed textile cloth on six locations determined by previous deployments for capping procedures (Figure 4). Capping operations continued for two days.

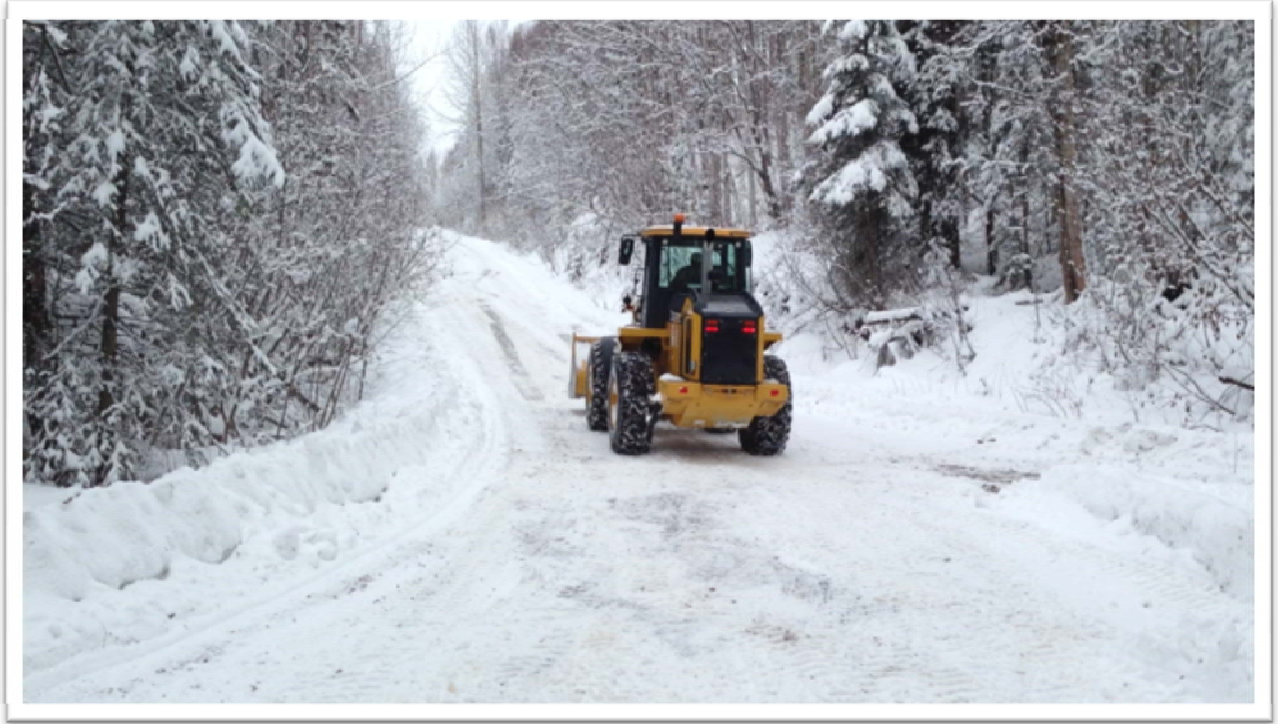
Chains for wheeled heavy equipment are needed for access to ERF if road conditions are icy (Figure 5).

Figure 5 Icy Road Conditions

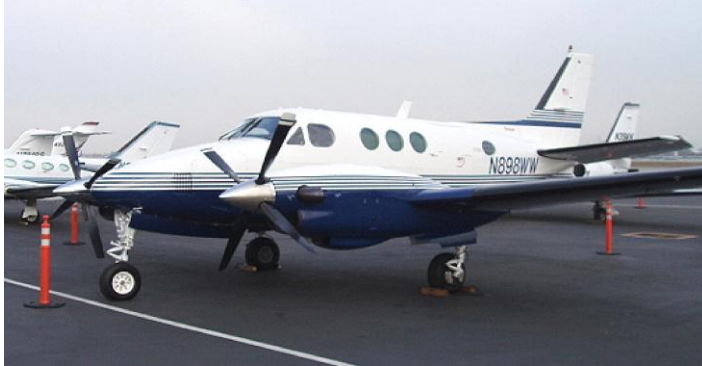
Aircraft description:

Aircraft Type: KingAir E-90
Aircraft Tail Number: N898WW
Fuel Type: Jet
True Airspeed: 245 knots
Max Altitude: 28,000'
Range: 1100 nautical miles
Max Endurance: 5.5 hours
Color: Blue / White

The overall objective of the project was to create a 0.25-foot color infrared ortho photo of the ERF area. To create the image, we flew 5 flight lines across the area, as shown on Figure 1. The imagery was captured on August 29, 2012.

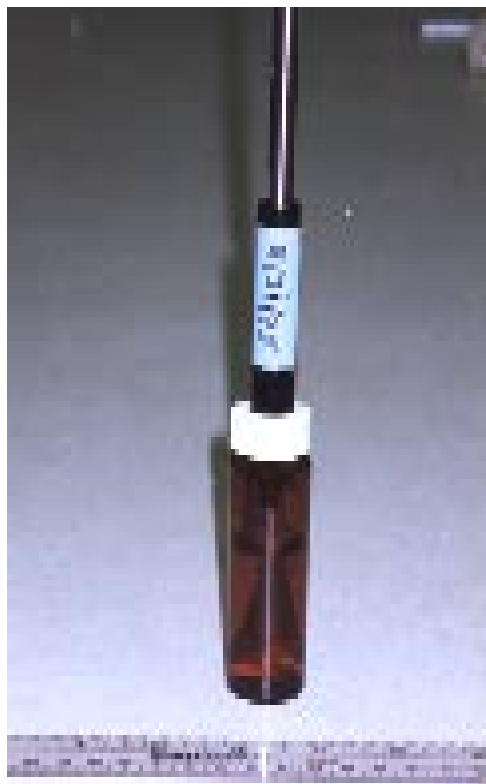
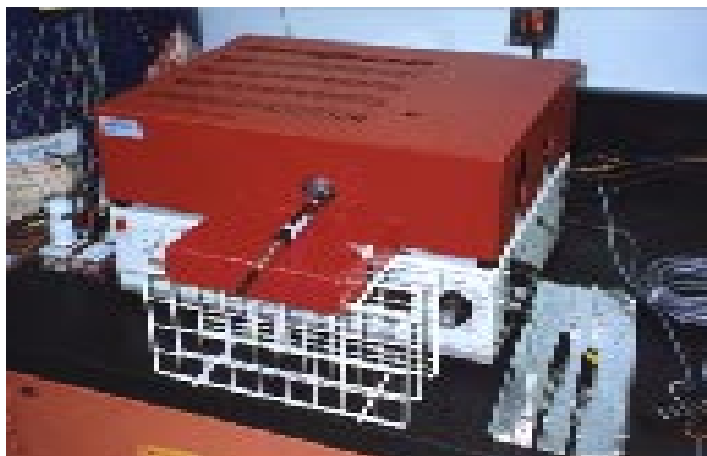
Figure 2. (left) Headspace SPME followed by (right) thermal desorption in injection port of gas chromatograph.

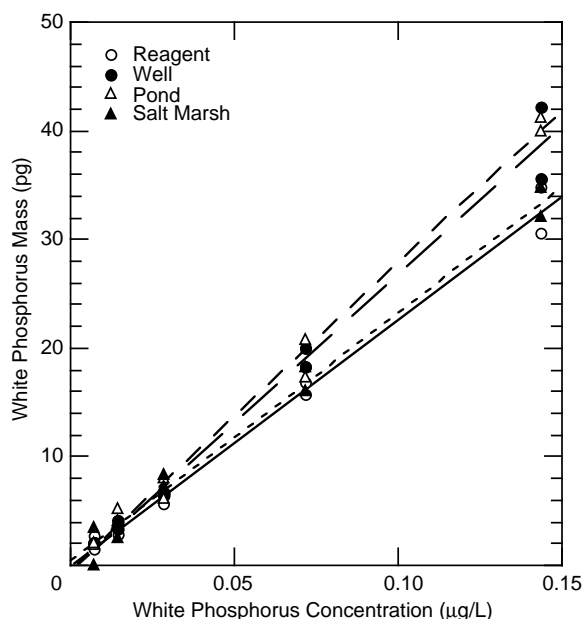
Figure 3. Mass of white phosphorus (pg) detected by headspace SPME vs. aqueous concentration over range of 0.0072 to 0.144 µg/L. Lines represent least squares regression models.

For data for each water matrix, a linear regression model with intercept (Fig. 3) and a linear regression model through the origin were tested for lack of fit. In all cases, linear models adequately described the data over the concentration range 0.0072 to 0.144 $\mu\text{g/L}$ (the F ratio for lack of fit was less than the critical value for 95% confidence)

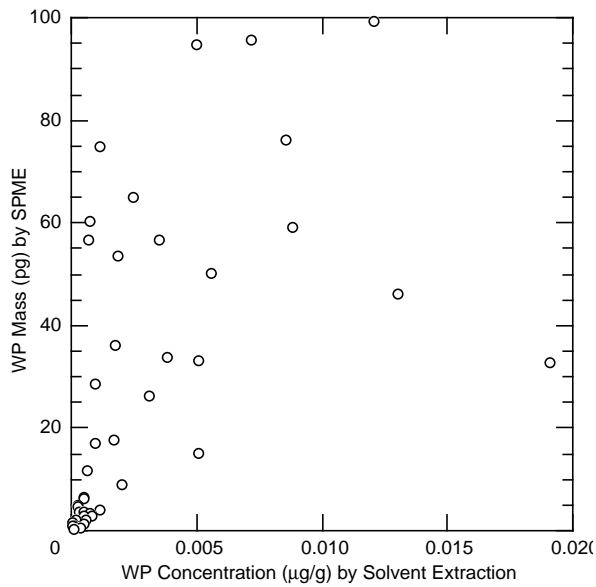
a. Data within linear range of detector.

b. Same data as a, showing results at lowest concentrations detected.

Figure 5. Mass of white phosphorus detected by headspace SPME and concentration found in same sediment sample following solvent extraction.
