FINAL REMEDIAL INVESTIGATION REPORT

**PORT HEIDEN RADIO RELAY STATION
REMEDIAL INVESTIGATION/FEASIBILITY STUDY**

PORT HEIDEN, ALASKA

May 2005

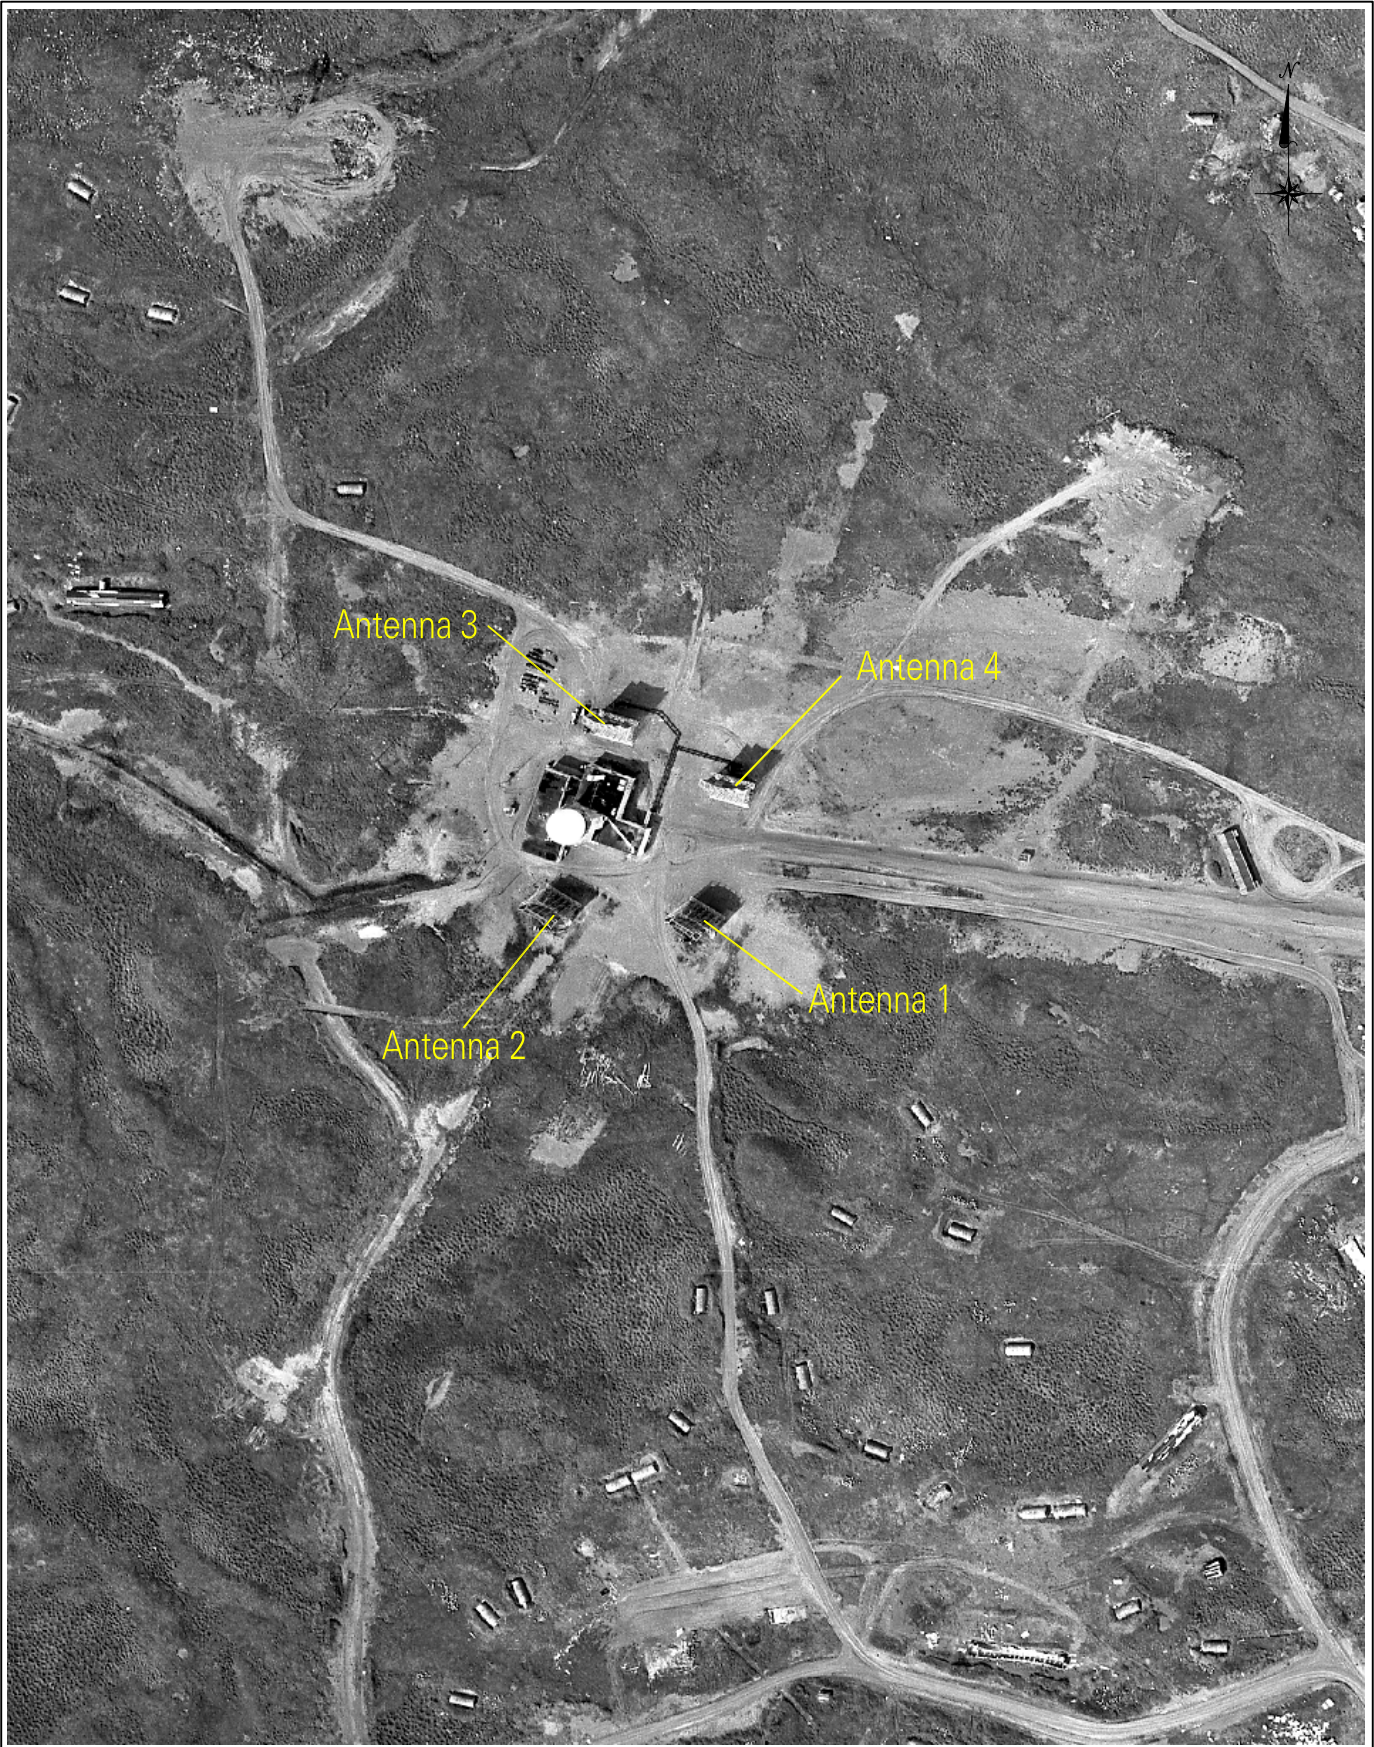
Figure No.
6.2-4

Site Locations
Former RRS Antenna Locations
UNITED STATES AIR FORCE
Port Heiden RRS, Alaska

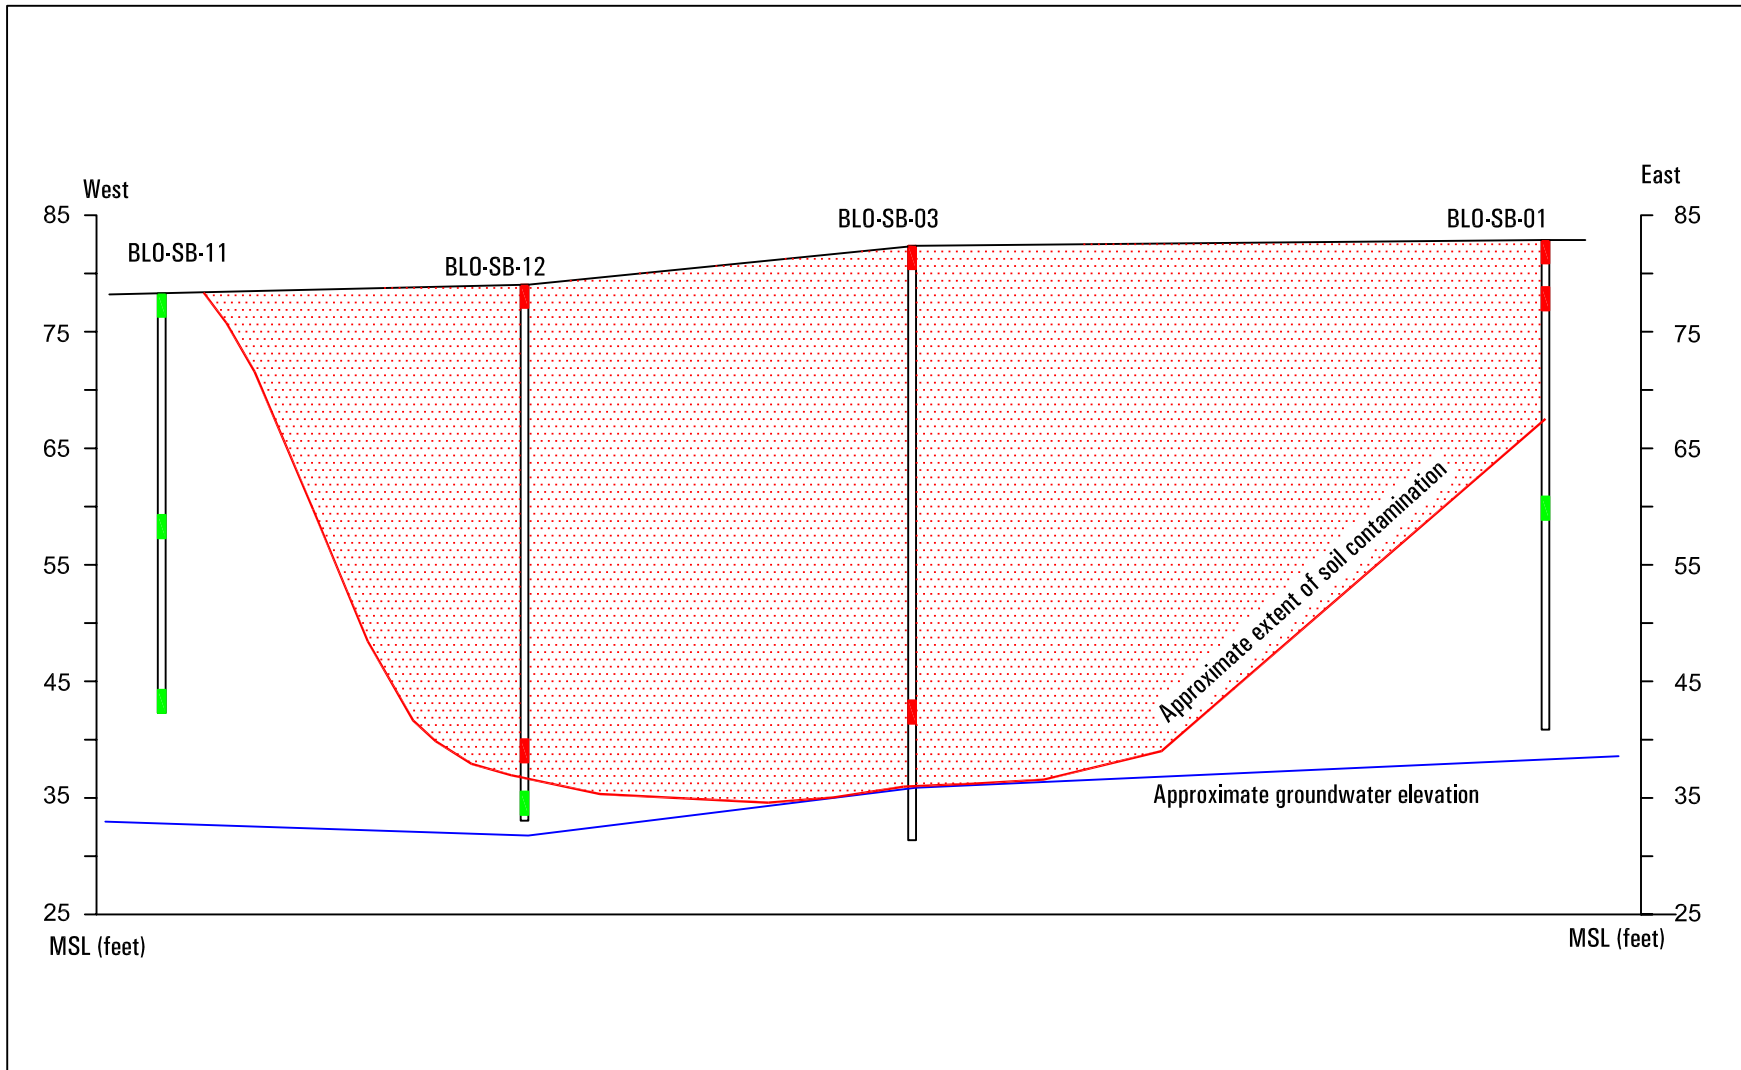
Figure No.
6.2-11

**Generalized Cross-Section West to East
 Black Lagoon Outfall
 UNITED STATES AIR FORCE
 Port Hieden RRS, Alaska**

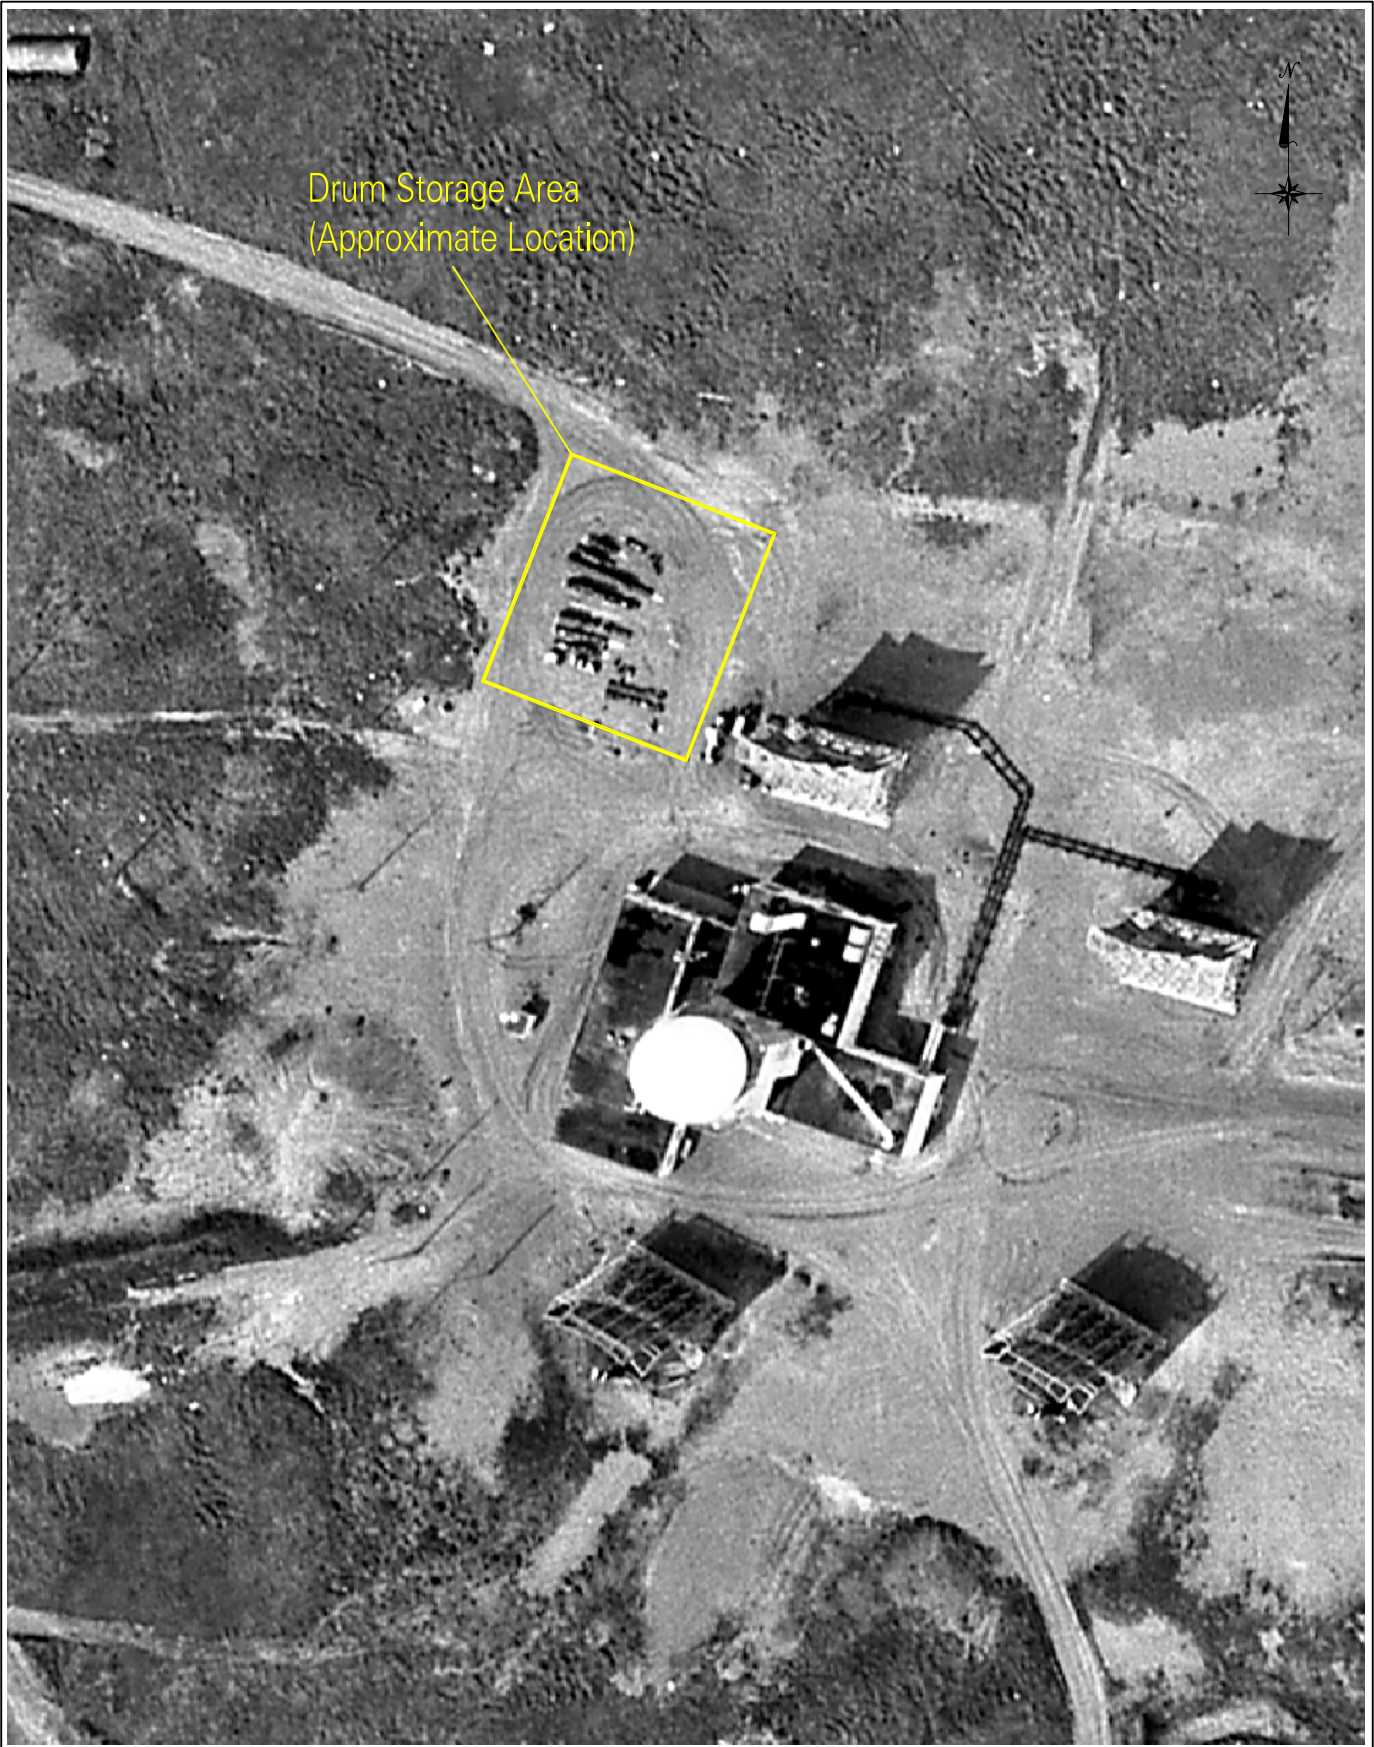
Figure No.
6.2-31

Site Location
Drum Storage Area
UNITED STATES AIR FORCE
Port Heiden RRS, Alaska
