FINAL REMEDIAL INVESTIGATION REPORT

**PORT HEIDEN RADIO RELAY STATION
REMEDIAL INVESTIGATION/FEASIBILITY STUDY**

PORT HEIDEN, ALASKA

May 2005

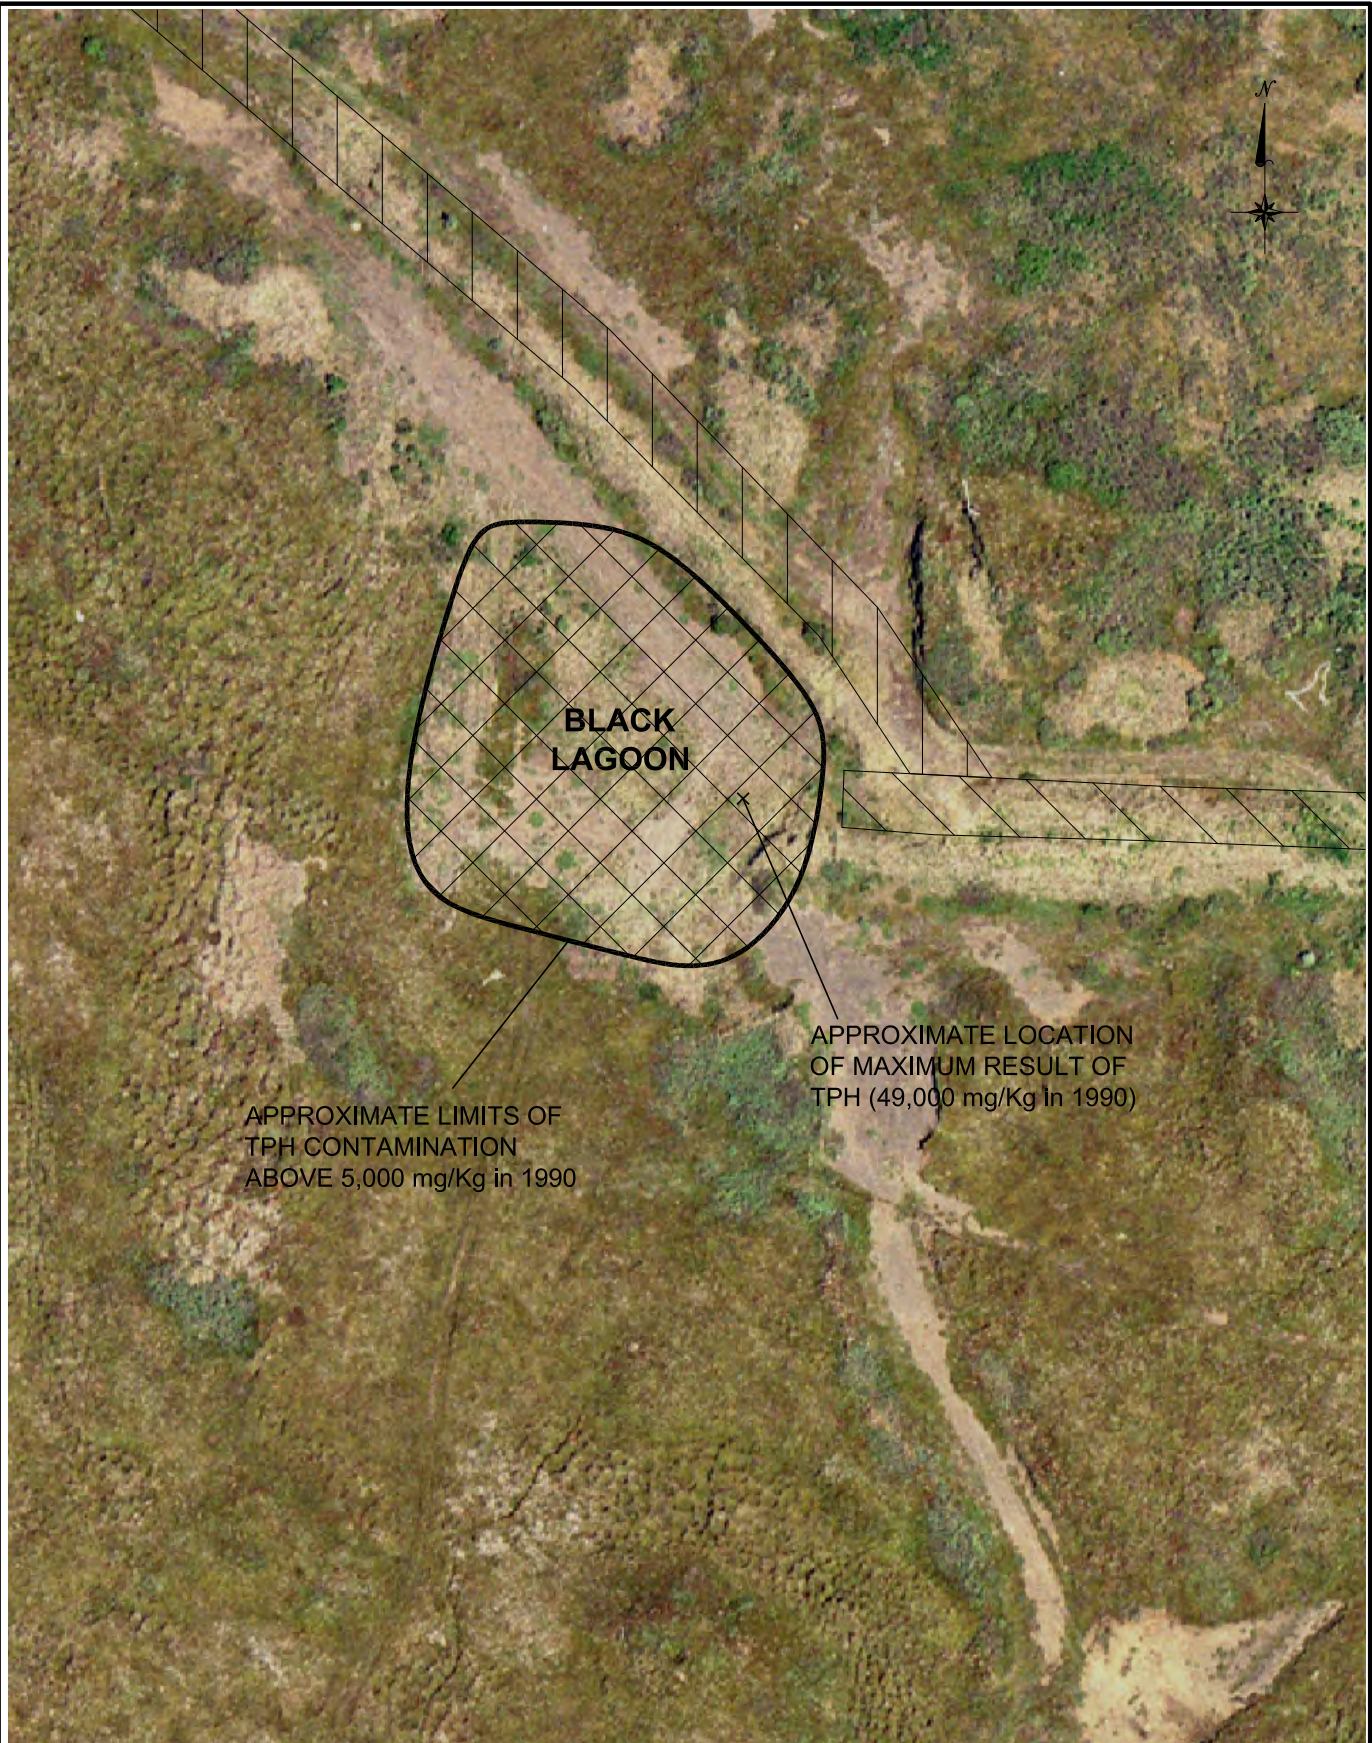
Figure No.
2-3

**Results of 1990 Soil Investigation at
Black Lagoon Outfall**
UNITED STATES AIR FORCE
Port Heiden RRS, Alaska

Analytical results varied from ND to 67,000 mg/Kg for TPH. These results are shown on Figure 2-3. Some of the data from 1990 were reportedly from unknown locations. These data are, therefore, not shown on Figure 2-3. Samples analyzed for PCBs were all ND. The extent of impacted soil with greater than 5,000 mg/Kg TPH was estimated in each trench. Impacted soil with greater than 5,000 mg/Kg TPH was found locally at the surface and to a depth of 12 feet bgs. Approximately 4,000 cy of impacted soil with TPH concentrations above 5,000 mg/Kg was estimated to remain in the Black Lagoon Outfall (USAF, 1996).

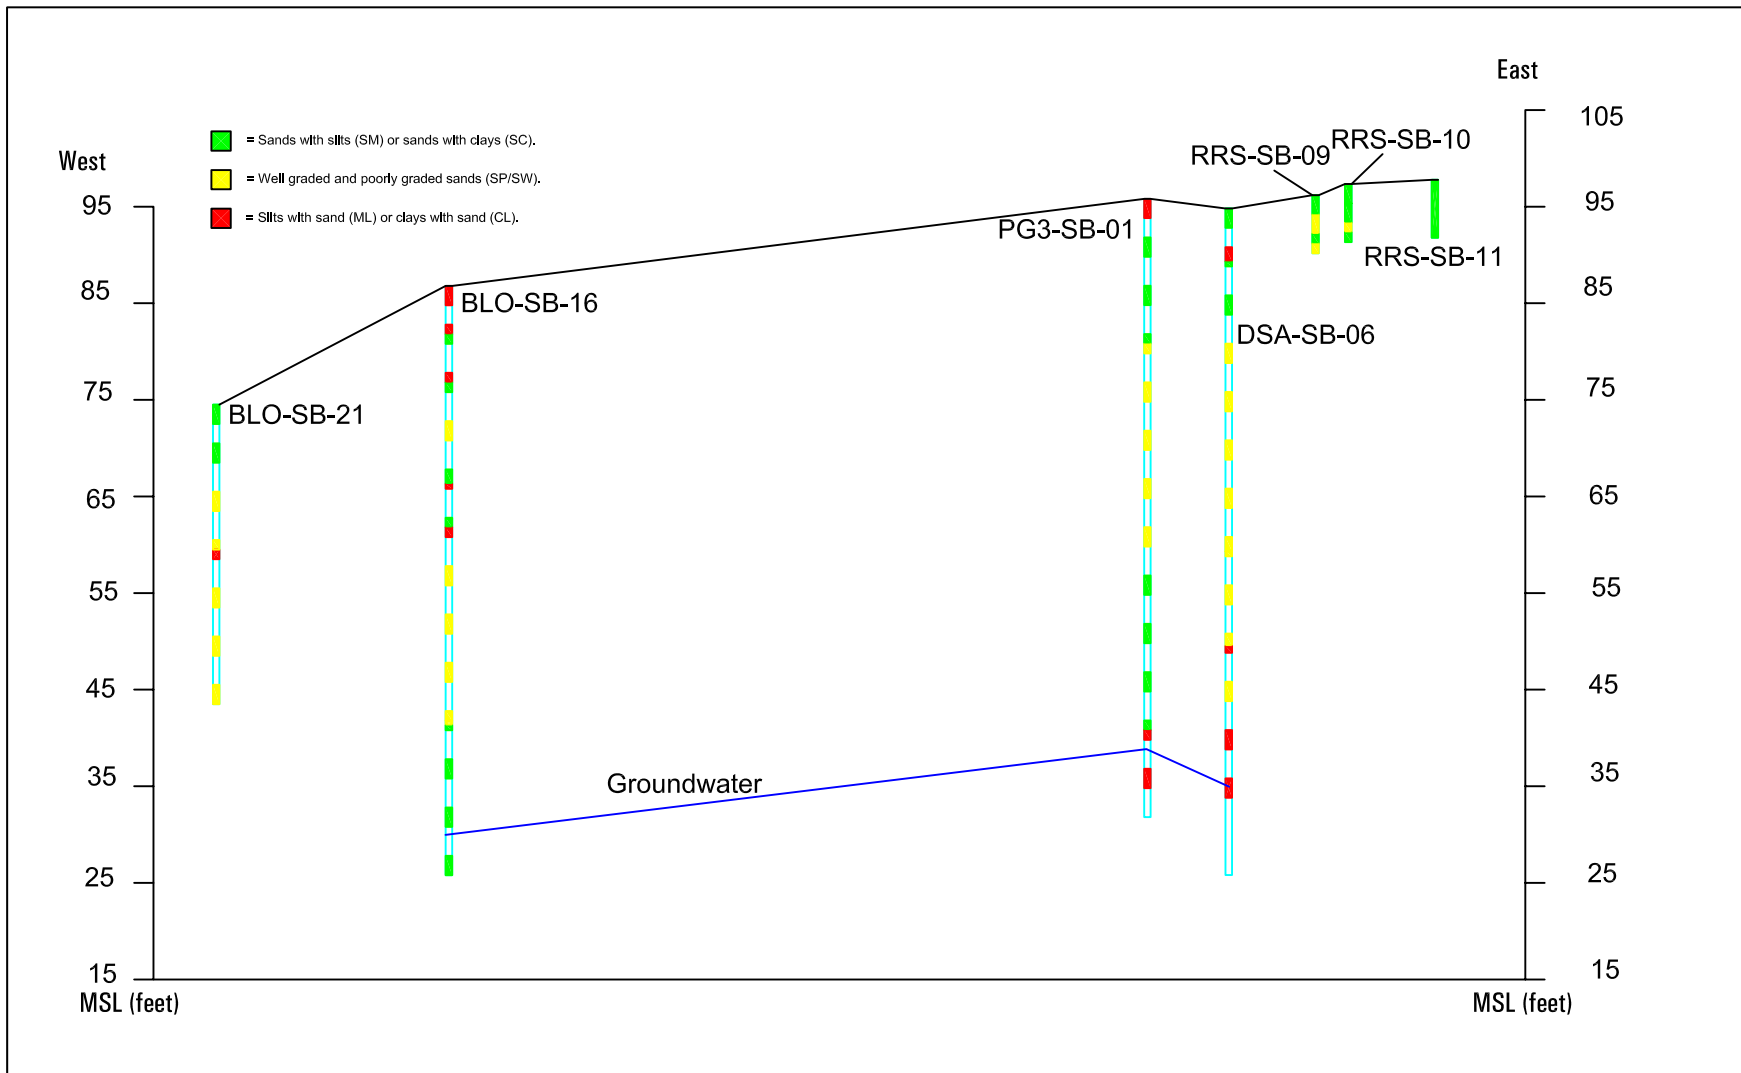
**Figure No.
6.1-4**

**Cross-Section West to East
Radio Relay Station
UNITED STATES AIR FORCE
Port Hieden RRS, Alaska**

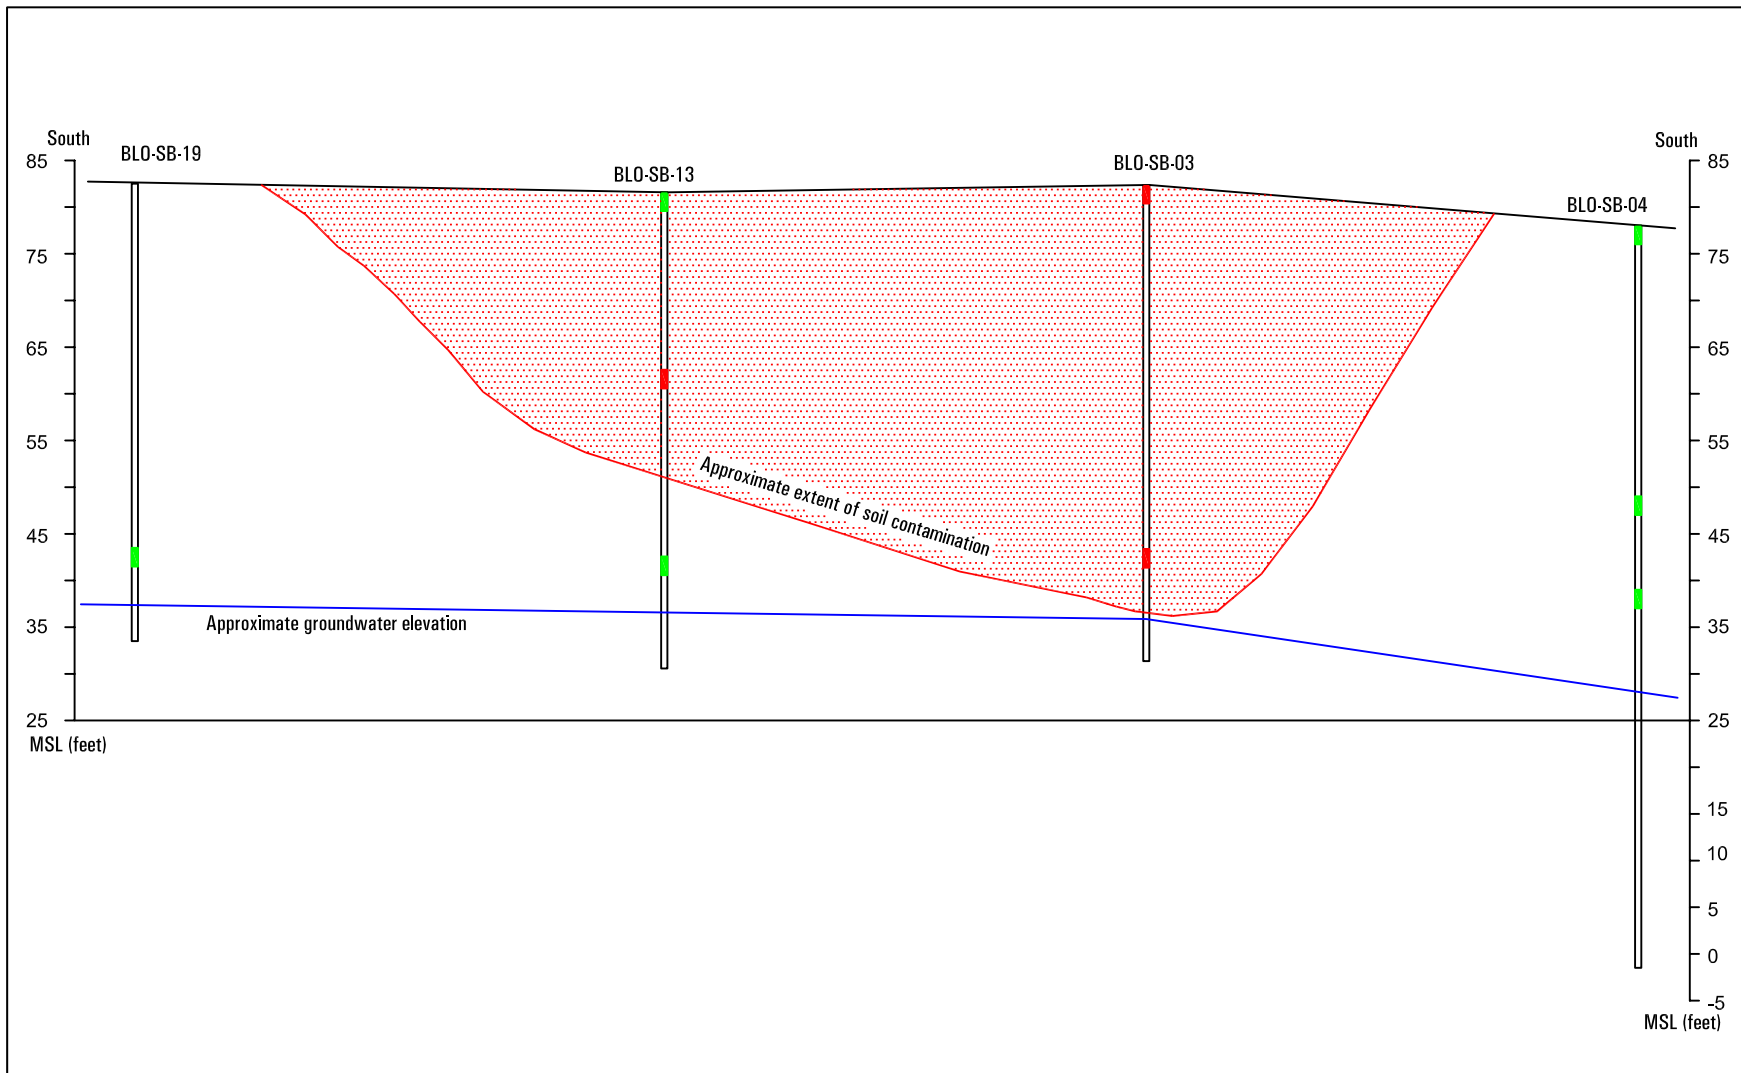
Figure No.
6.2-12

**Generalized Cross-Section South to North
Black Lagoon Outfall
UNITED STATES AIR FORCE
Port Hieden RRS, Alaska**

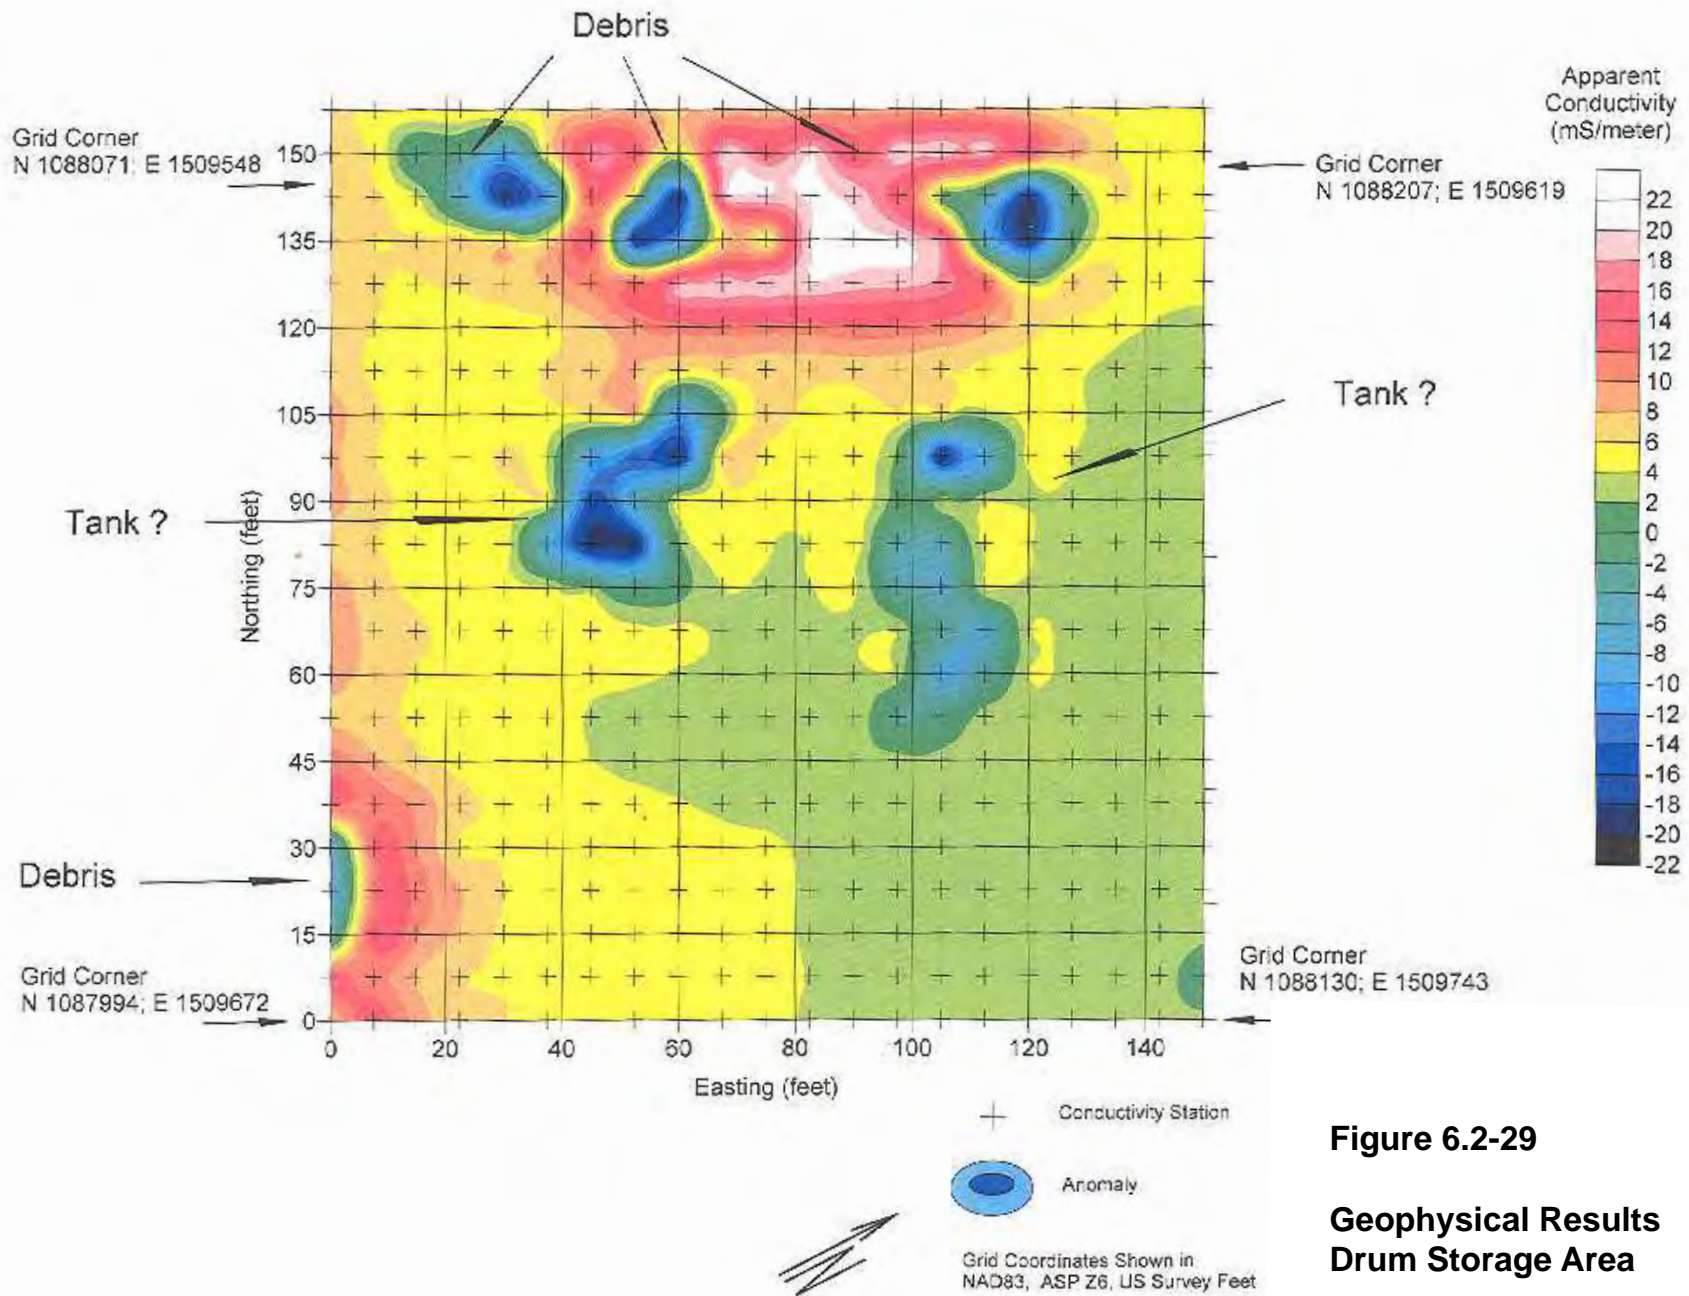
Figure 6.2-29

**Geophysical Results
Drum Storage Area**
