**UNITED STATES AIR FORCE
JOINT BASE ELMENDORF-RICHARDSON,
ALASKA**

THIRD CERCLA FIVE-YEAR REVIEW REPORT

JBER-RICHARDSON, ALASKA

**FINAL
FEBRUARY 2013**

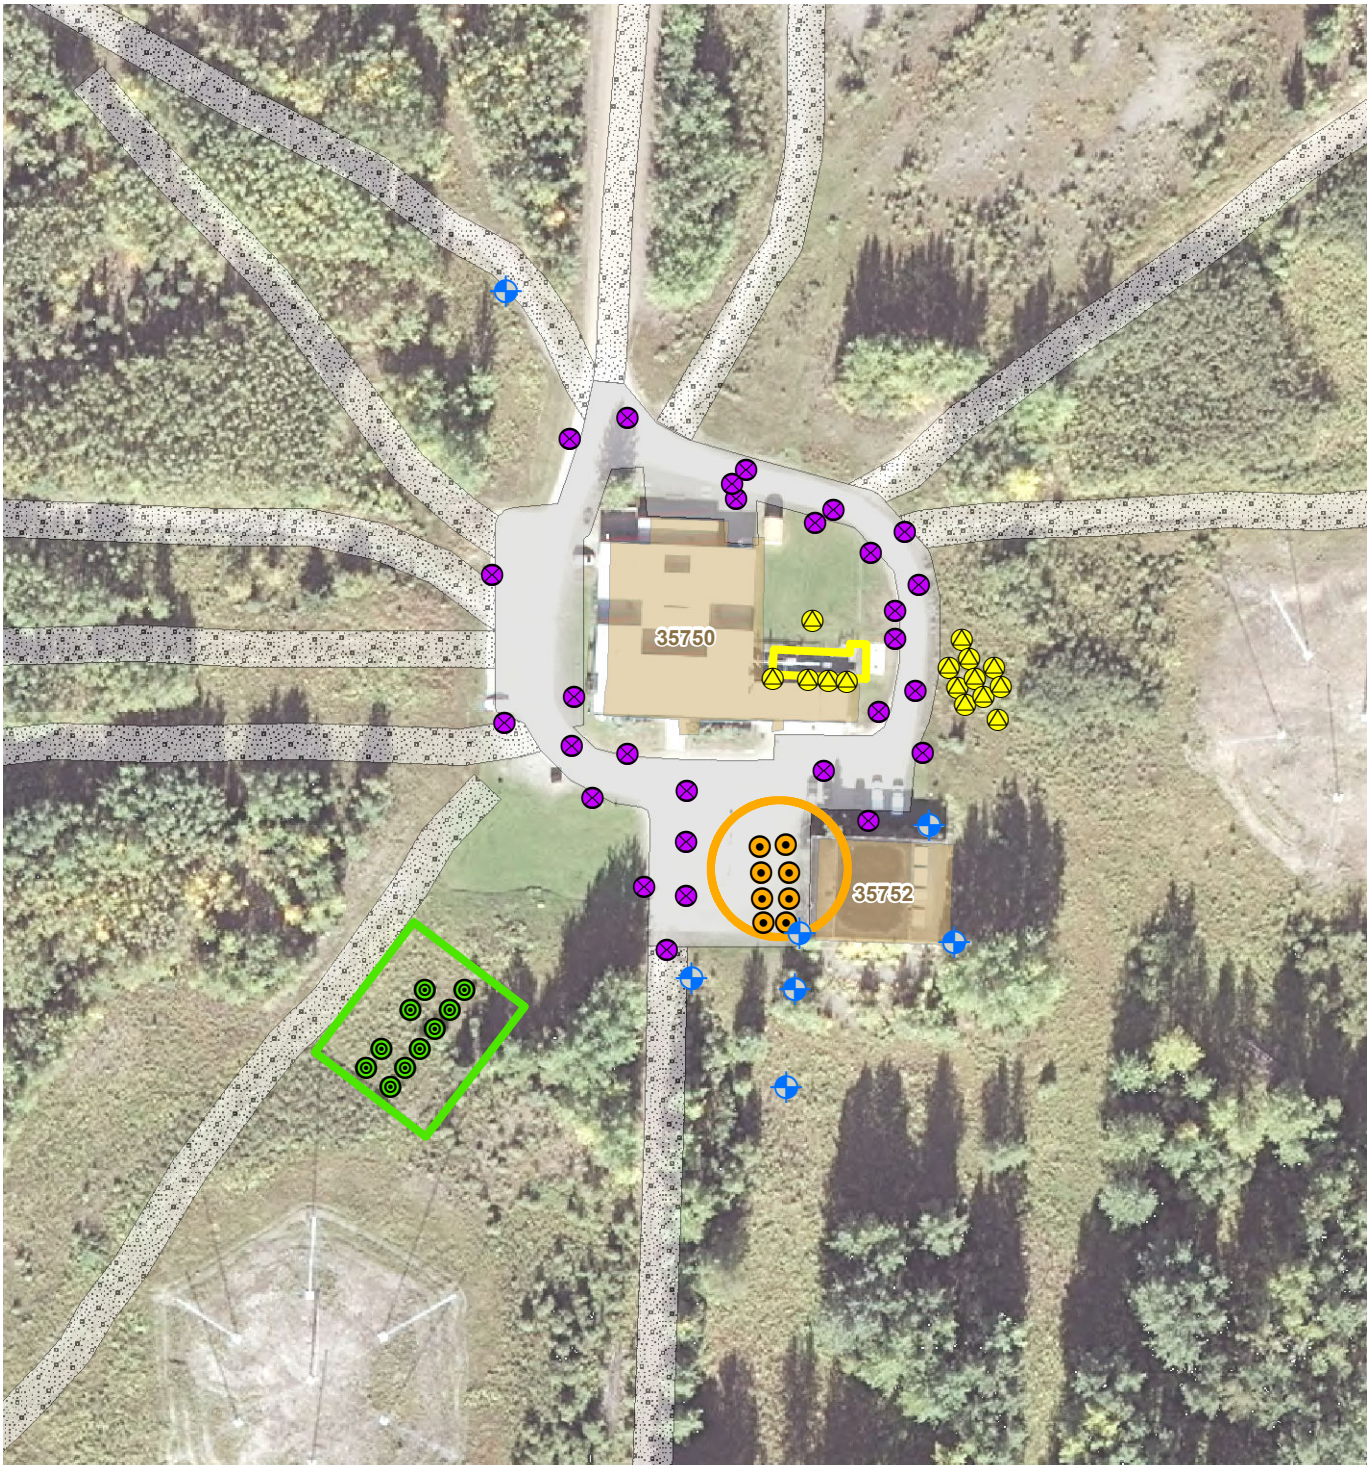
Soil Investigation: The highest concentration of PCBs detected during the RI (99.9 mg/kg) was confined to an area less than one square meter in size that was located in close proximity to a transformer mounting pad near Building 35-750. This area has limited accessibility as it is located between the transformer enclosure and the building and is not commonly utilized except during the maintenance of transformers and other electrical equipment. However, due to concerns for potential exposure, the surface soils around the transformer mounting pad were excavated upon completion of the RI activities.

All areas outside the building fit the definition of low-occupancy under the Toxic Substances Control Act (TSCA) regulation (e.g., unoccupied areas outside a building, electrical equipment vaults, or non-office space in a warehouse where occupancy is transitory). For this reason, a TSCA cleanup level of 25 ppm was established for the site. All of the surface soils located in the vicinity of the transformer mounting pad that contained PCBs exceeding a concentration of 1 mg/kg were excavated and disposed of at a TSCA landfill. The highest concentration of PCBs detected in the subsurface soils upon completion of excavation activities was 14.1 mg/kg; the sample had been collected at a depth of approximately 1 foot bgs. The concrete surface of the mounting pad was tested using wipe samples; PCB concentrations identified during the wipe sampling were less than detection limits (1 microgram per 100 square centimeters [1 $\mu\text{g}/100\text{ cm}^2$]). The entire area was subsequently capped with geotextile fabric and a minimum of 0.5 foot of clean soil.

- Burn Pit Soil Sample
- Peripheral Road Sample
- Stockpile Soil Sample
- Transformer Soil Borings
- Existing Monitoring Well
- Burn Pit Area
- Soil Stockpile Footprint
- Transformer Mounting Area
- Building
- Paved
- Unpaved

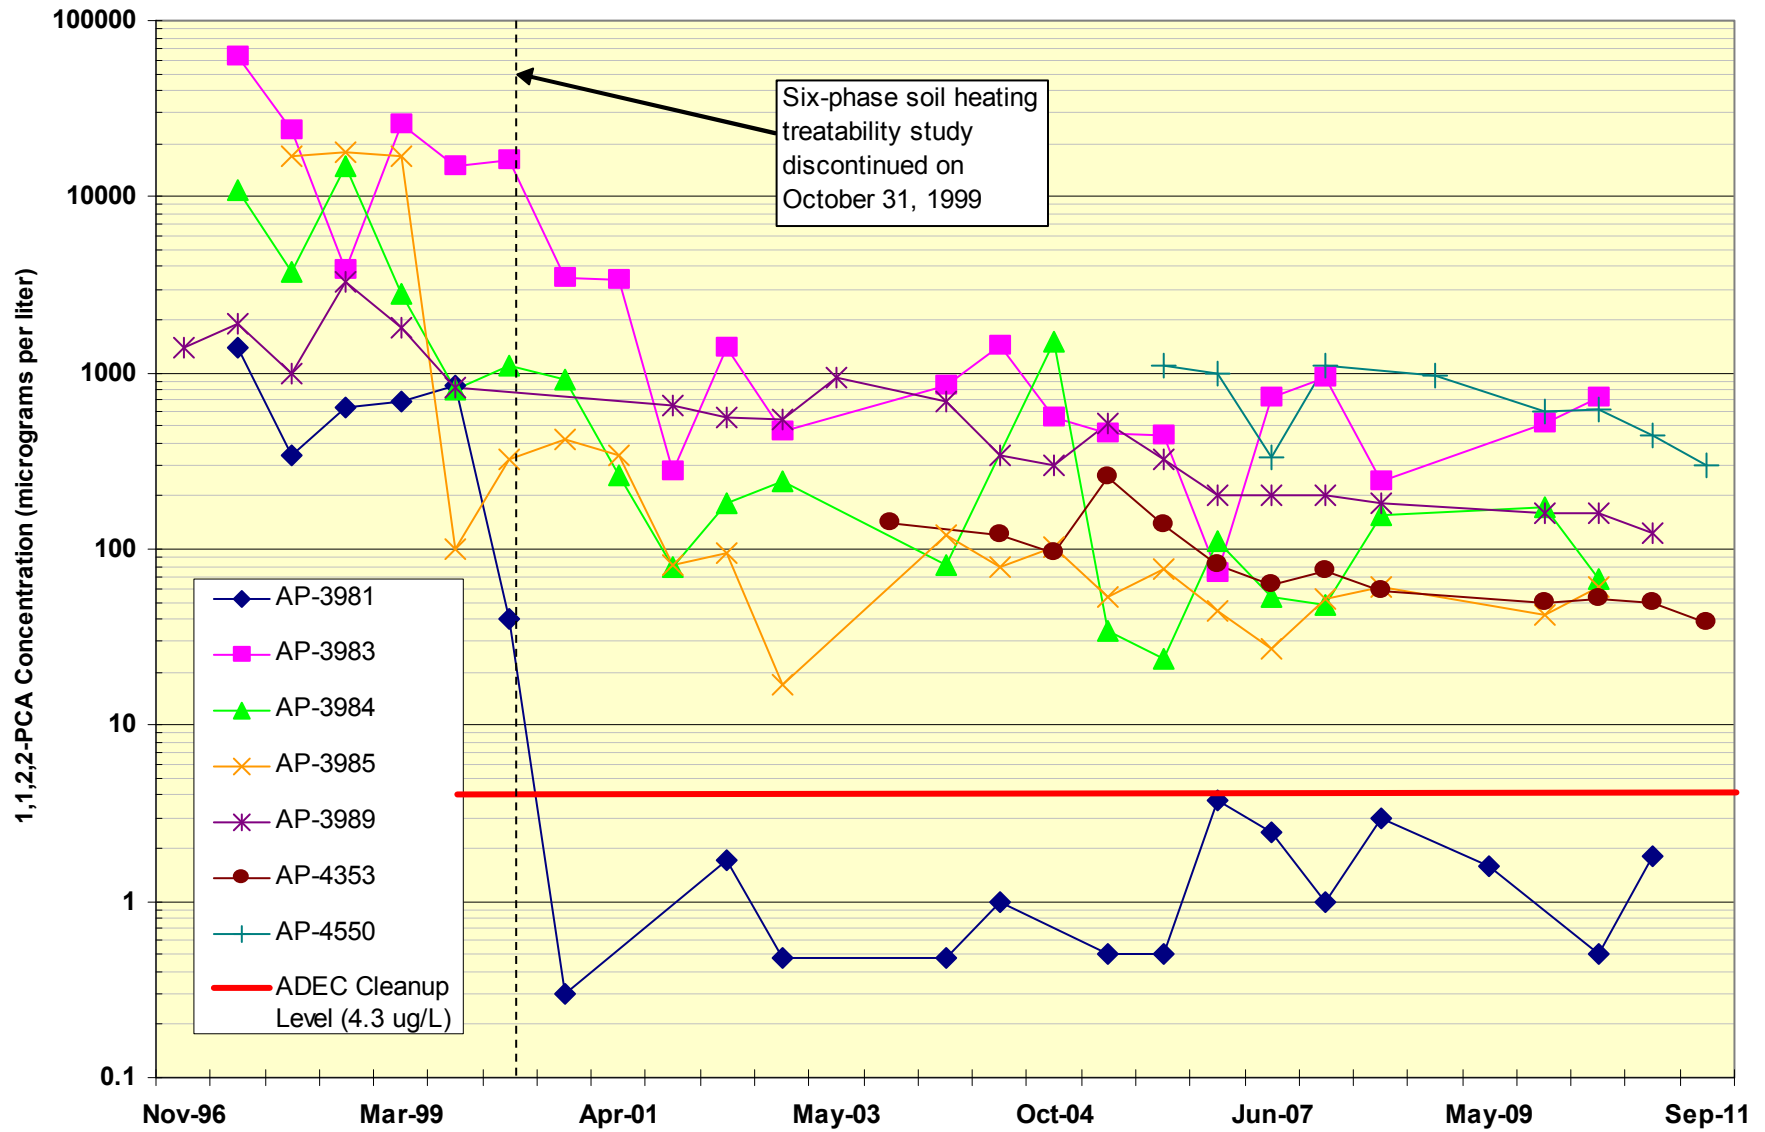
OUB 1,1,2,2 - PCA CONCENTRATIONS VS TIME FOR SHALLOW WELLS

in, the *Long-term Groundwater Monitoring Work Plan* for OUB (USACE 2001). Twenty-three rounds of groundwater samples have been collected from November 1997 through November 2011. Separate reports for each of the groundwater monitoring events are available and included in the Administrative Record. Results of the groundwater samples collected during the groundwater monitoring have shown that the concentrations of the primary VOCs (1,1,2,2-PCA, TCE, and PCE) were reduced as a result of the SPSH treatment in 1997 and 1999. Figures 4-3 and 4-4 show contaminant concentrations over time for 1,1,2,2-PCA, TCE, and cis-1,2 dichloroethene. The latest groundwater monitoring report (USAF 2012a) includes a table with contaminant trends for 10 compounds in four wells. Using the Mann-Kendall statistical analysis, no compounds exhibit increasing trends, 10 have decreasing trends and 30 have no statistically significant trend.

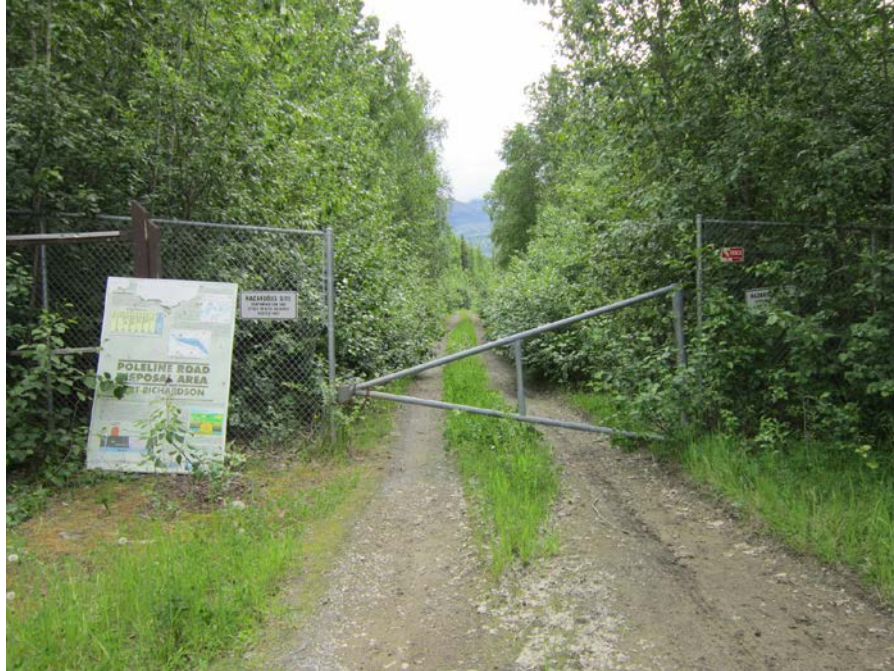
Photo No. 1 – 27 June 2012

The secured access gate to the OUB Poleline Road Disposal Area site (facing southeast).

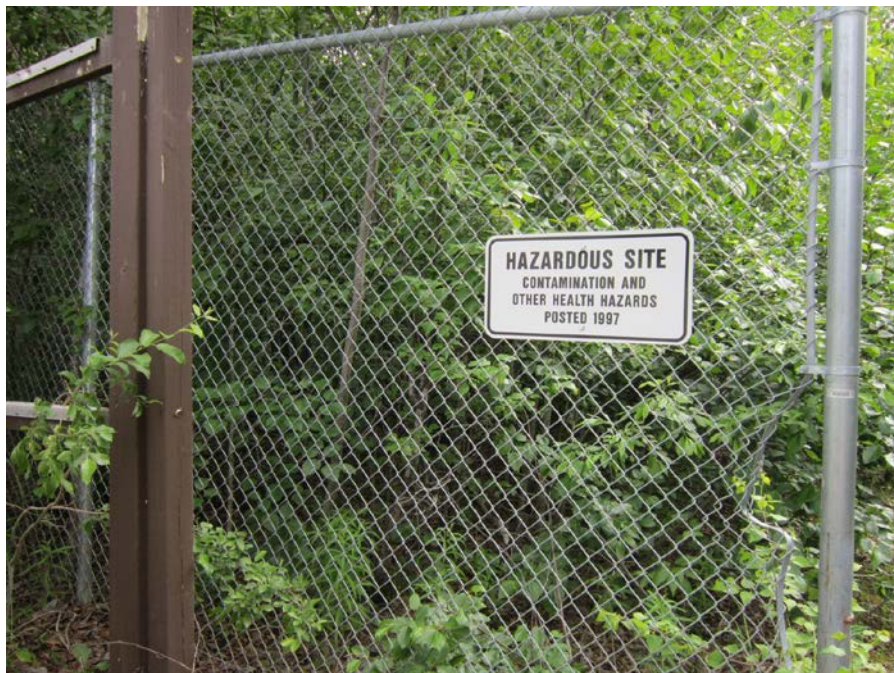
Photo No. 2 – 27 June 2012

Signage on boundary fencing of the OUB Poleline Road Disposal Area site (facing southeast).

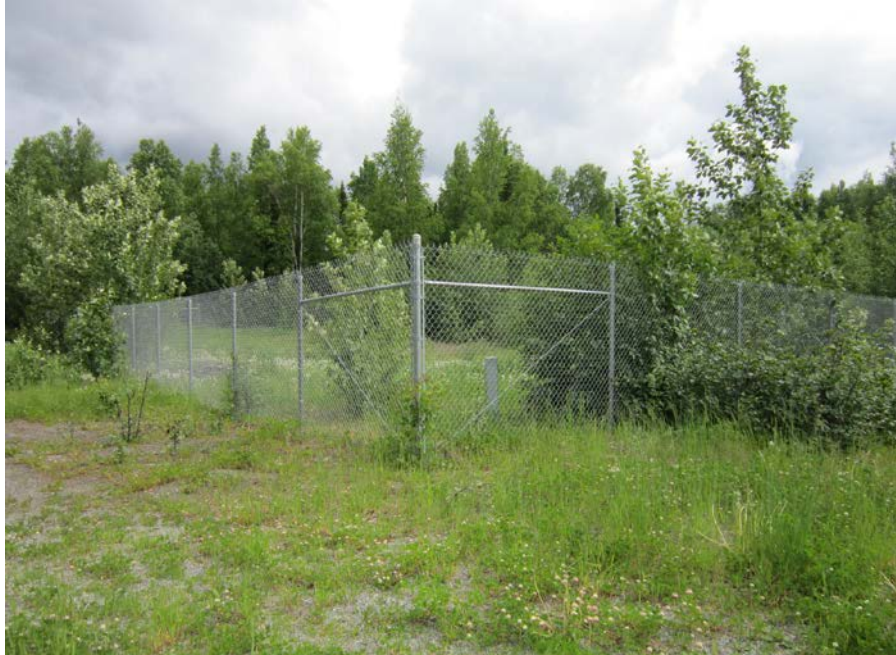
Photo No. 3 – 27 June 2012

Security fencing at the OUB Poleline Road Disposal Area site (facing northeast).

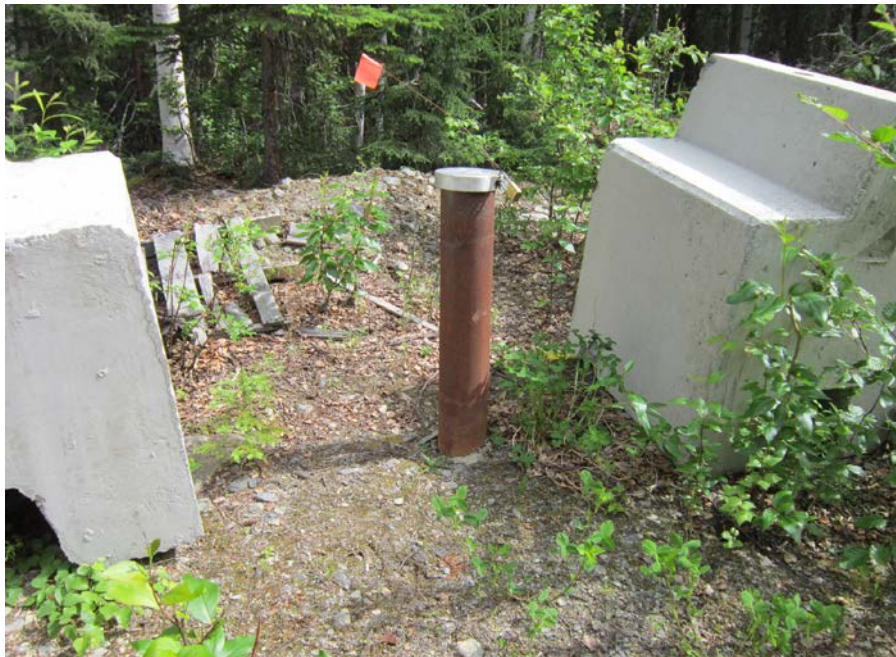
Photo No. 4 – 27 June 2012

Typical monitoring well with a newly-installed concrete barrier at the OUB Poleline Road Disposal Area site (facing east).

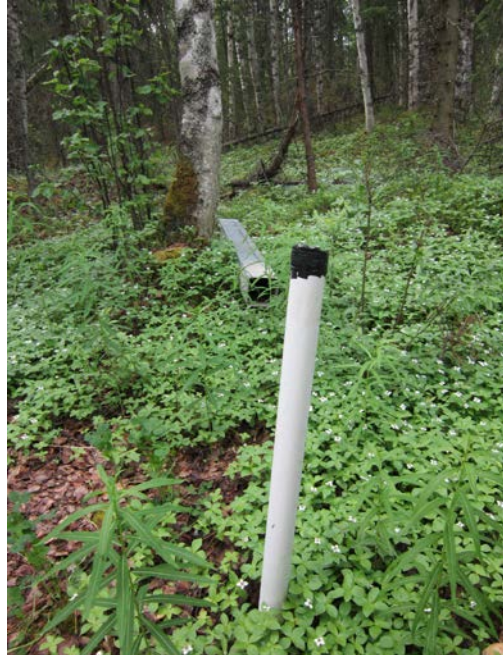
Photo No. 5 – 27 June 2012

Exterior casing from Monitoring Well AP-4348 had been removed at the OUB Poleline Road Disposal Area site (facing east).

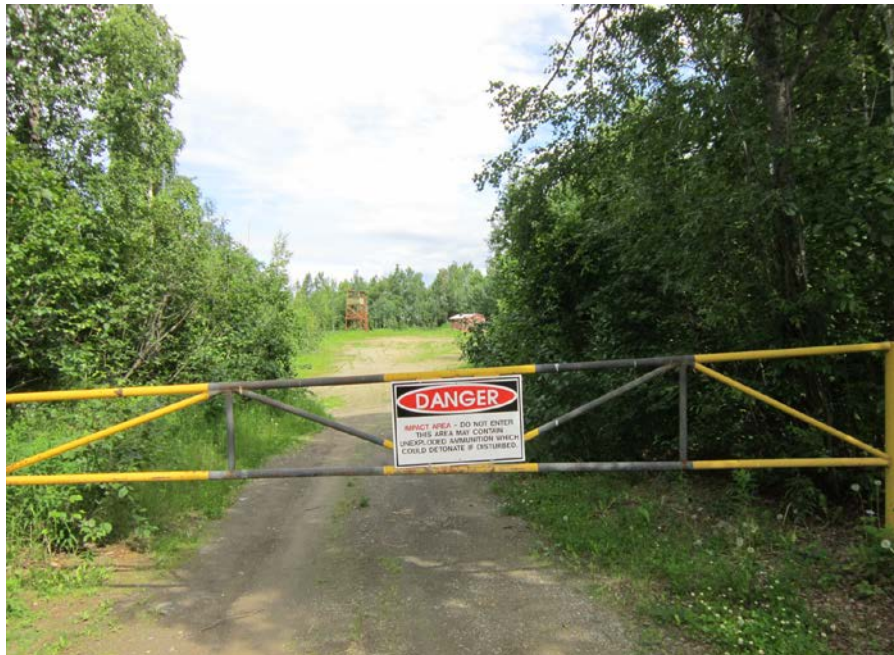
Photo No. 6 – 27 June 2012

Secured exterior gate at the OUC Eagle River Flats site (facing north).

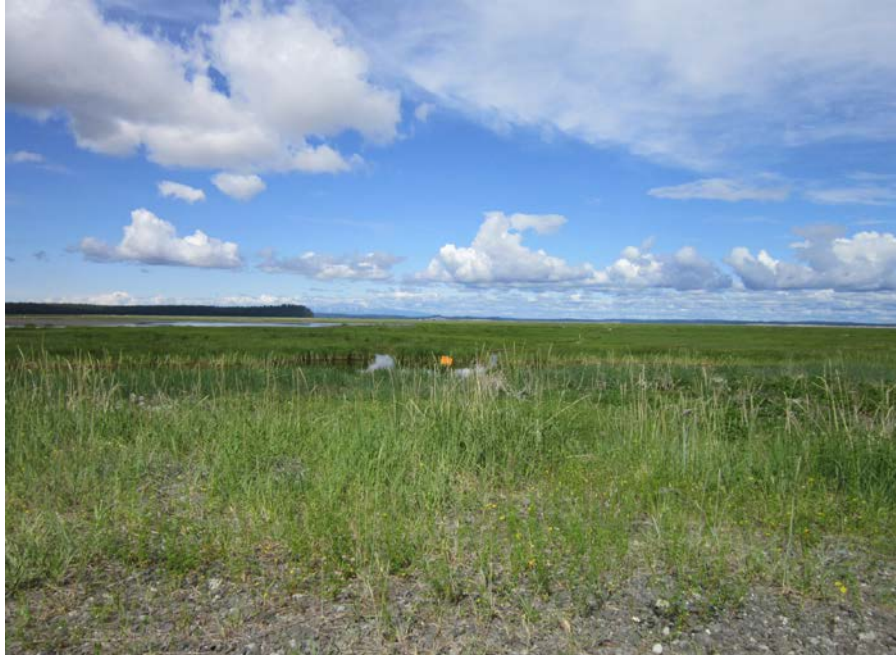
Photo No. 7 – 27 June 2012
General view of the OUC Eagle River Flats site (facing west).

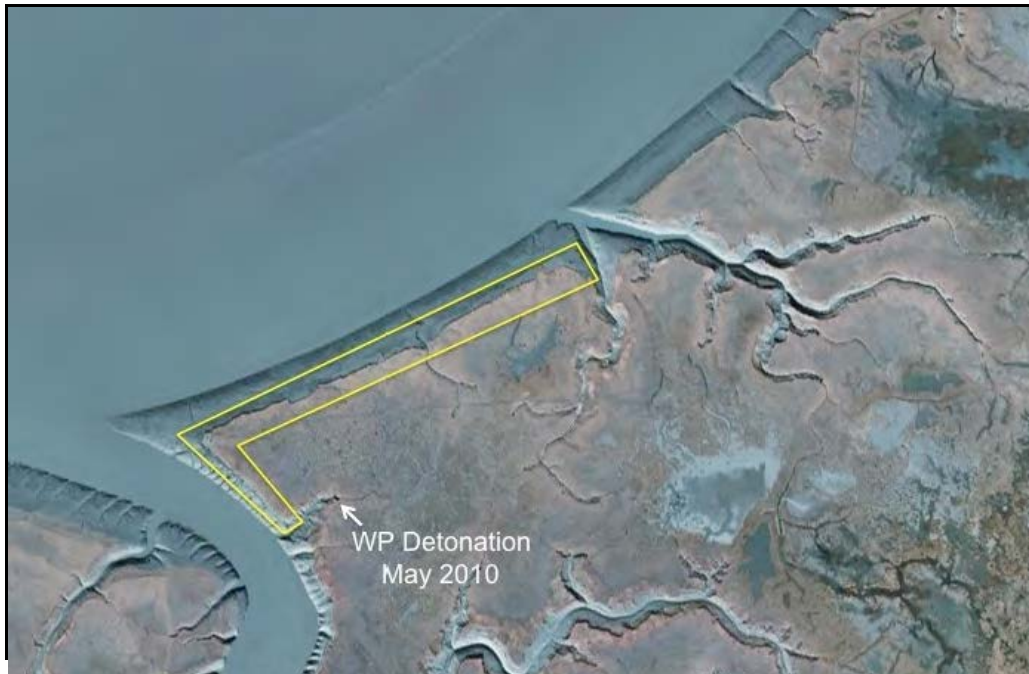
Photo No. 8 – 20 August 2009
Aerial image of coastal east bank monitored for ordinance in May of 2010 at OUC Eagle River Flats (Aero-Metric [2009]). Digital Orthophoto.

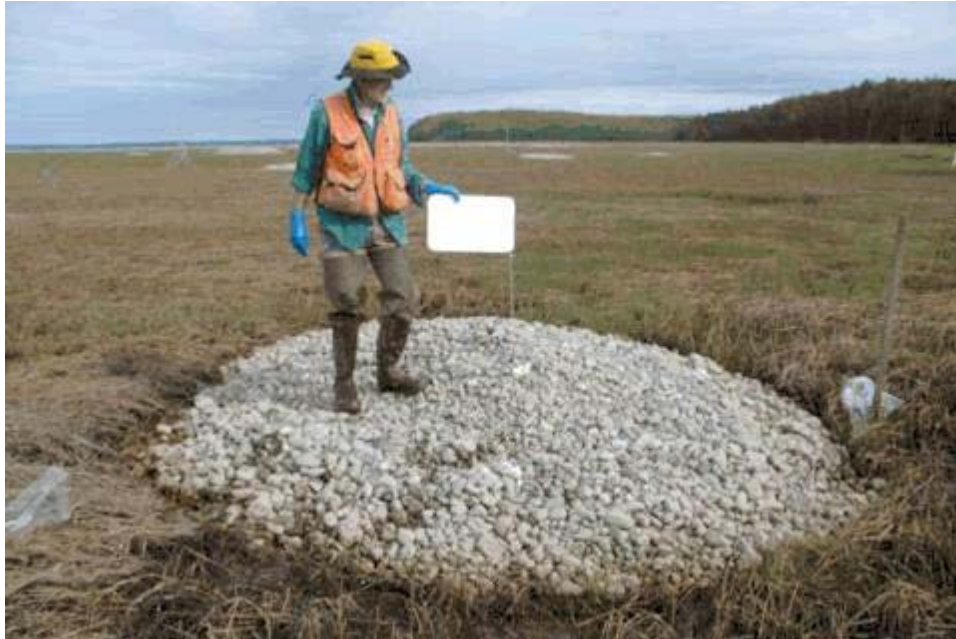
Photo No. 9 – June 2008
Gravel Cap at 03DIS38 in OUC Eagle River Flats.

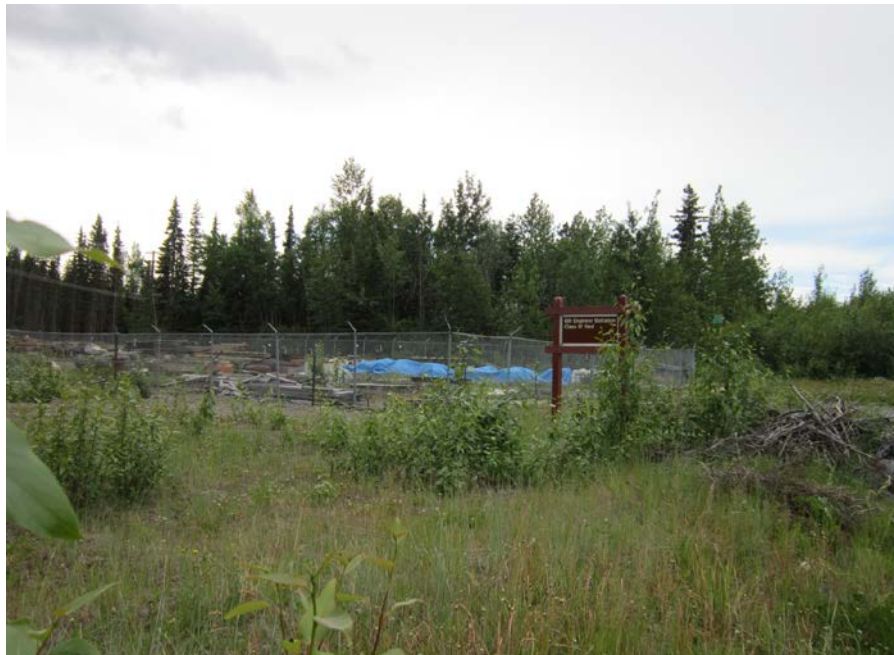
Photo No. 10 – 27 June 2012
U.S. Army 6th Engineer Battalion Class IV Yard located within the OUE AVMA site area
(facing south-southwest).

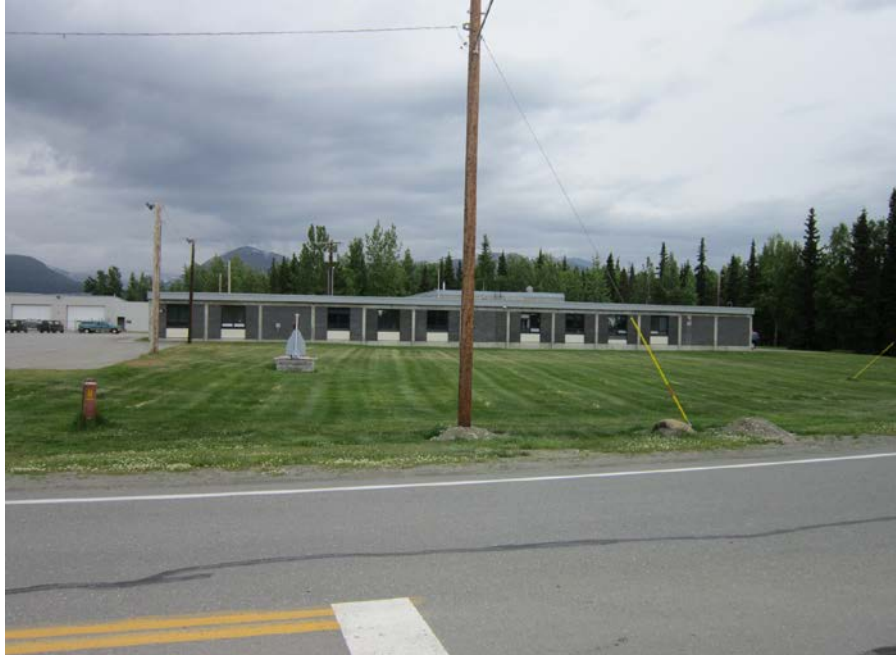
Photo No. 11 – 27 June 2012

Building 733 and associated grounds, located within the OUE AVMA site area (facing southeast).

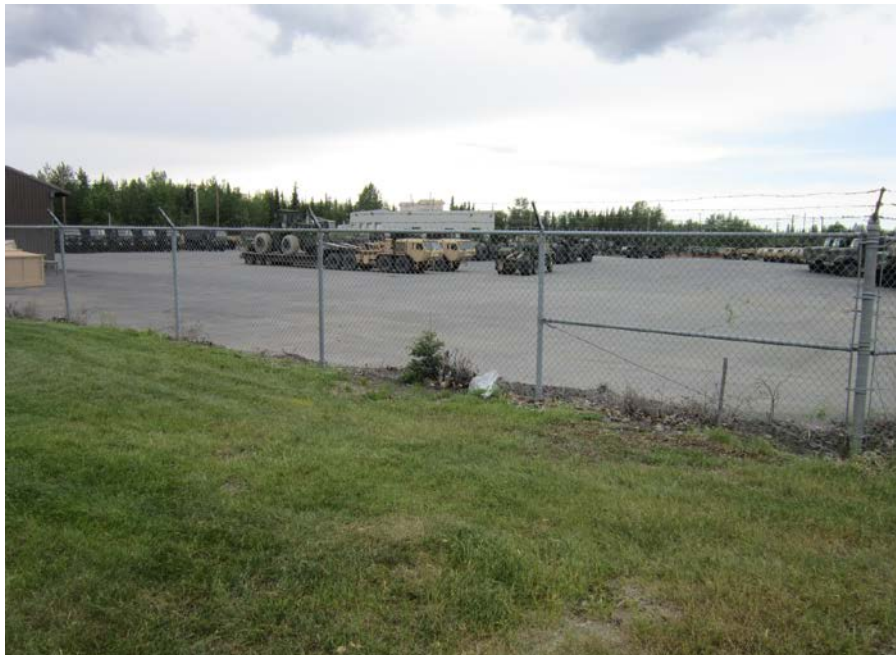
Photo No. 12 – 27 June 2012

Building 732 and associated storage yard, located within the OUE AVMA site area (facing southwest).

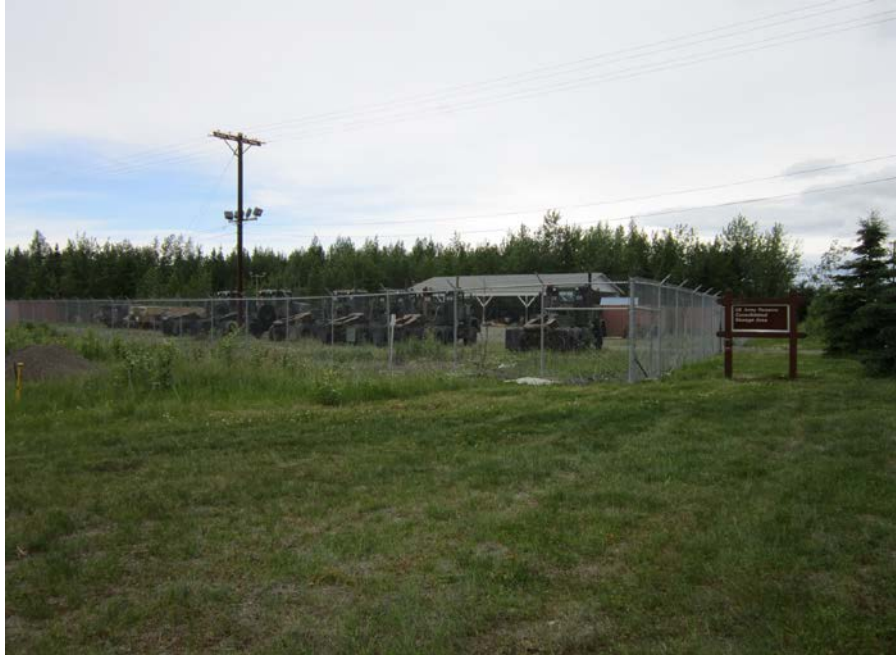
Photo No. 13 – 27 June 2012

U.S. Army Consolidated Storage Yard located within the OUE AVMA site area
(facing north).

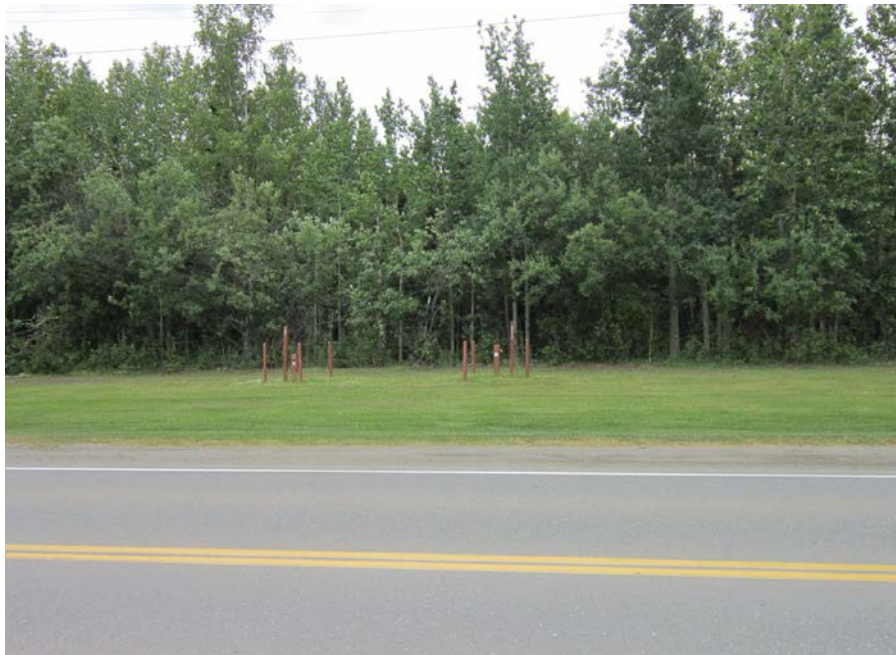
Photo No. 14 – 27 June 2012

Monitoring Wells AP-3468 and AP-3534 at the OUE AVMA site
(facing north-northwest).
