Date 28 May 2015

To Meseret Ghebreslassie (USACE)
Pat Roth (USAF)

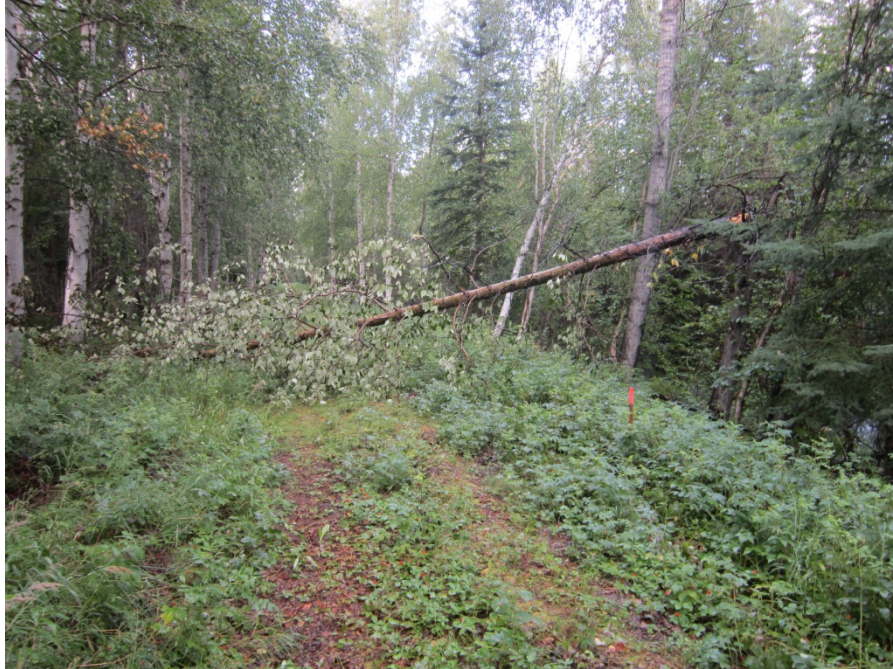
Photo No. 1 – 19 August 2014.

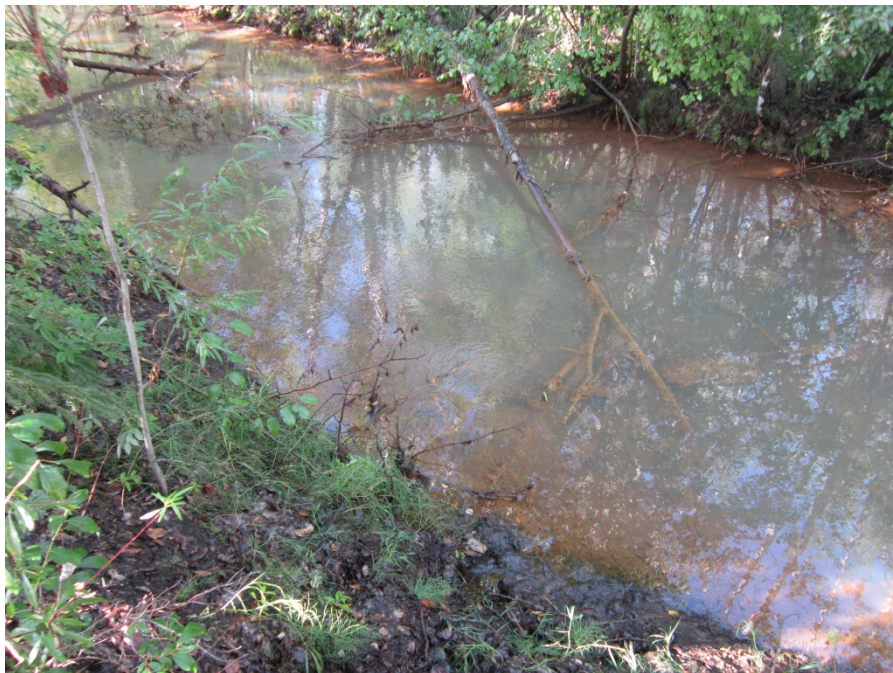
Photo No. 2 – 19 August 2014.

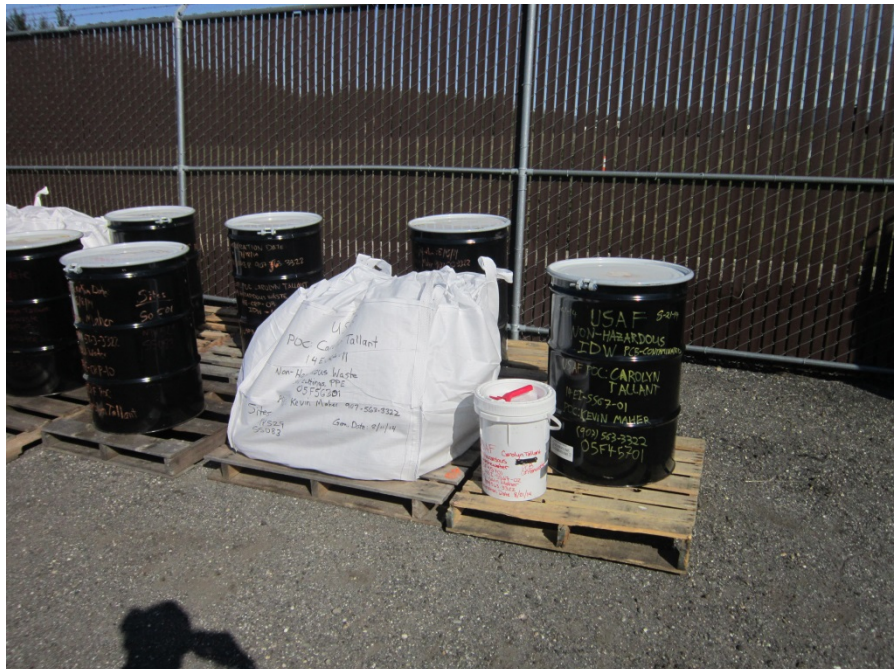
Photo No. 4 – 22 August 2014.

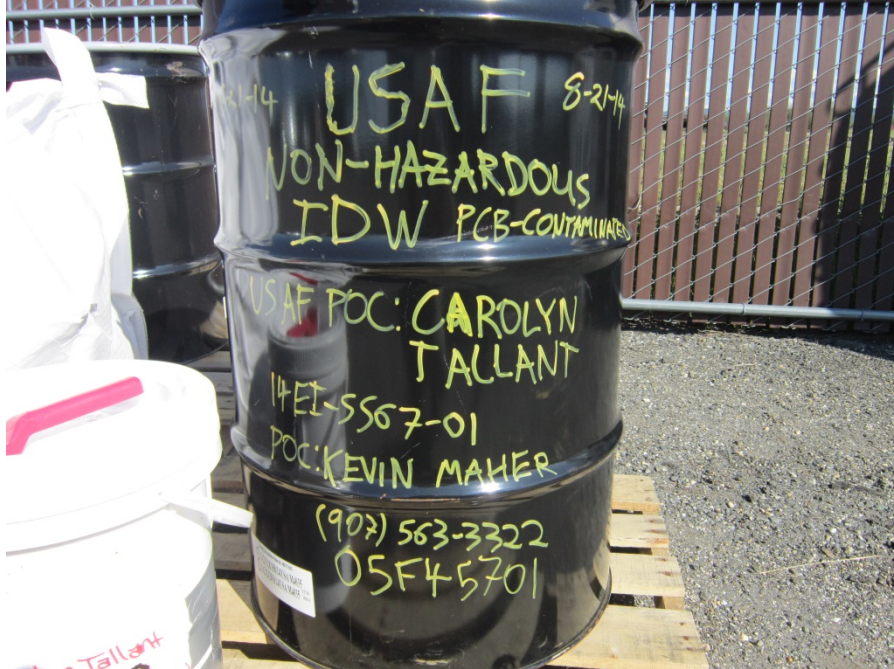
Photo No. 5 – 22 August 2014.
The drum of used PPE and sampling equipment was properly labeled (close-up view).
