Final Report
Additional Environmental Investigation

Haines Area Sites
(PMP 17.7, 19.5, and 25.5)

Haines-Fairbanks Pipeline
Formerly Used Defense Site

Haines, Alaska

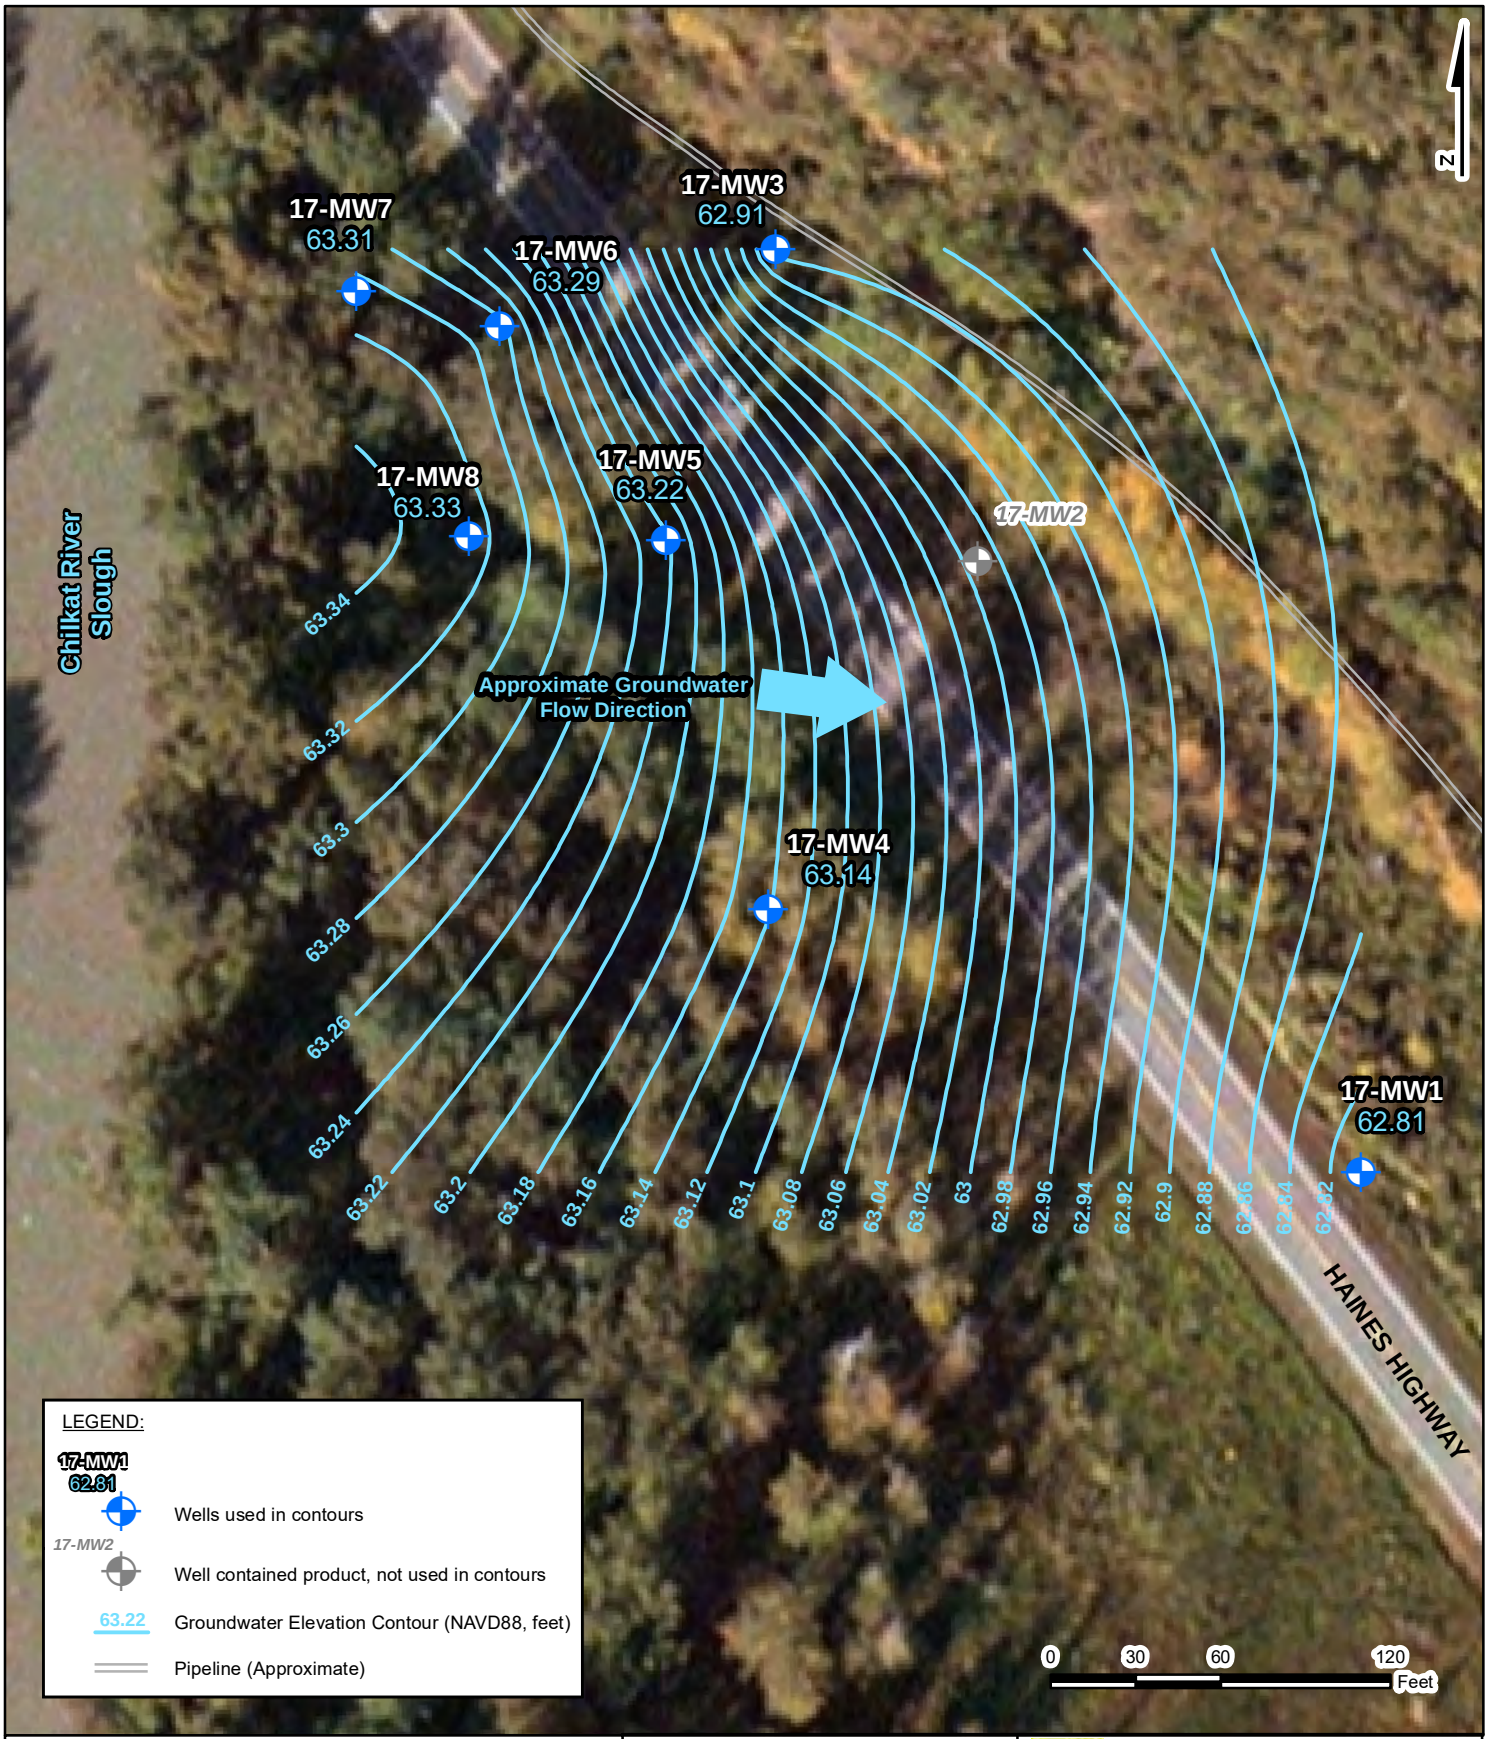
Contract: W911KB-12-D-0001, TO29	Figure: 3-2	Date: 12/14

- Benzene concentrations exceeded the groundwater cleanup level of 0.005 mg/L in five wells. The highest benzene concentration of 0.65 mg/L was found in well 17-MW3.
- Calculated TAH and TAqH values exceeded the surface water criteria of 0.010 and 0.015 mg/L, respectively, in six wells at the site. The well nearest the Chilkat River slough, 17-MW7, had TAH and TAqH concentrations below the surface water criteria. The next closest well, 17-MW8, had TAH and TAqH values of 0.0148 and 0.0153 mg/L, just slightly above the surface water criteria.

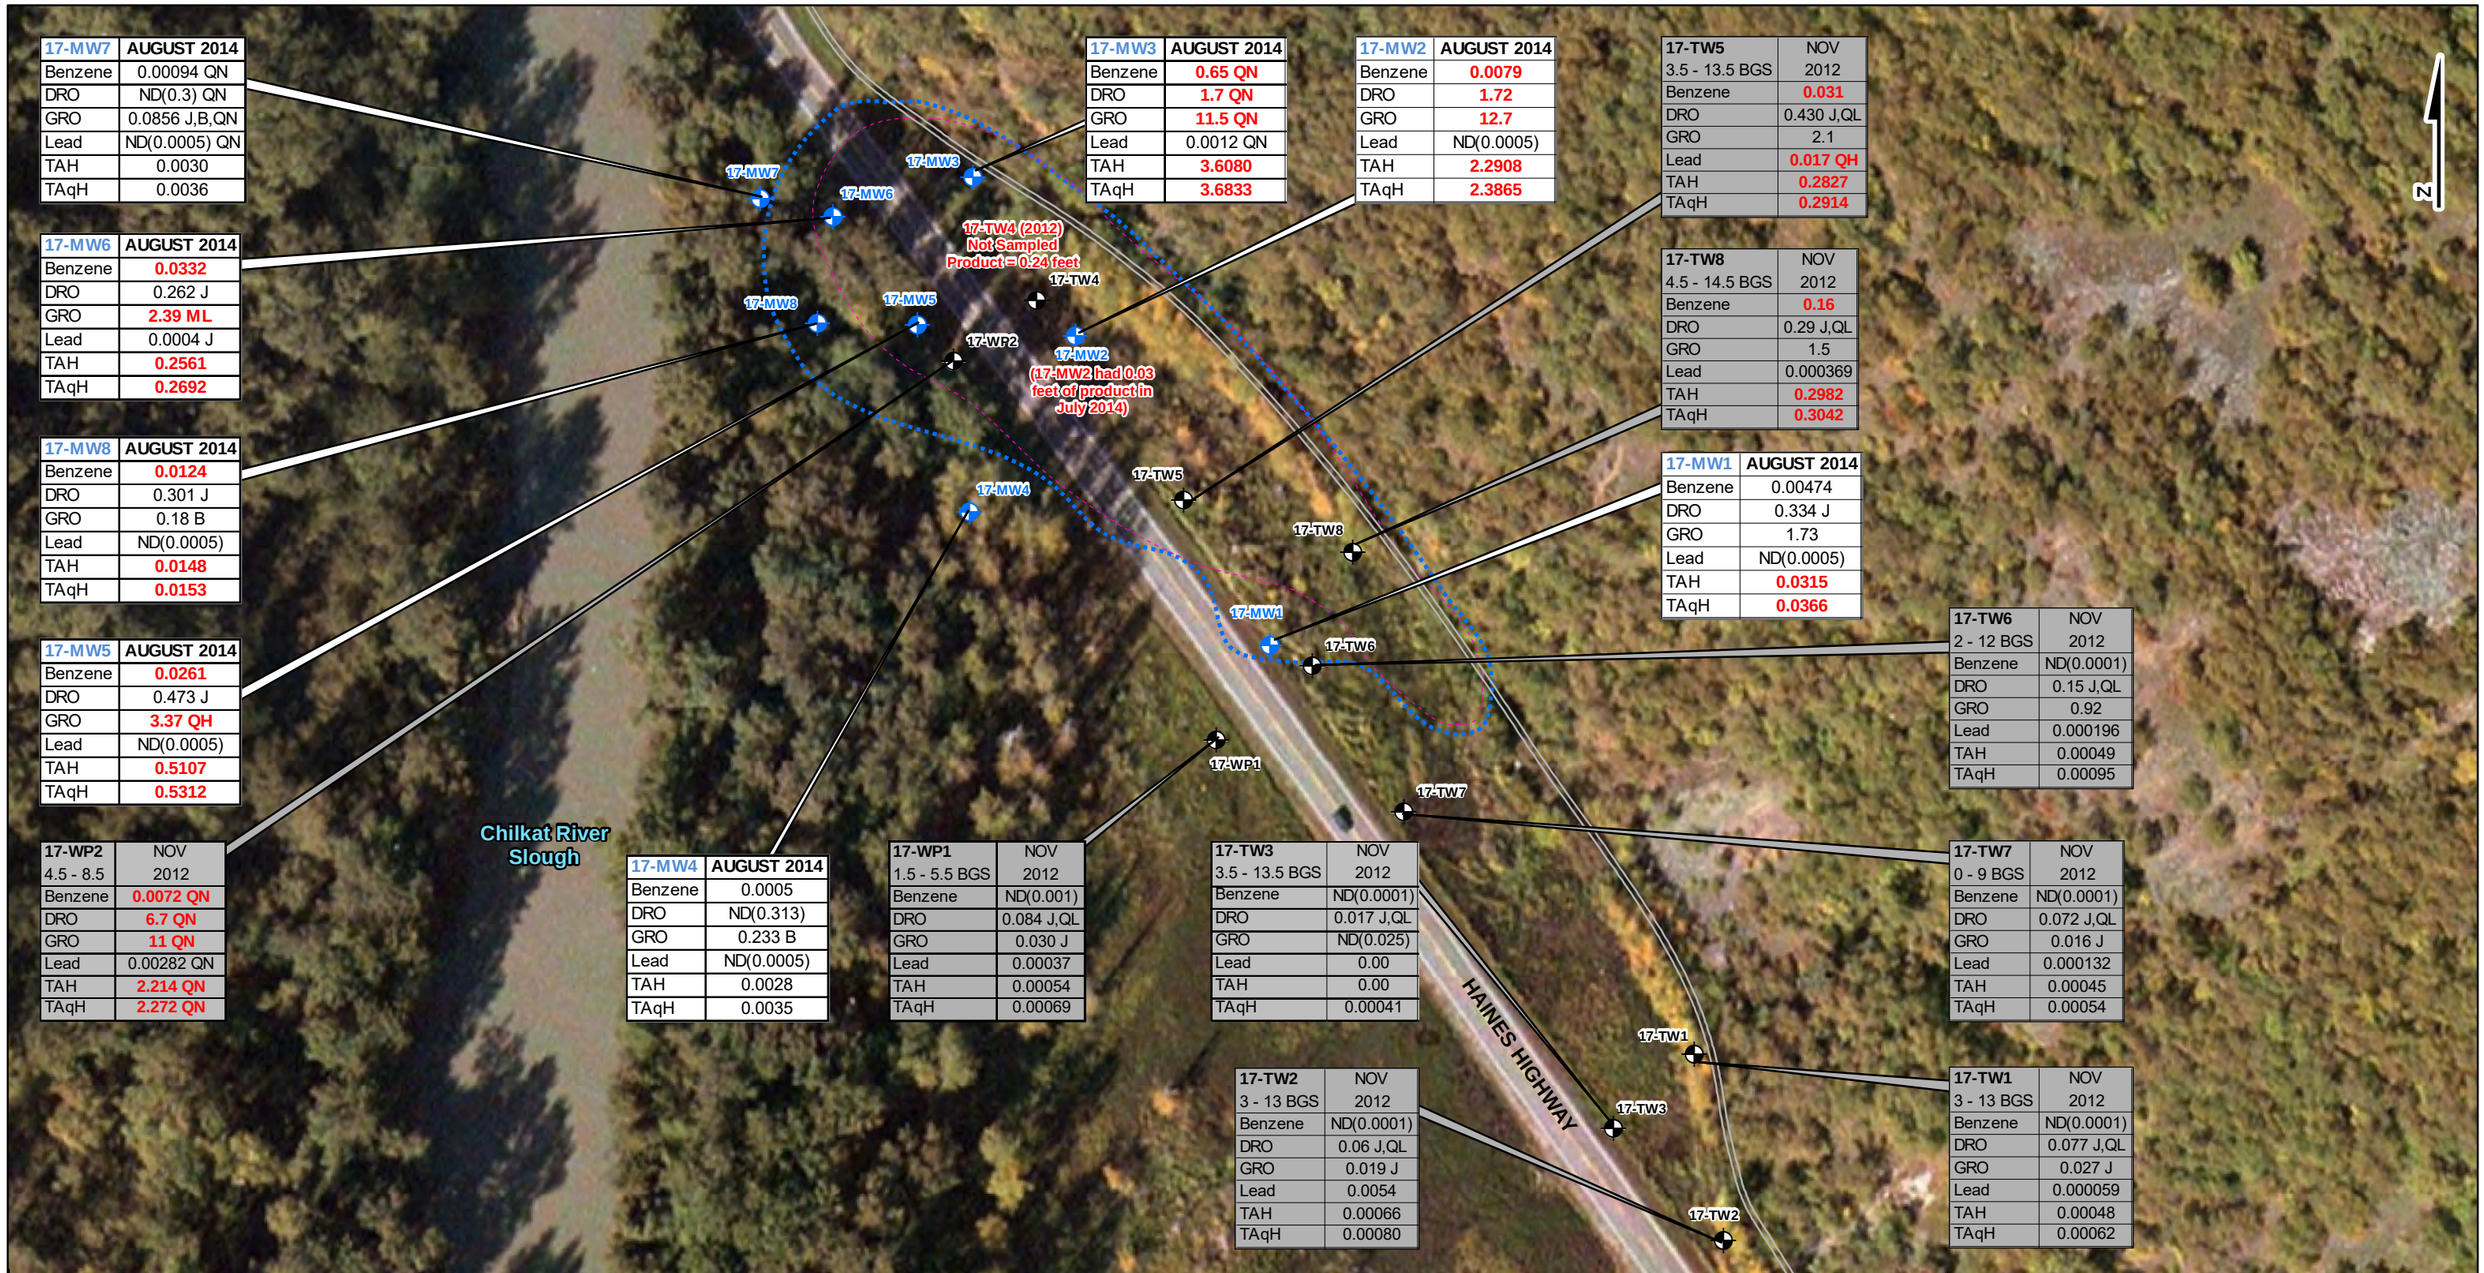
Groundwater depth measurements were collected from each of the wells on July 28, 2014. Using the well survey data (Appendix F), groundwater elevations were calculated. Groundwater contours shown on Figure 3-2 indicate the general flow direction is to the east. Groundwater contours from November 2012 depicted groundwater flow roughly towards the northwest in the northern part of the site. Groundwater elevations were approximately 3.8 feet higher during July 2014 than measured in November 2012 at similar site locations.

2014 Groundwater Elevation Contours
Pipeline Milepost 17.7
Additional Environmental Investigation Report
Haines-Fairbanks Pipeline FUDS Alaska
Project #: F10AK1016-14

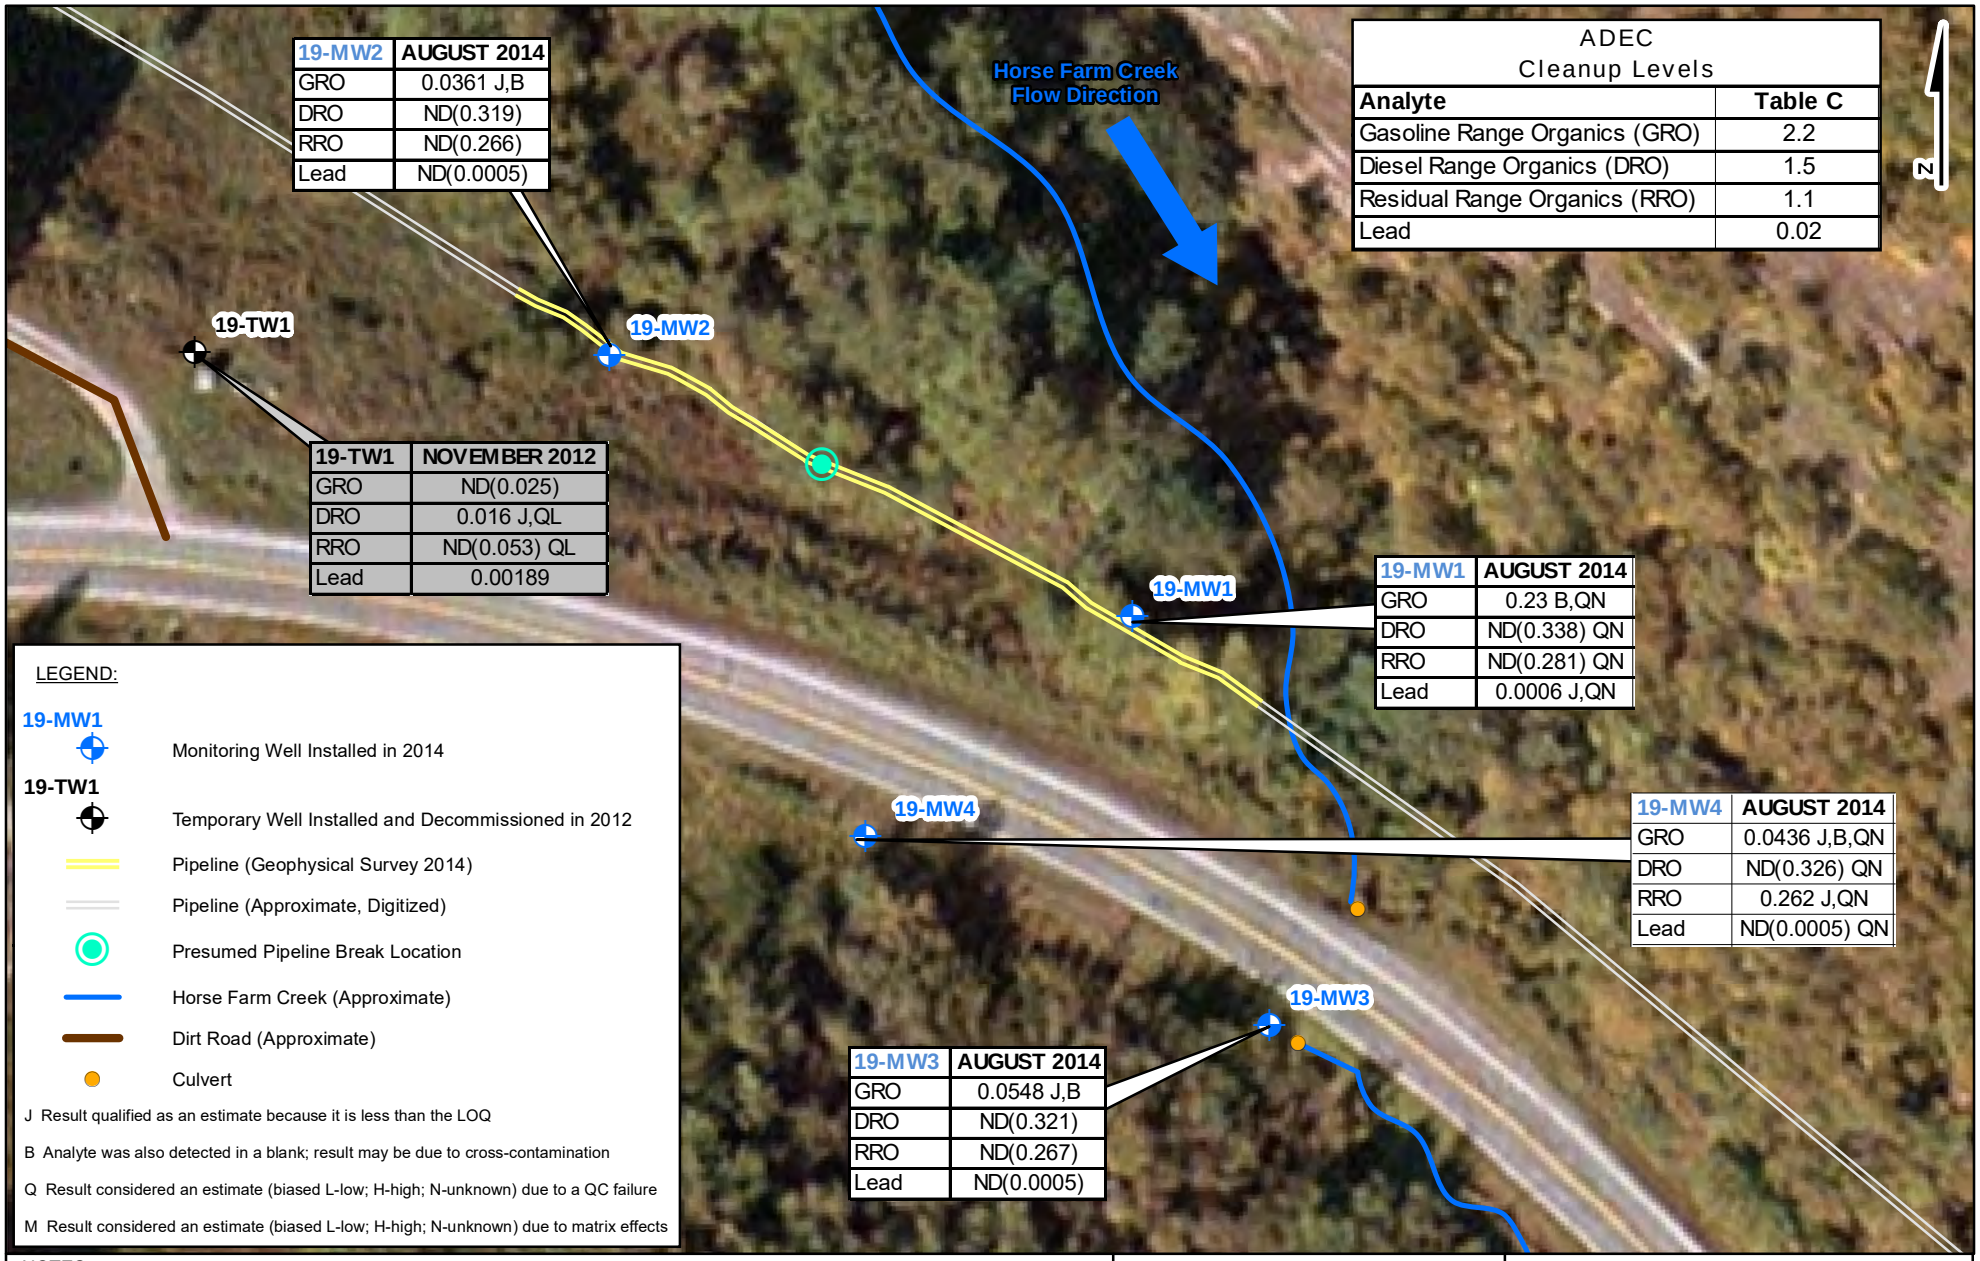
Contract: W911KB-12-D-0001, TO29	Figure: 4-2	Date: 12/14

Groundwater depth measurements were collected from each of the wells on July 27, 2014. Using the survey data (Appendix F), groundwater elevations were calculated (Table 4-2). As indicated by the groundwater surface elevation contours included on Figure 4-2, the groundwater flow direction in this area of the site follows the surface topography and Horse Farm Creek flow direction to the south-southeast. The horizontal hydraulic gradient was relatively flat, approximately 0.008 ft/ft.

2014 Groundwater Elevation Contours
Pipeline Milepost 19.5
Additional Environmental Investigation Report
Haines-Fairbanks Pipeline FUDS, Alaska
Project #: F10AK1016-03

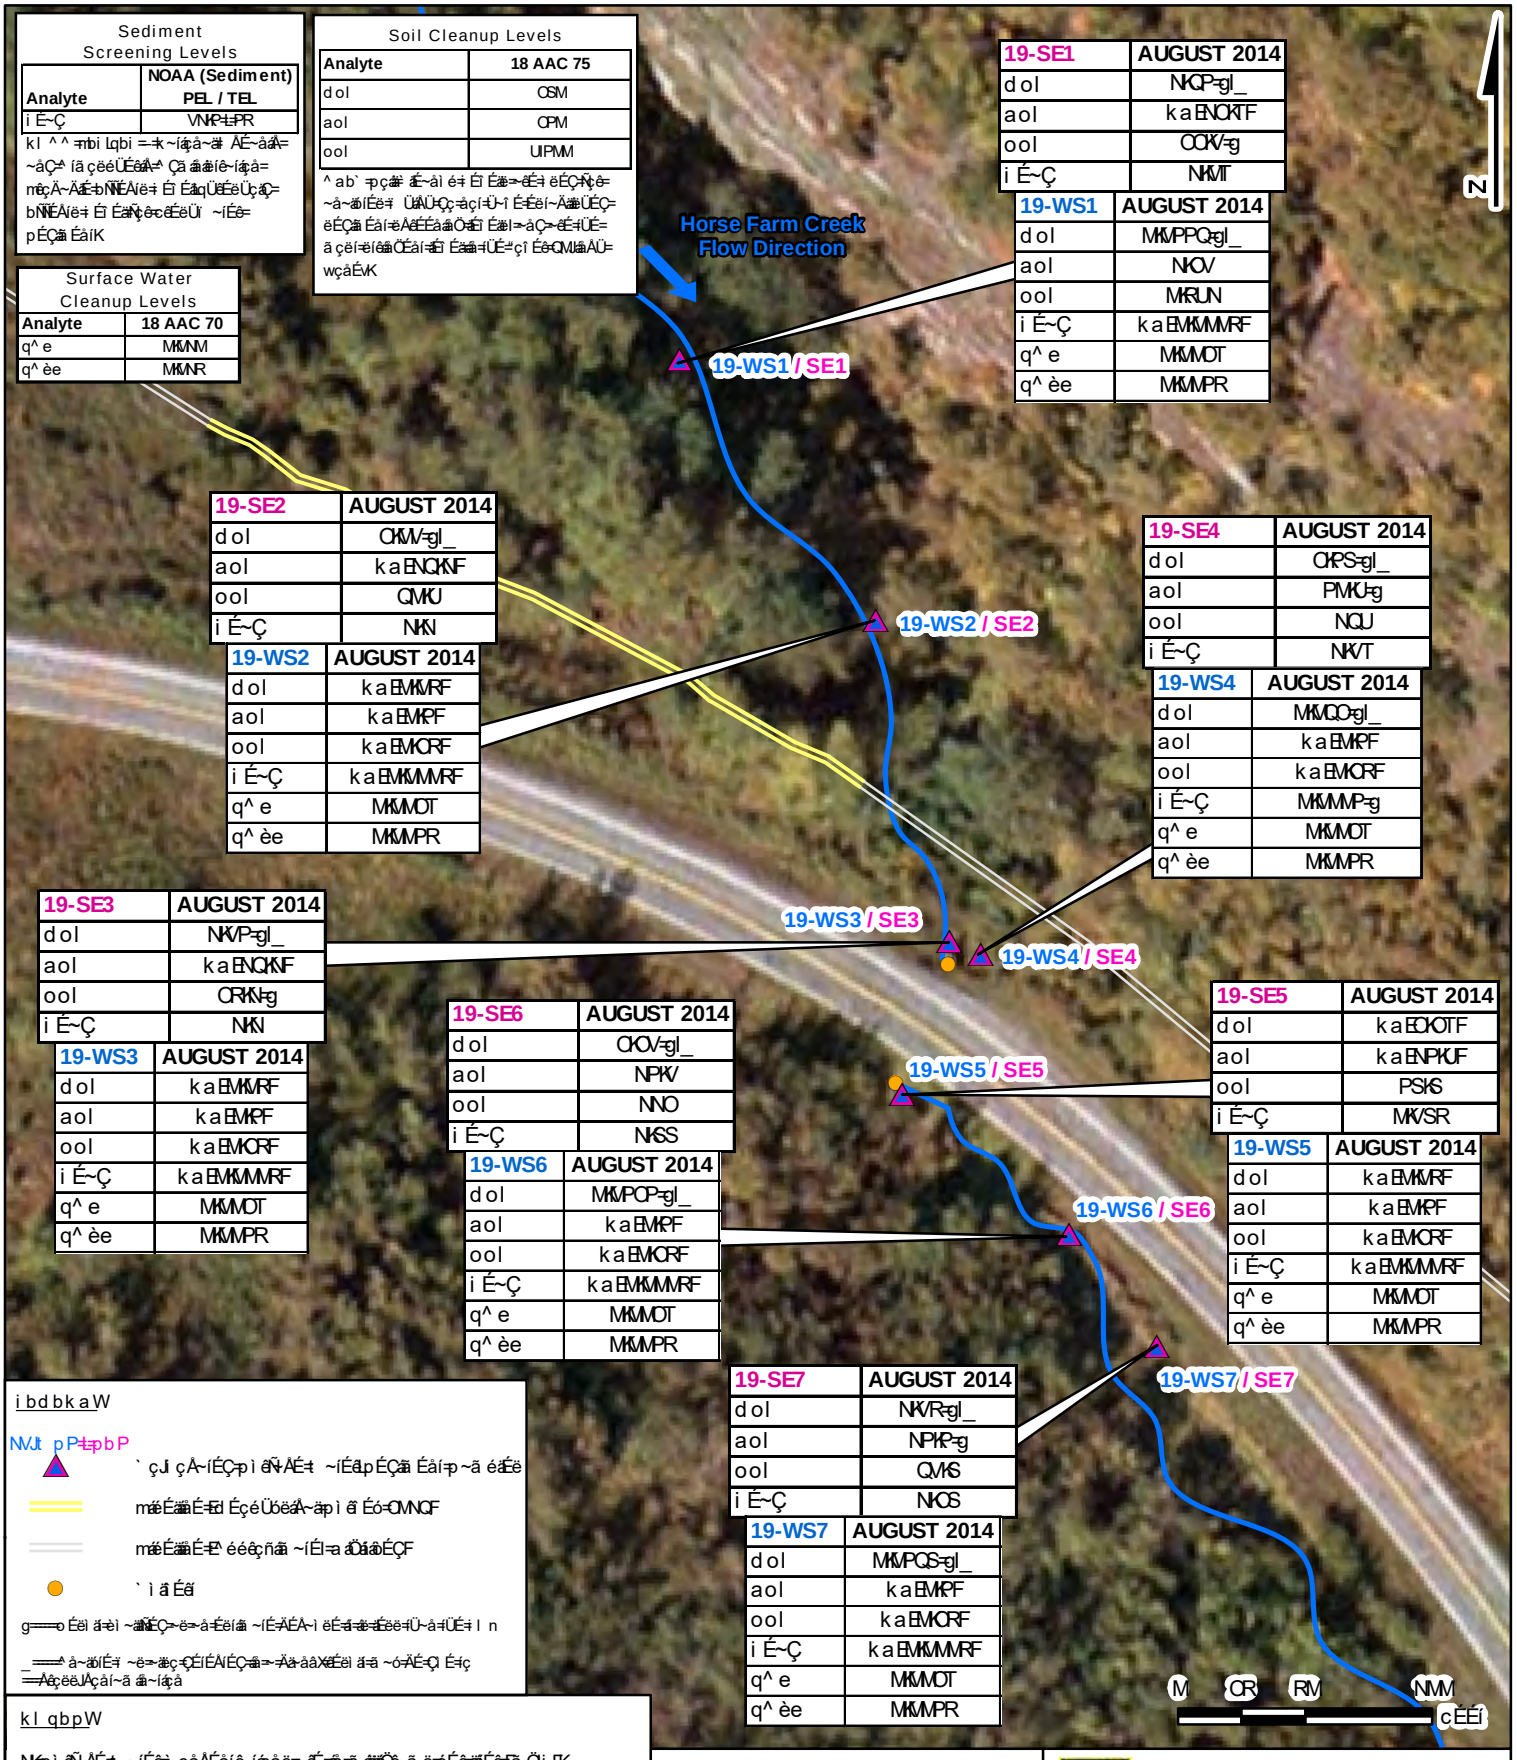
Contract: W911KB-12-D-0001, TO29 | Figure: 4-3 | Date: 12/14

19-MW2	AUGUST 2014
GRO	0.0361 J,B
DRO	ND(0.319)
RRO	ND(0.266)
Lead	ND(0.0005)

Contaminant Concentrations in Groundwater Samples
Pipeline Milepost 19.5
Additional Environmental Investigation Report
Haines-Fairbanks Pipeline FUDS, Alaska
Project #: F10AK1016-03

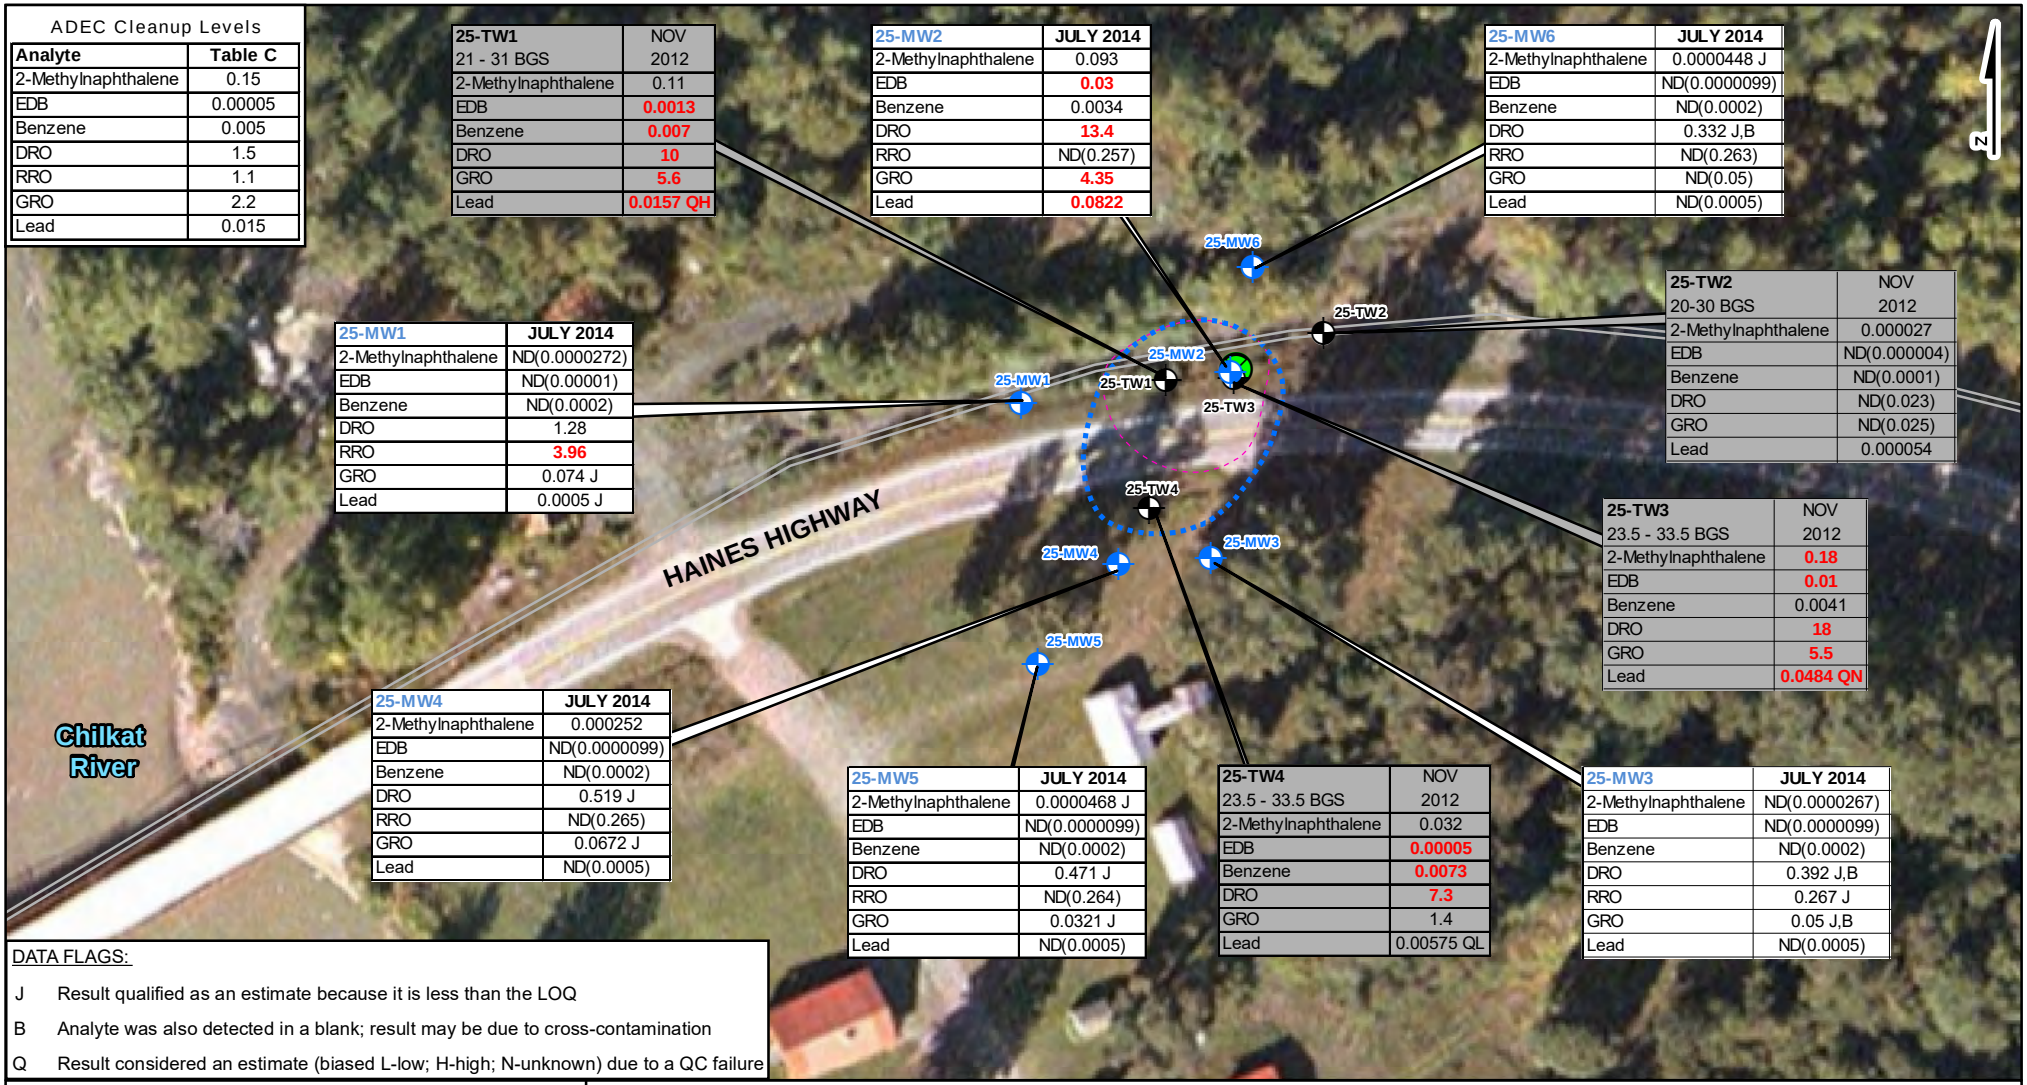
Contract: W911KB-12-D-0001, TO29	Figure: 5-2	Date: 12/14

Groundwater depth measurements were collected from each of the wells on July 30, 2014. Using the well survey data (Appendix F), groundwater elevations were calculated for each of the wells (Table 5-2). Groundwater contours shown on Figure 5-2 indicate the flow direction is towards the southwest towards the Chilkat River, similar to the groundwater flow direction observed during the 2012 RI. Groundwater elevations were approximately 3 feet higher in July 2014 than November 2012. The horizontal hydraulic gradient was relatively flat, approximately 0.002 ft/ft, which was slightly steeper than indicated by the 2012 data.

2014 Groundwater Elevation Contours
Pipeline Milepost 25.5
Additional Environmental Investigation Report
Haines-Fairbanks Pipeline FUDS Alaska
Project #: F10AK1016-03

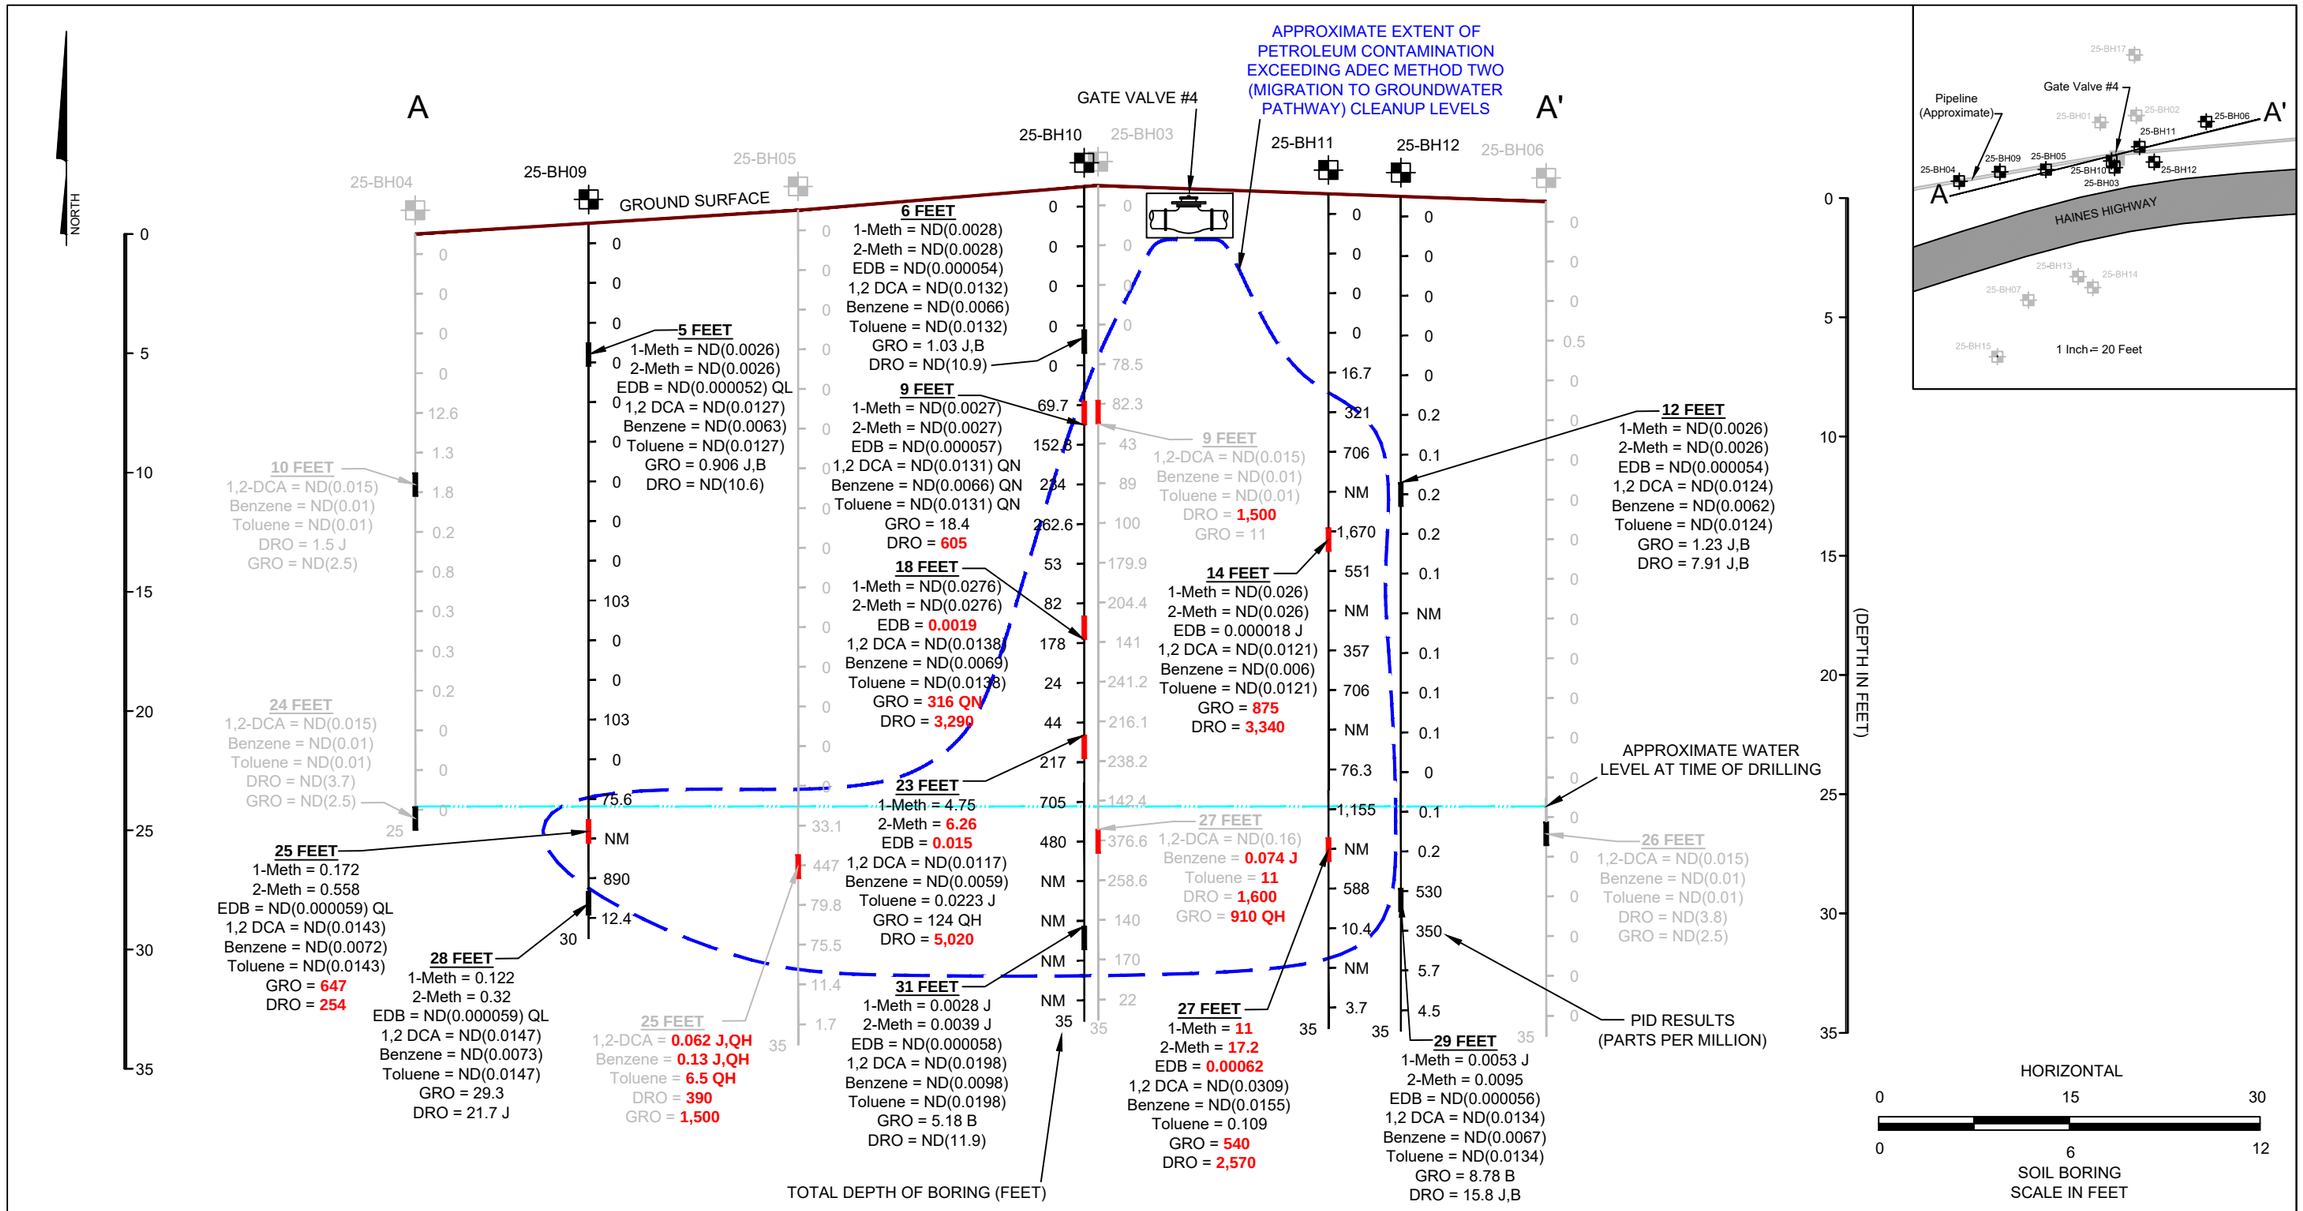
The groundwater plume appears to have originated from the gate valve area and migrated south and west in the direction of groundwater flow. The estimated extent of groundwater contamination is approximately 7,000 sq. ft. The groundwater flow direction was determined to be towards the southwest and the Chilkat River. However, considering that fuel releases occurred over 40 years ago, there has been limited contaminant migration. Groundwater geochemistry indicates that the aquifer is reduced in the contaminated area near the gate valve, indicating that biodegradation has occurred at the site. Additional groundwater sampling should be conducted to evaluate contaminant trends, the potential for contaminant migration, and the effectiveness of natural attenuation as a remedial option.

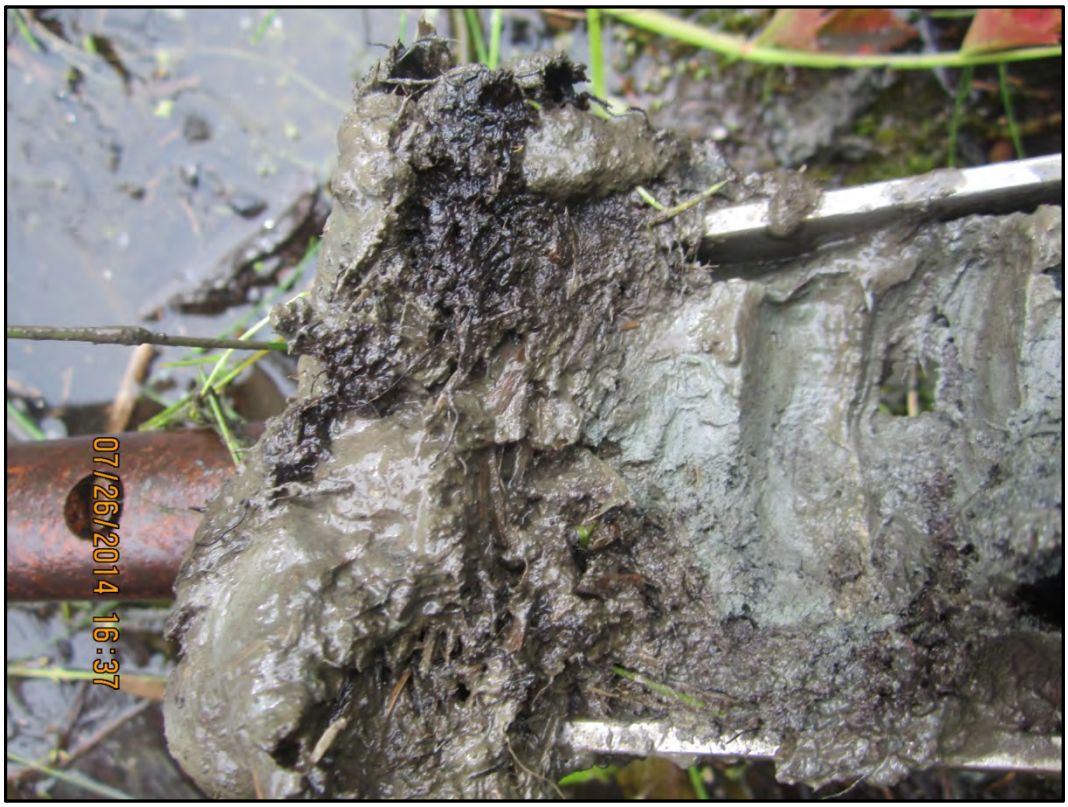
Photograph 16 – All wetland sediment samples contained swamp grass organics on top of the sediment.

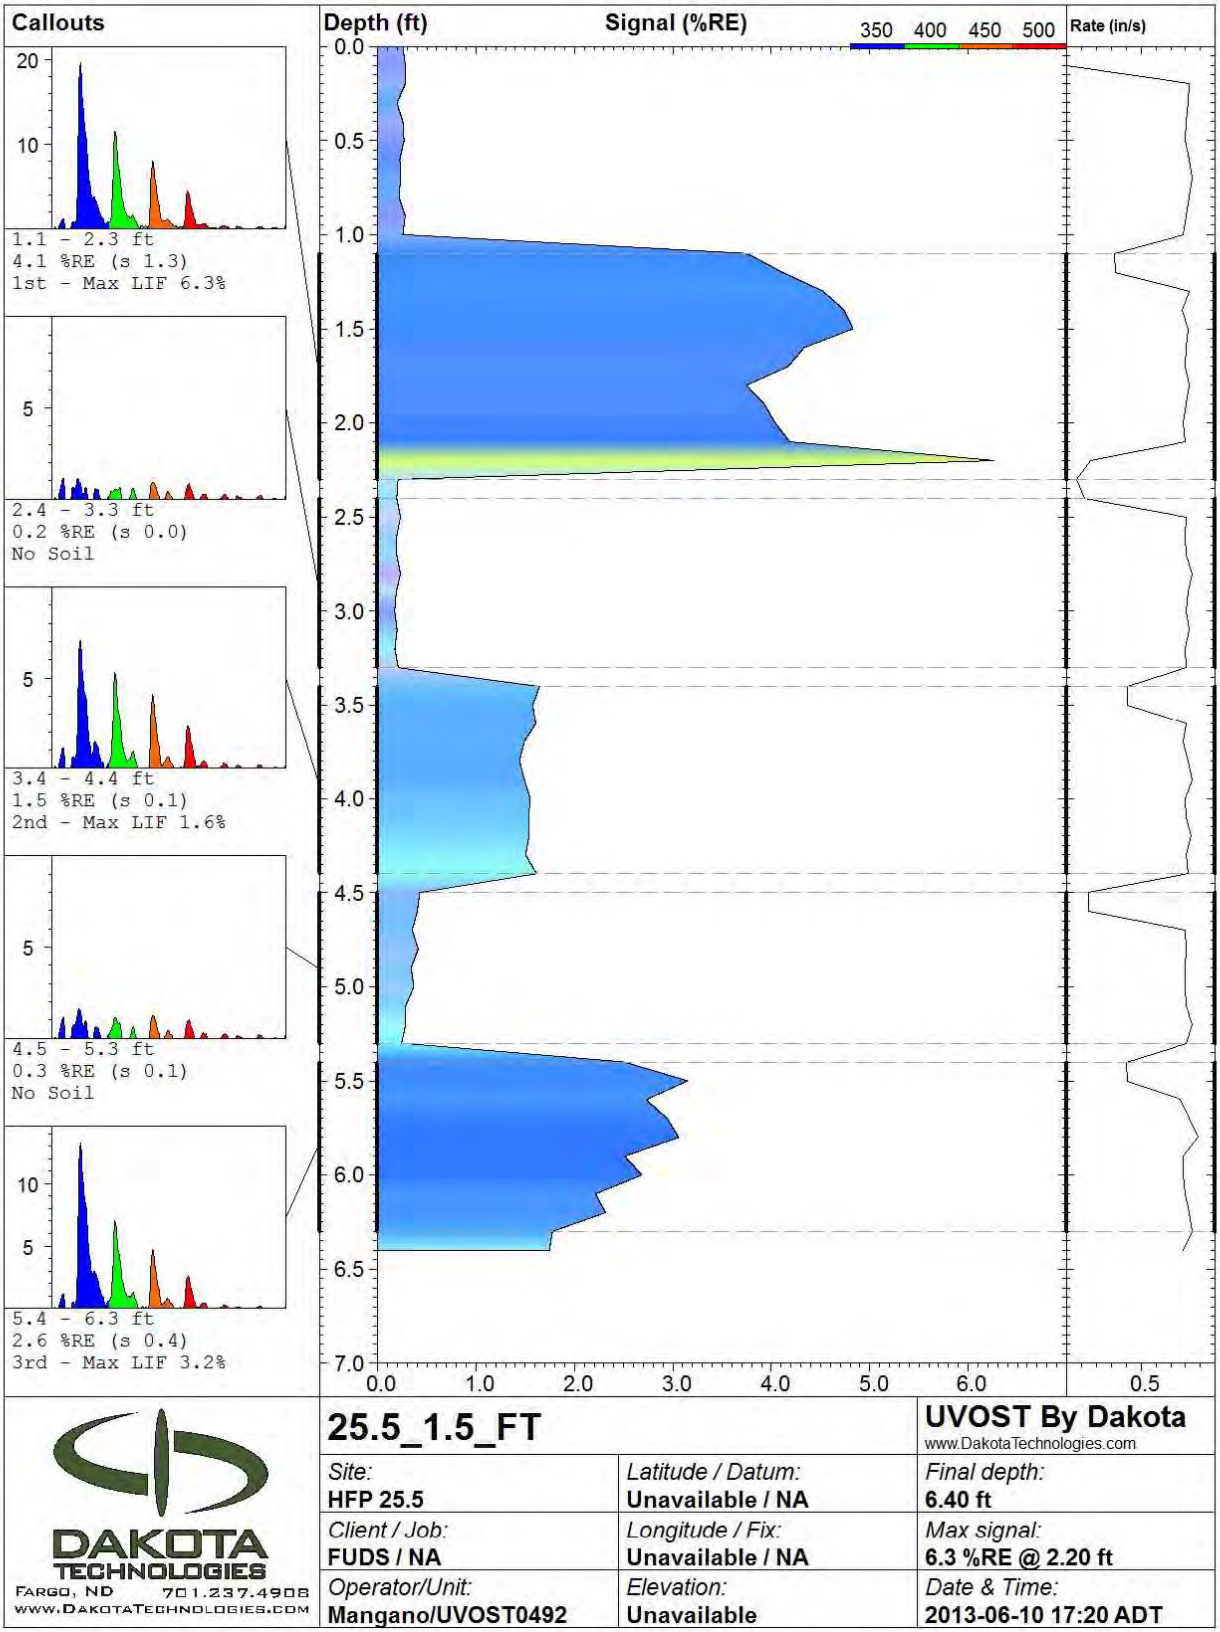
Figure 2: UVOST Log

The second task involved collecting soil samples from the gate valve located adjacent to the Jacquot property. The bottom of the valve pit was approximately 36" below the surrounding ground surface. A hand auger was used to collect soil increments from the 18" and 36" intervals beneath the floor of the valve pit (approximately 4.5 and 6 feet below ground surface). Soils from these depths were screened using a PID and the one with the highest response was further screened with a UVOST to determine the suitability of this technology to detect the fuel type at this project site. The 36" deep soils were screened with the UVOST and fuel signatures were detected by the tool. See figure 2 for the UVOST log. Based on these results, it appears that the UVOST would be a useful tool for delineating fuel contamination in this area.
