**TECHNICAL MEMORANDUM**

**SUBJECT:** Joint Base Elmendorf-Richardson Conceptual Site Model  
Anchorage, Alaska  
FA3002-07-D-0015, TO 0015

This technical memorandum presents the results of a Base-wide conceptual site model (CSM) for Joint Base Elmendorf-Richardson (JBER) prepared for the Air Force by AECOM on behalf of the Air Force Civil Engineer Center (AFCEC). The evaluation consisted of three principal tasks:

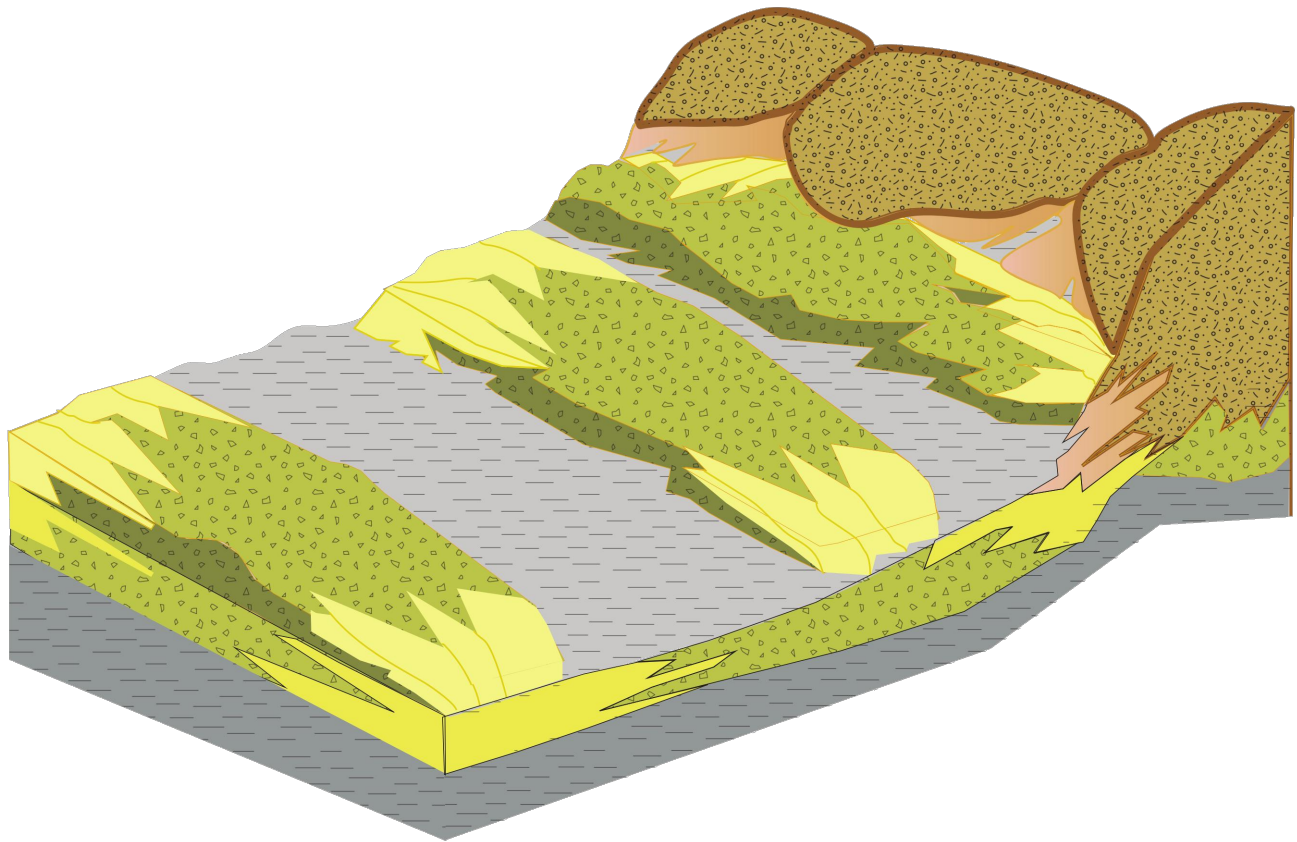
**Figure 3**

# JBER STRATIGRAPHIC MODEL, ELMENDORF AREA

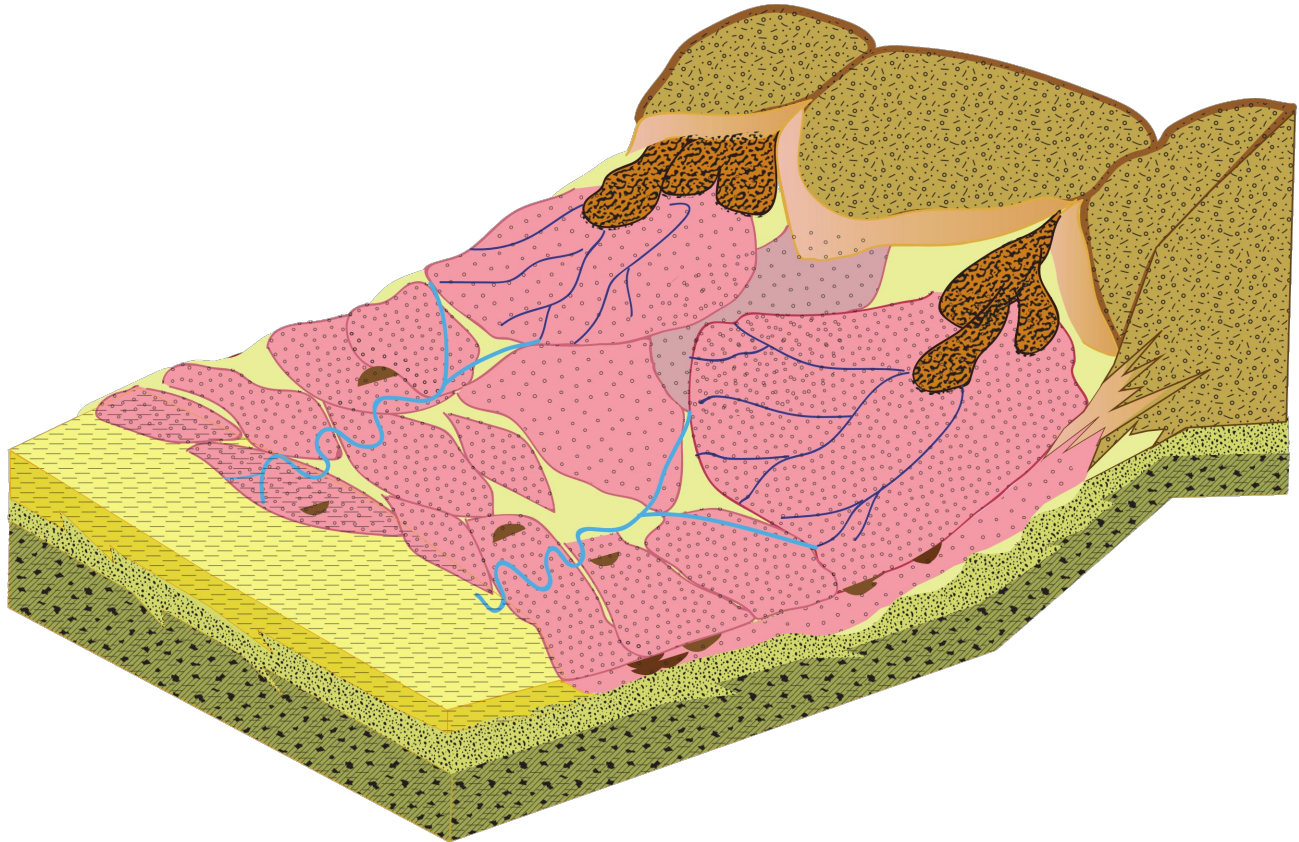
**Figure 4**

# JBER STRATIGRAPHIC MODEL, FORT RICHARDSON AREA

The oldest strata encountered in boreholes in the Fort Richardson area consist of diamictons and claystones (**Figure 4**) that bear resemblance to the Bootlegger to the west (and may represent a similar mechanism of origin).
